## INCIDENT REPORT

**INSPECTION #:** 1462559

**REPORT DATE:** April 27, 2020

## Municipal Employee Fatally Injured While Jumpstarting Mobile Equipment

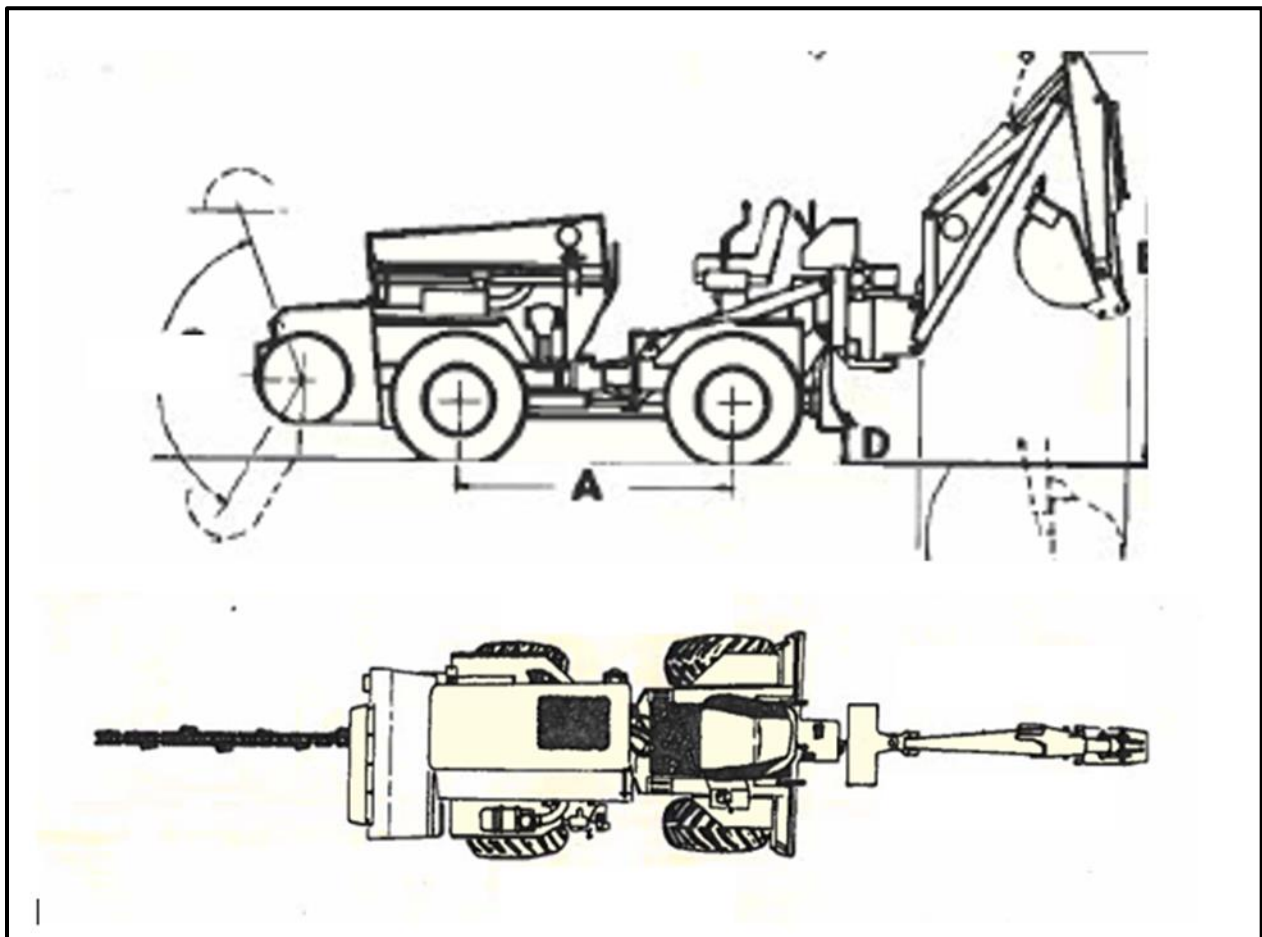
Figure 1 – Davis Fleetline 30+4 Trencher.

The piece of mobile equipment involved was a Davis Fleetline 30+4 Trencher manufactured in 1976 and purchased new by the city. The trencher is used to perform earth moving by use of a trenching boom arm or backhoe attachment. The trencher is propelled by a four-wheel-drive hydrostatic transmission with two mechanisms, the creep control knob (figure 11) or the “mono-stick” (figure 9), to control forward and reverse travel and one mechanism, the “mono-stick”, to control mid-body articulation. Due to the design of the closed loop hydrostatic transmission, the trencher cannot be towed without removing two drive shafts. The operator's manual was kept separate from the trencher at the city water/sewer building. The employer was able to produce the original operator's manual within fifteen minutes of IL-OSHA's request.

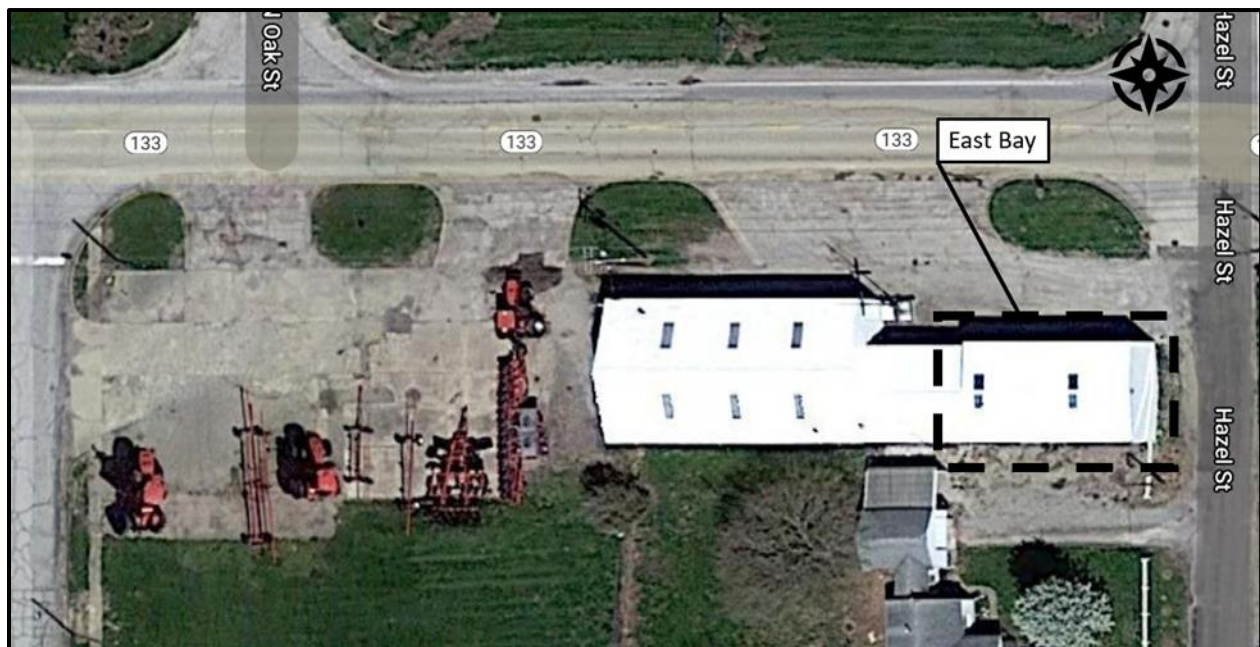
*Figure 2 – City streets/alleys building.*

The east vehicle bay of the city streets/alleys building is of post and beam construction, metal skinned, with no insulation and a 20' sliding door located on the north wall. The roof is of gable construction, with the ridge running east to west. The bay is approximately 50' long x 30' wide x 20' high (figure 2). The bay is unheated with a dirt floor. It has electricity and is illuminated with overhead lights. Illumination is poor, requiring flashlights to make out details.

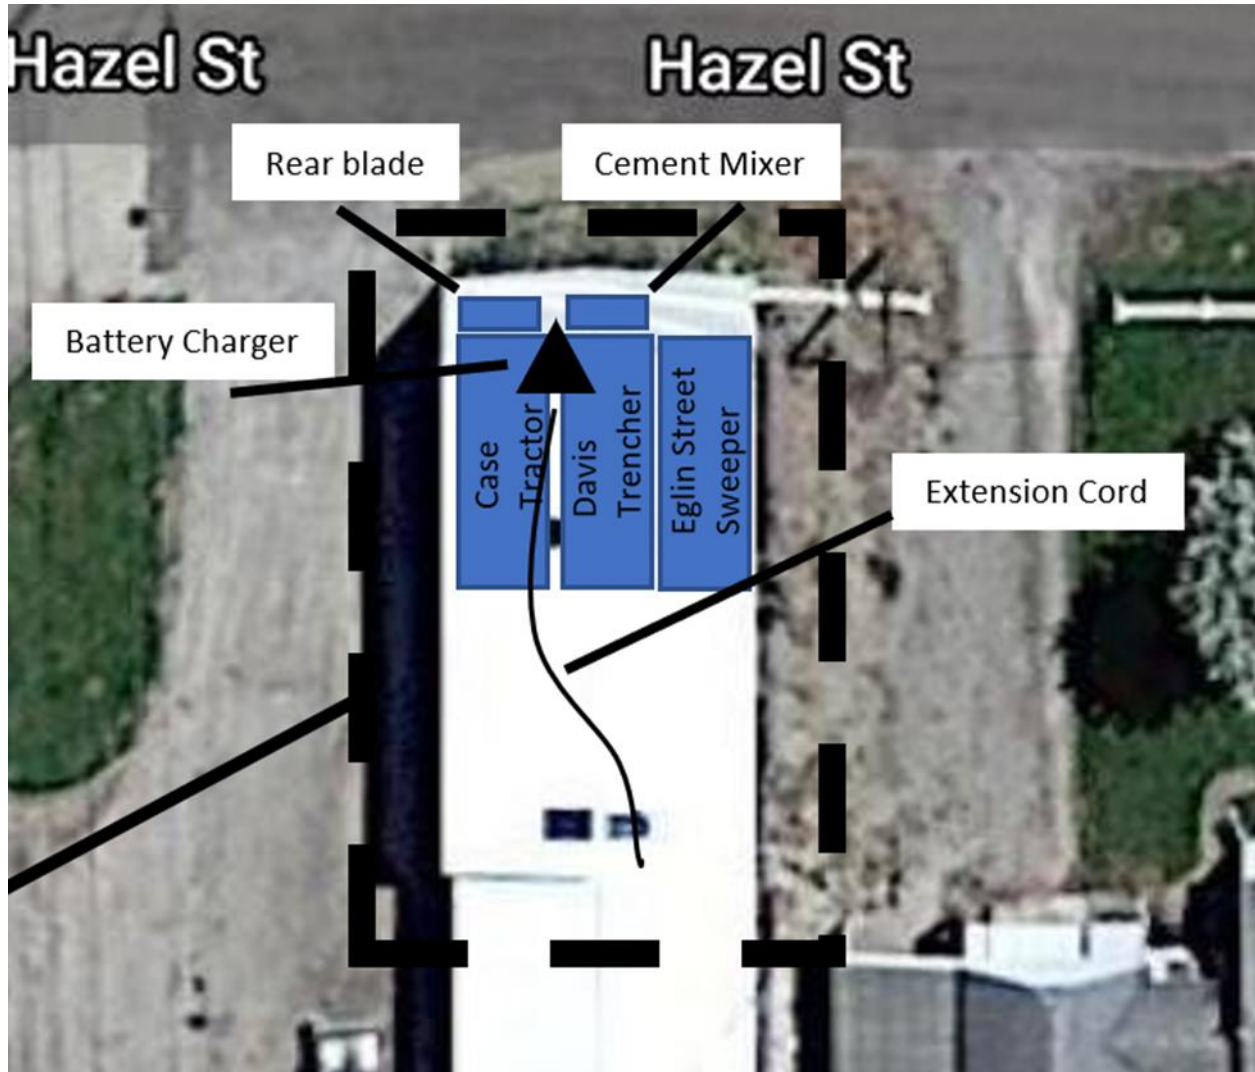
At the time of the incident, the trencher was co-mingled with several other pieces of equipment to include: A Case L-Series tractor with an attached finish mower, a three-point-hitch rear blade attachment, a battery charger connected to an extension cord, a Wikomi three-point-hitch cement mixer, and an Eglin street sweeper (figures 3-6). Close placement of equipment resulted in limited walking and working areas between

equipment. No rafter-supported chain hoist or other lifting equipment was present. The battery charger was observed between the tractor and trencher (figure 3). NOTE: A floor jack was brought in to facilitate rescue operations after the incident occurred.

Figure 3 – East vehicle bay showing place of equipment and implements.

- Ensure equipment storage areas have adequate work space for employee movement and access.
- Ensure equipment storage areas have adequate lighting.
- If possible, replace older generation mobile equipment with newer generation equipment that contains features such as safety interlocks that do not require action by the user.

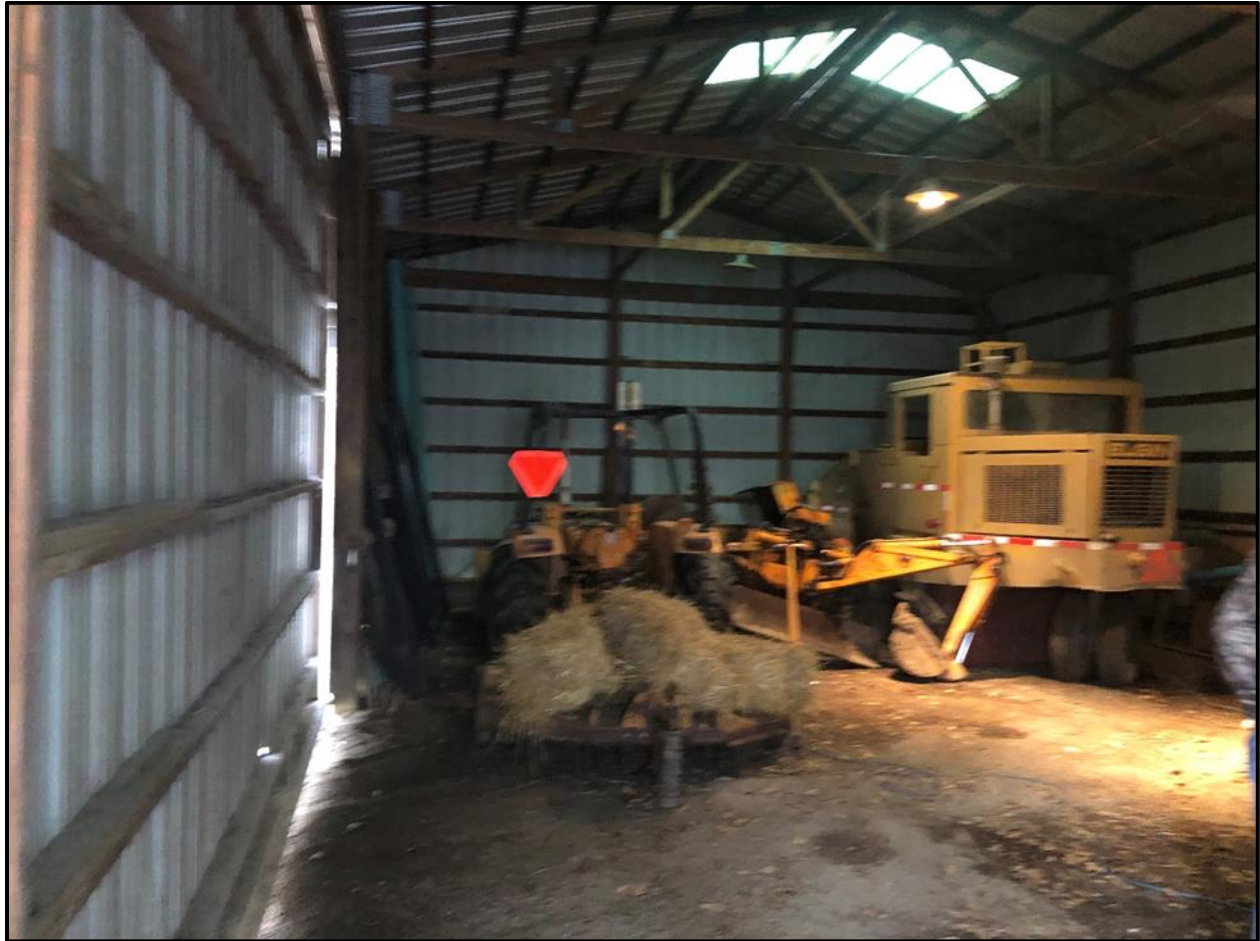
4. Close placement of equipment in the vehicle bay resulted in limited walking and working areas between equipment and could have caused the victim to unintentionally engage the creep control lever or “mono-stick” due to restricted movement. When the trencher came to rest, it left approximately 11-inches between the tractor's southeast (right-front) wheel and the trencher's northeast (left-front) wheel along a north/south axis. Based on field measurements and tire dimensions, the tractor's and trencher's tires would have aligned in a north/south axis, requiring the victim to either step over, on, or in between tires, thereby increasing the likelihood of slips, trips and falls.

*Figure 4 – East vehicle bay (standing west looking east).*

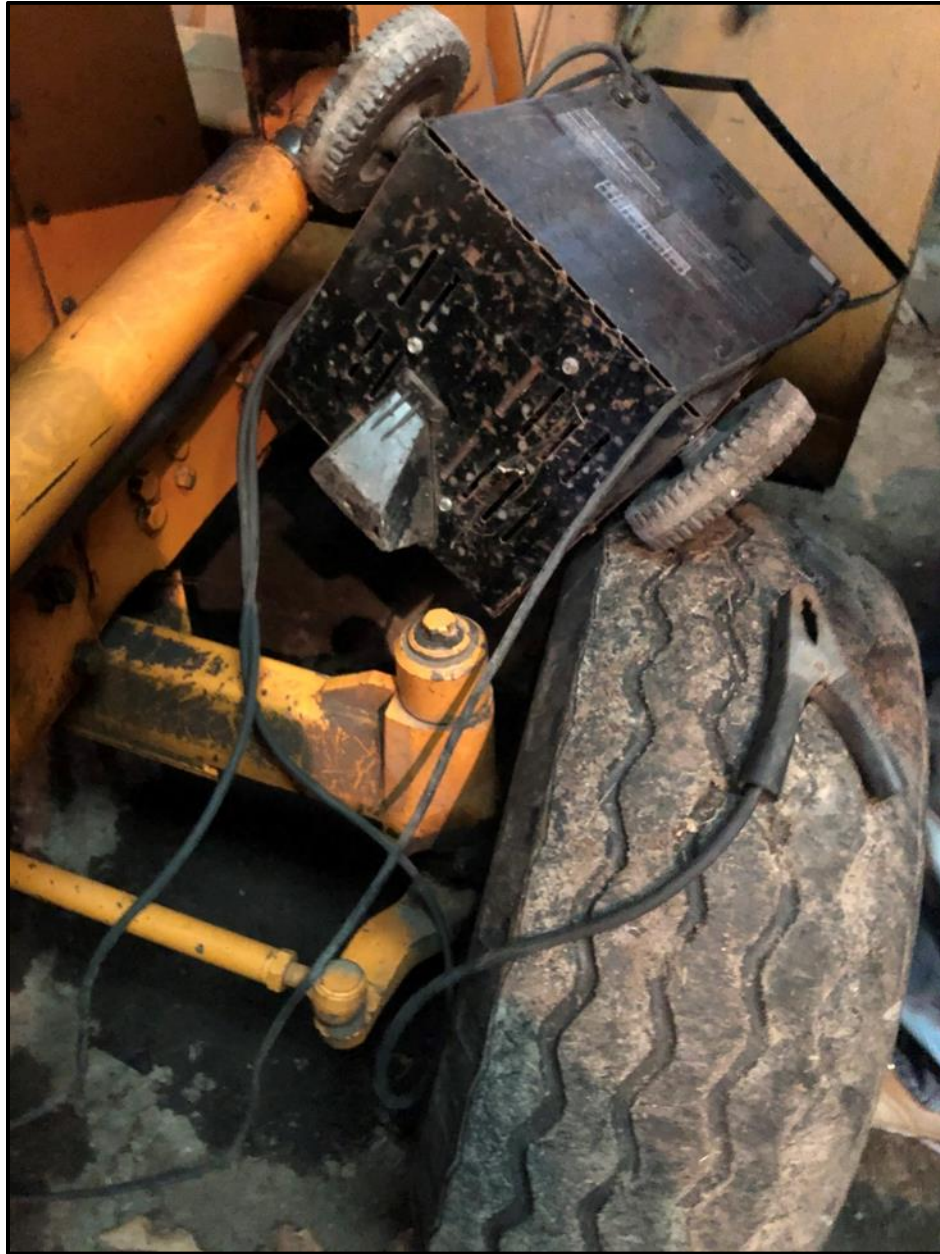
*Figure 5 – Case L-Series Tractor, southeast wheel.*

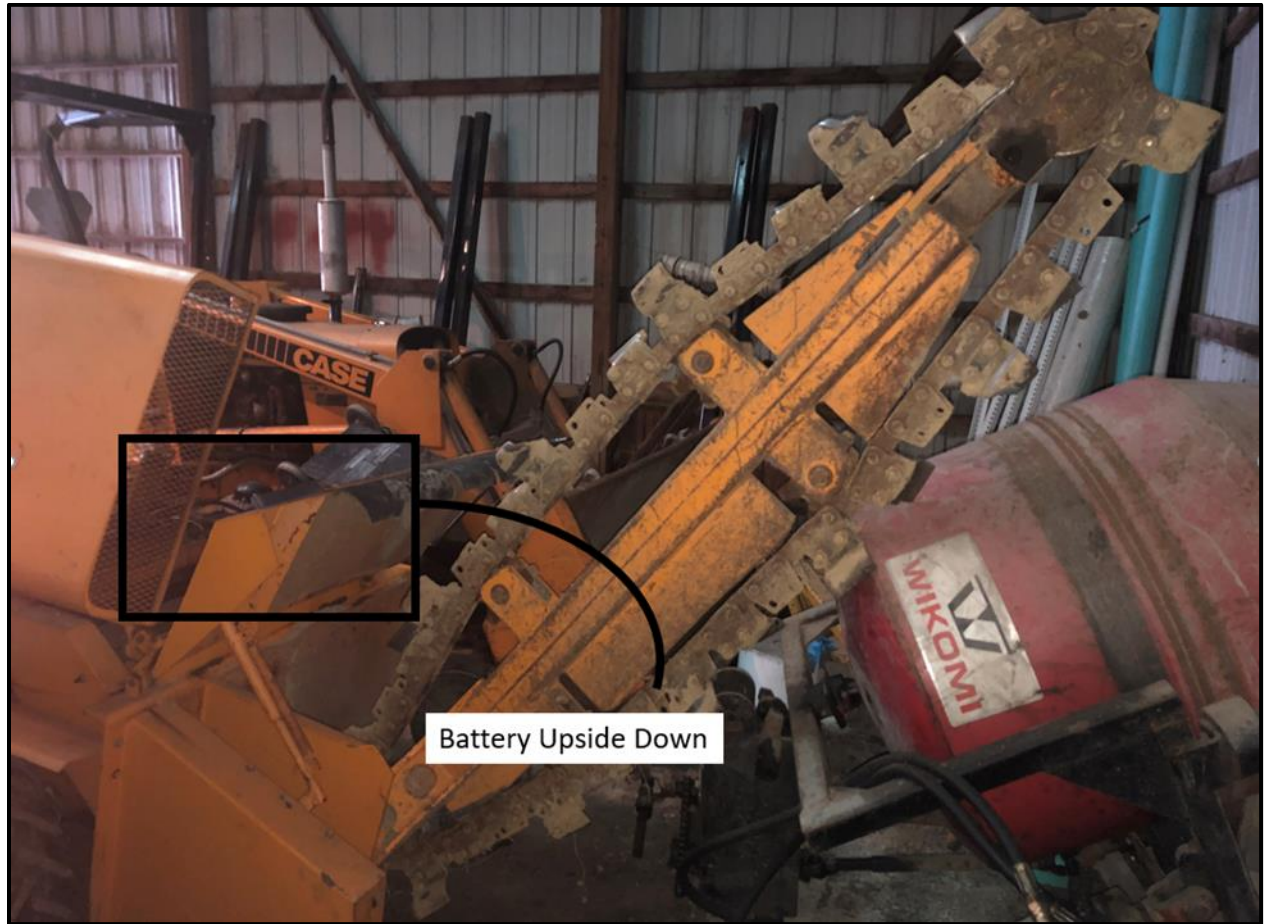
Figure 6 – Standing south of trencher (facing north).

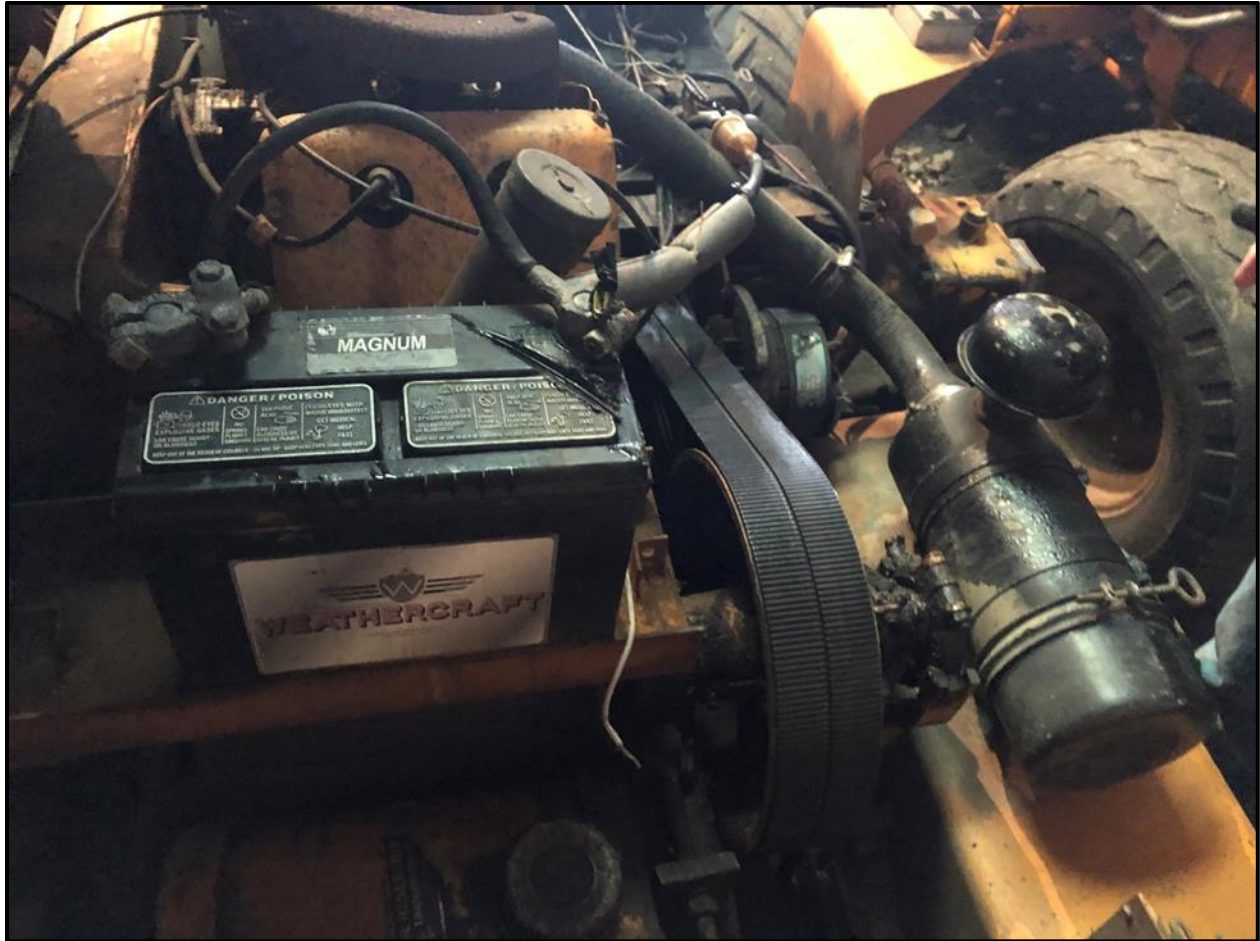
IL-OSHA inspectors arrived at the streets/alleys building on February 11<sup>th</sup> at approximately 3:15 PM to investigate the incident. The public works superintendent confirmed that the scene of the incident had not been altered since removal of the victim's body. Observations were as follows: The battery charger was displaced by first responders and came to rest upside down on the Case tractor's southeast tire (figure 5) with the charging cables located between the tractor's south wheelbase gap. The trencher's battery was displaced outside of the battery box (figure 6) coming to rest upside down, resting on the friction clutch (driven sheave assembly). The trencher's battery sustained friction burns due to contact with a moving belt (figure 7). The trencher's creep lock lever was in the down position (see figure 8).

It was determined through employee interviews that the trencher had electrical issues that required the battery to be charged to start it (jumpstarted). An electrical cord was observed running from the west wall along the floor to the battery charger. The battery charger cables were observed to be attached to the trencher's battery according to statements from on scene emergency personnel.

*Figure 7 – Trencher battery with friction damage.*

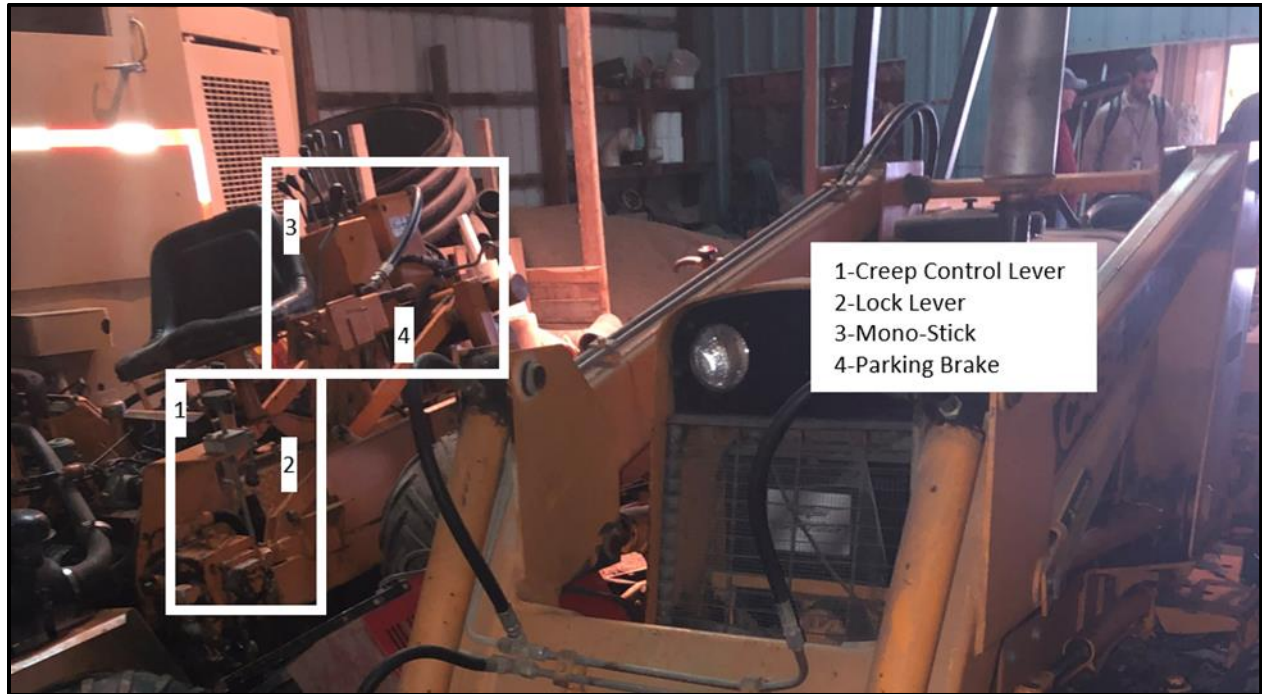
The trencher's parking brake was in transport mode, physically in the down position (see figures 8 & 9). The trencher's starter safety latch was flipped away from the "mono-stick" and was resting in the down position (figure 9). The trencher's warning stickers were in place and legible. Based on impressions on the dirt floor, the following measurements are approximate: The trencher's hydraulic angle backfill blade moved 12" from west to east (rear to front), the southwest (right-rear) tire moved 30" from west to east (rear to forward), the southeast (right-front) tire moved 32" from west to east (rear to front), the concrete mixer's front shoe (west end) moved 5" from north to south. Based on measurements on the concrete mixer drum, the trencher's digger boom arm teeth appeared to have contacted and scraped the mixer drum paint from west to east approximately 5".

1. The trencher's parking brake was not functional and was not engaged at the time of the incident (see figures 8 and 9). During interviews, it was determined employees do not routinely utilize the trencher's parking brake as part of shut down procedures. The trencher's parking brake has dry friction pads that contact the driveline when engaged. A functional and engaged parking brake would have immobilized the trencher, potentially preventing the incident. The original owner's manual, provided by the employer, states in several sections and warning statements to engage the parking brake before shutting down the equipment.

Figure 8 – Standing northwest, facing southwest (condition when IL-OSHA arrived).

- Perform periodic inspections of mobile equipment to ensure all components are functional. If an inspection reveals that a safety component is not functional, remove the equipment from service until it is repaired.

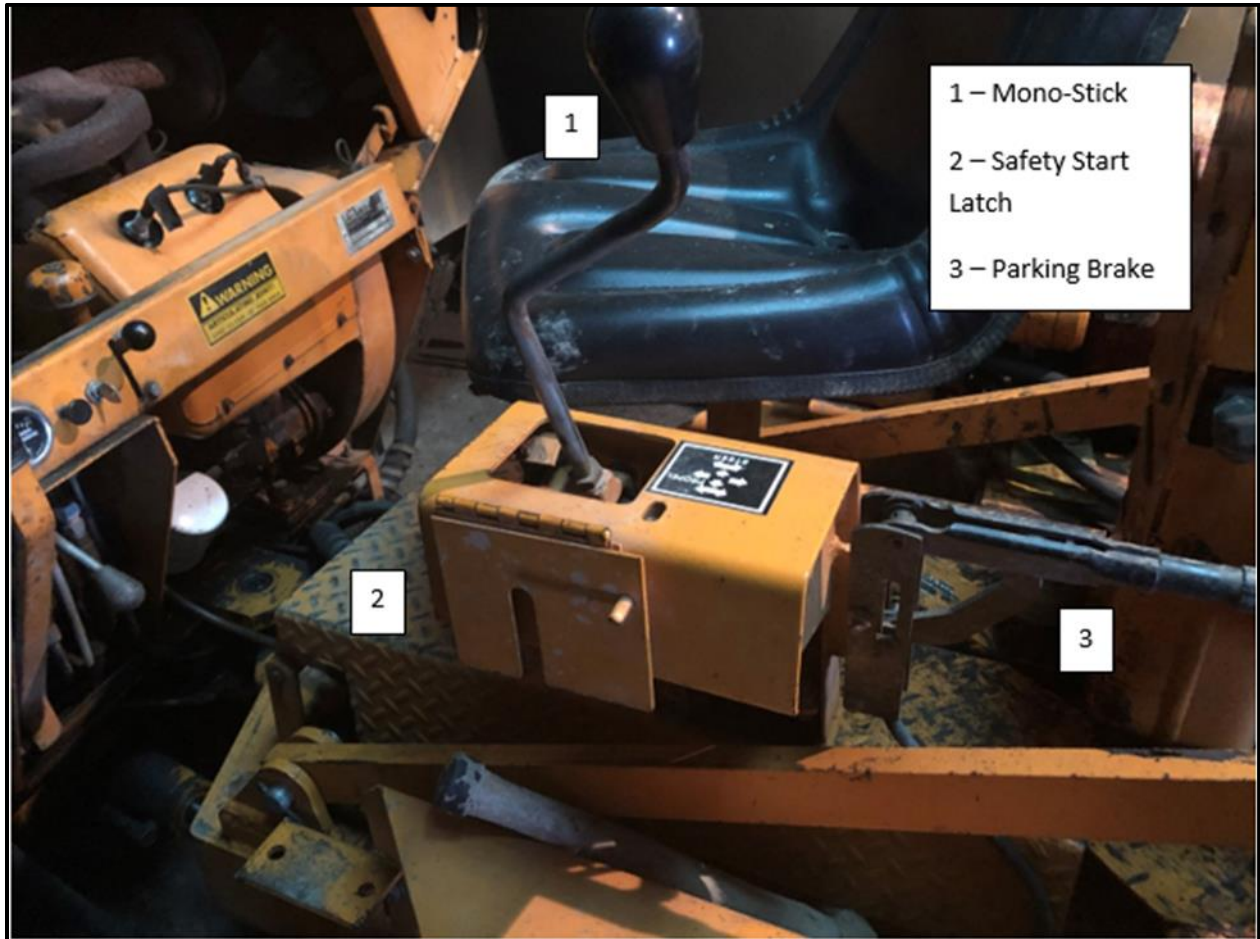
3. The trencher’s safety start latch was prematurely placed in a position to allow trencher movement for the work environment and task at hand. The original operator’s manual instructions outlined on page 21, as well as the trencher’s warning labels, were followed by the employee despite the outcome. The start latch acts as an interlock, ensuring the “mono-stick” is in a neutral position before engaging the starter, thereby preventing equipment from lurching during starting operations (see figure 10). Removing the start latch allows the propulsion system to function and avoids accidentally activating the starter (figure 9).

Figure 9 – "Mono -stick", safety starter latch and parking brake handle (condition when IL-OSHA arrived).

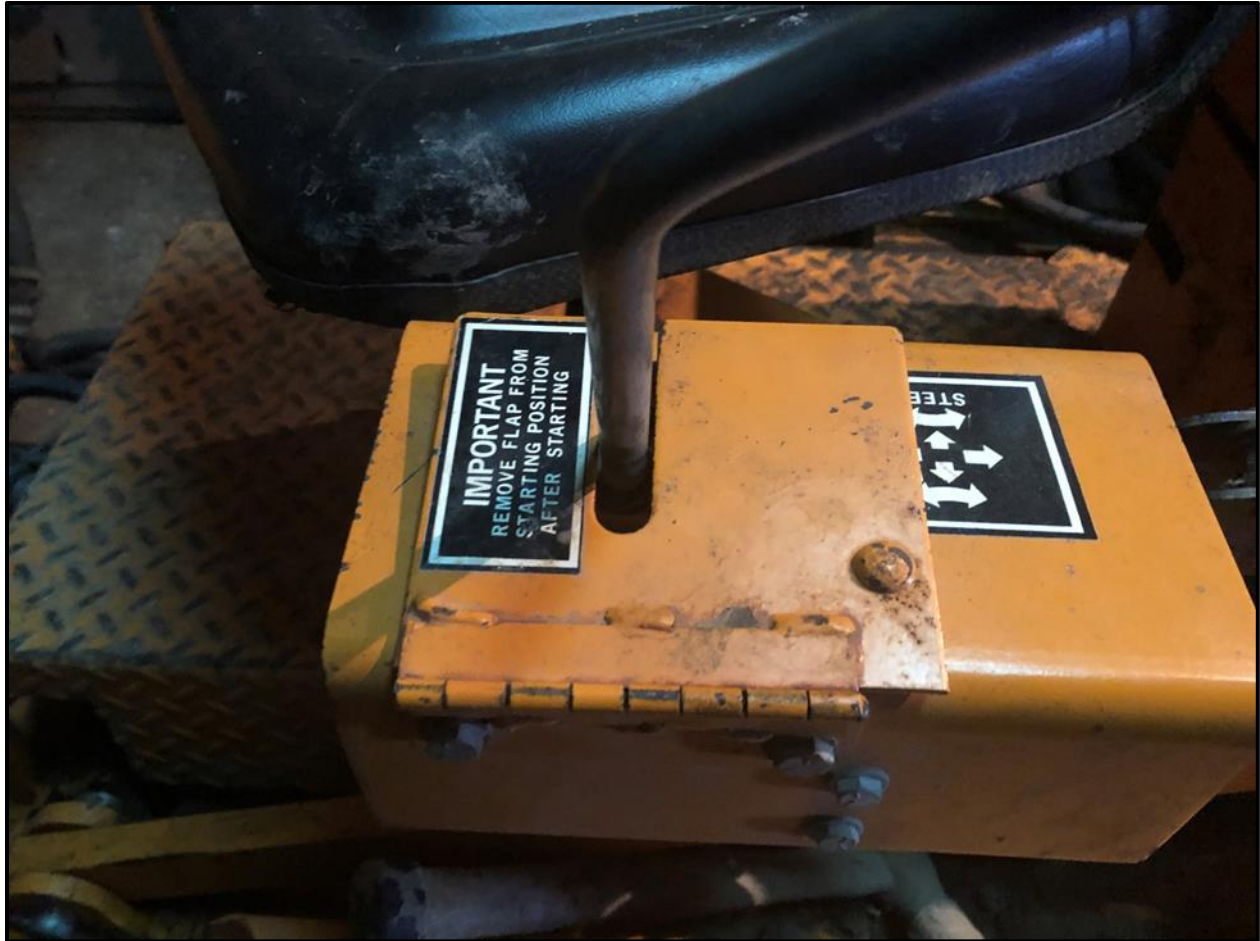
*Figure 10 – Safety start latch in "start" mode.*

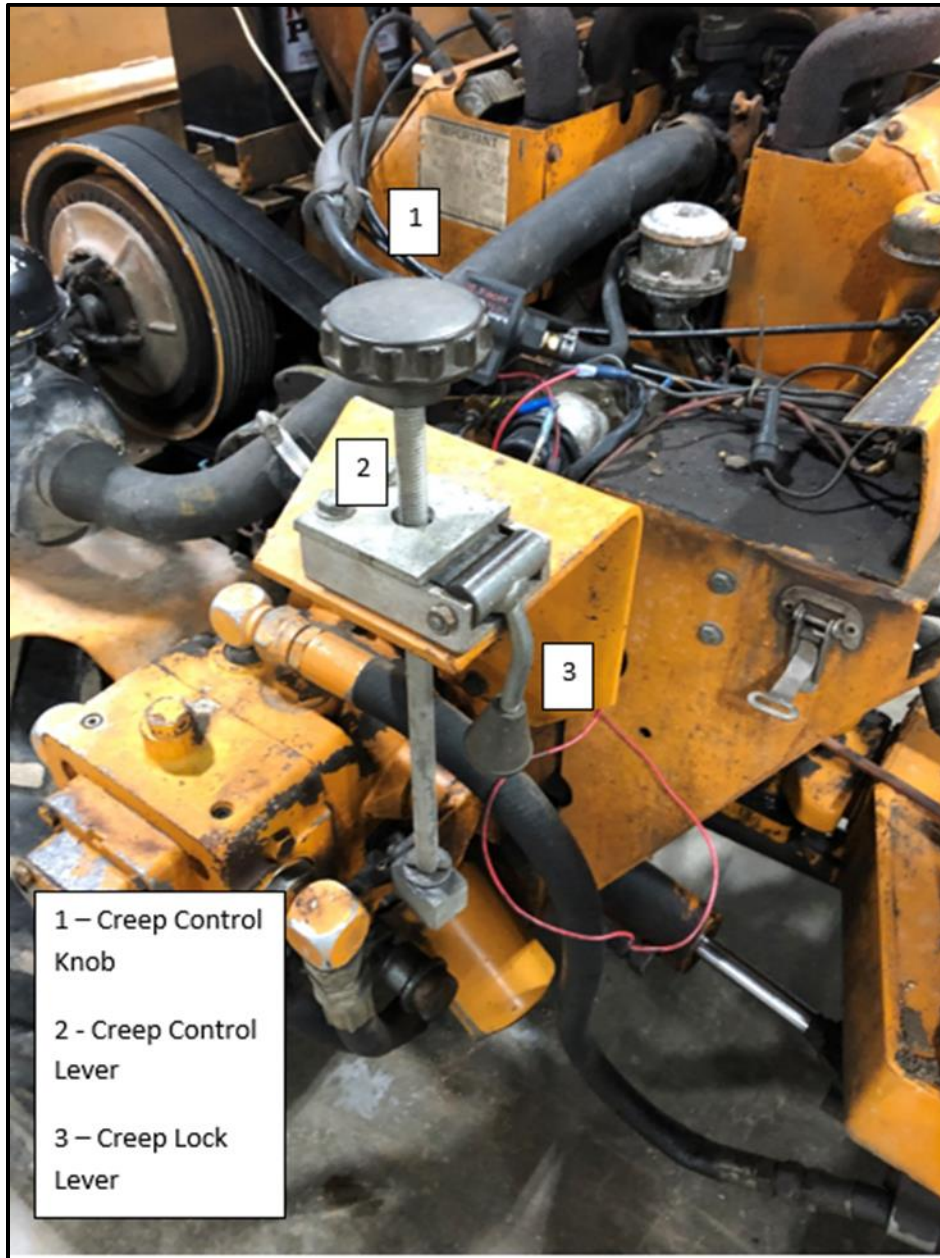
2. The trencher's creep lock lever was not engaged, thereby allowing the propulsion system to function. The creep lock lever is an L-shaped bracket hinged on the creeping control lever housing that prevents creep control lever movement by a friction lock wedged rubber block (figures 11 and 12). The original owner's manual does not address using the creep lock lever to prevent forward or rear movement but

Figure 11 – Creep lock lever in "unlock" position.

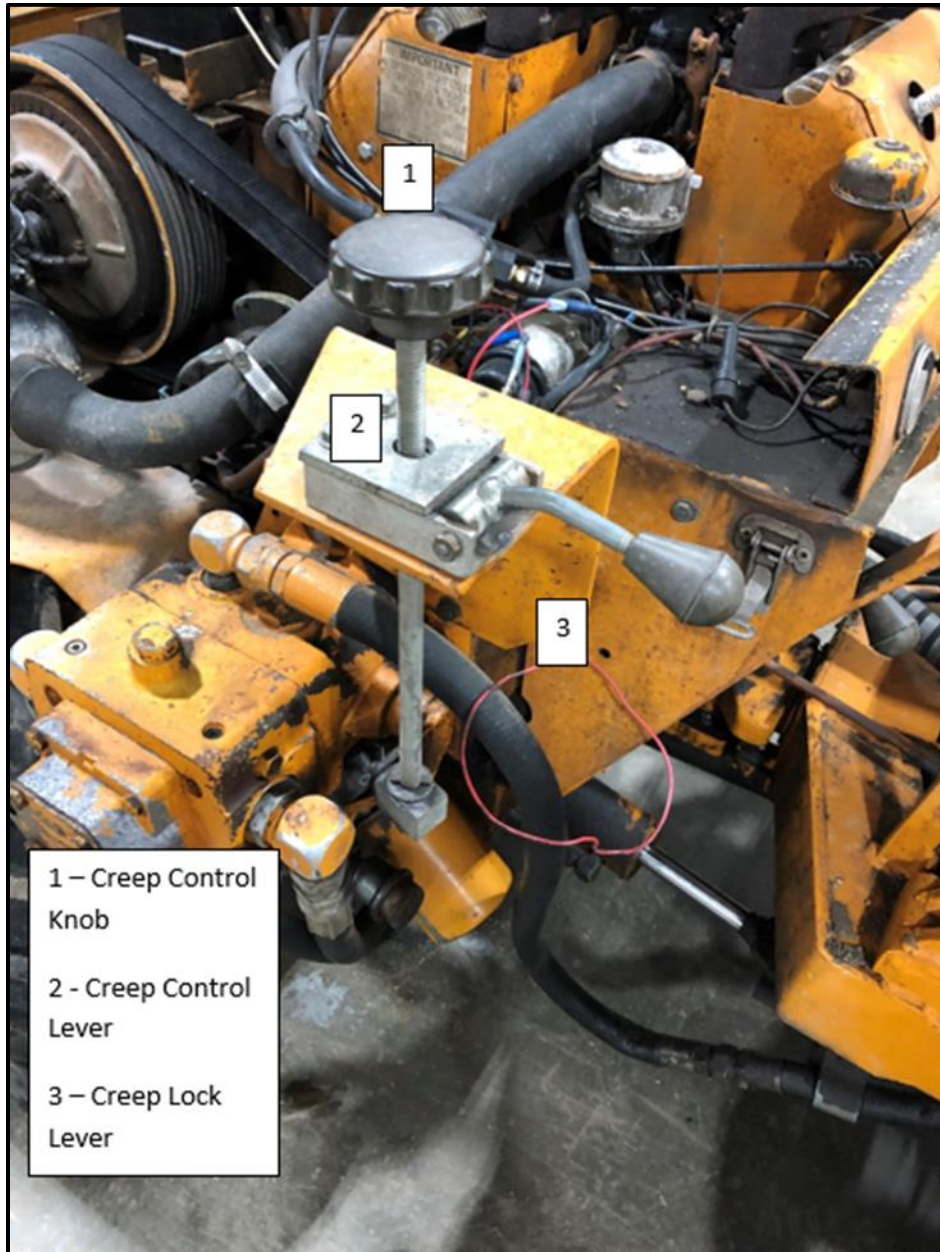
*Figure 12 – Creep lock lever in "lock" position.*
