## INCIDENT REPORT

**INSPECTION #:** 1515215    **REPORT DATE:** July 20, 2021

## Wastewater Plant Lead Operator Drowns in Clarifier in Cold Weather

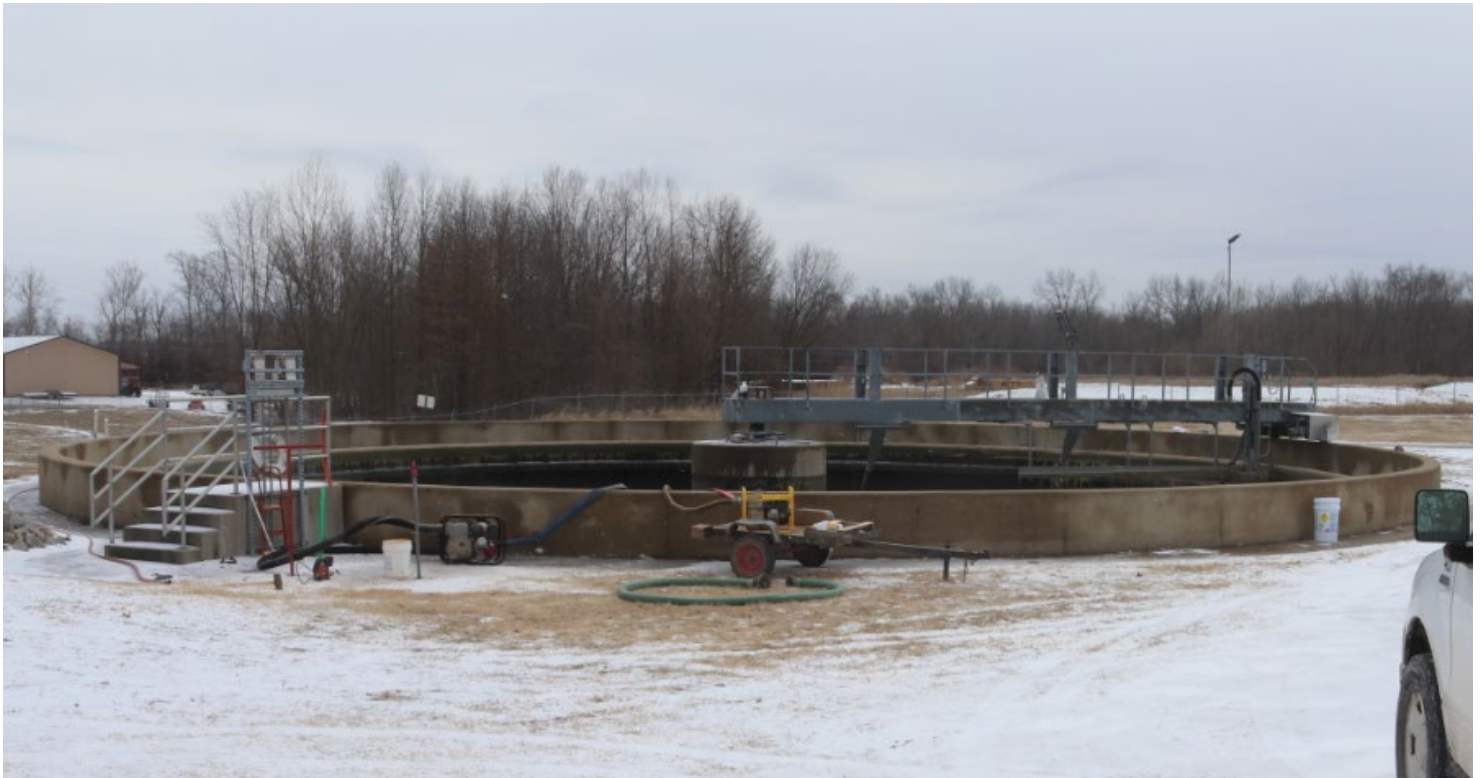
*Figure 1 – Clarifier on 2/14/21, post incident (photo credit: Illinois State Police).*

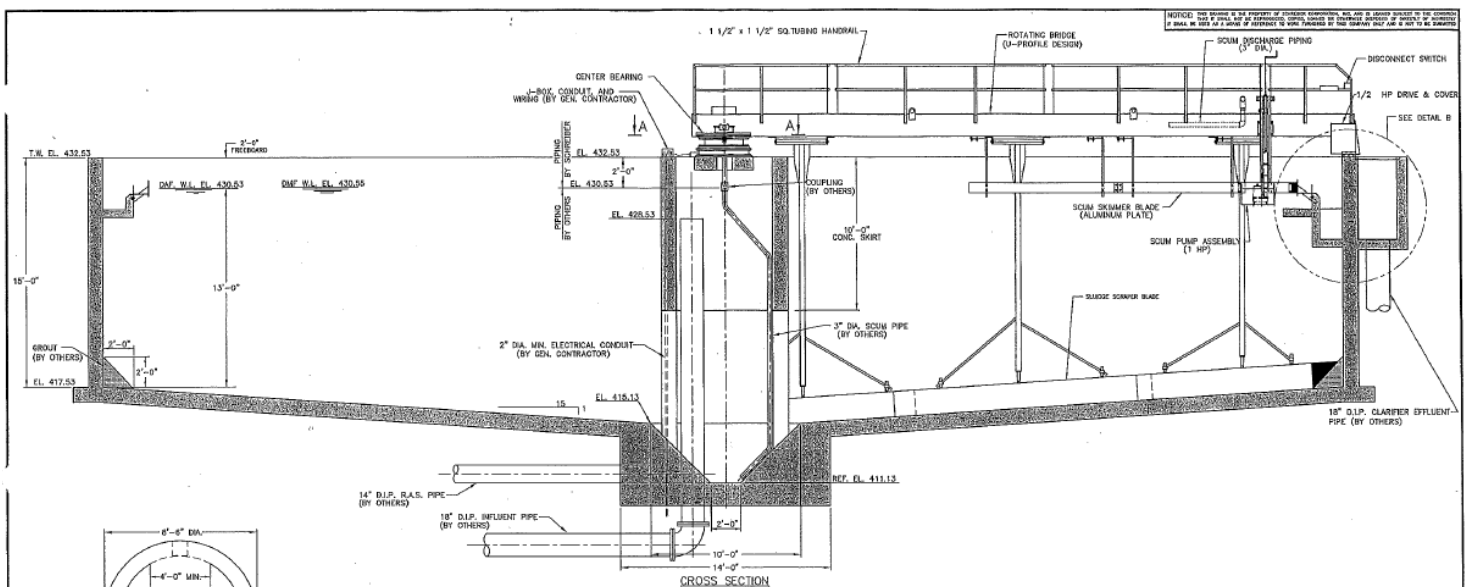
The involved structure is a peripheral drive, rotating bridge, final clarifier. The inside radius of the clarifier is forty-one feet and the depth as measured at the outer weir plate is approximately thirteen feet. The floor of the clarifier gradually slopes downward to the center for the collection of solids. One end of the rotating bridge sits on a center bearing pivot point on a concrete pillar in the middle of the clarifier. The other end of the bridge moves around the outer wall via two ½ horsepower motors that drive neoprene rollers and travel along the top of the outer wall. Sludge scraper blades (bottom) and a scum skimmer plate (surface) are attached to the bridge. One 360-degree rotation of the bridge takes approximately sixty minutes. A fixed, engineered access point with steps aligns with the bridge during rotation (see figure 1, left side of photograph). This allows employees to stop the bridge and safely access the bridge walking surface.

Figure 2 – Clarifier cross section.

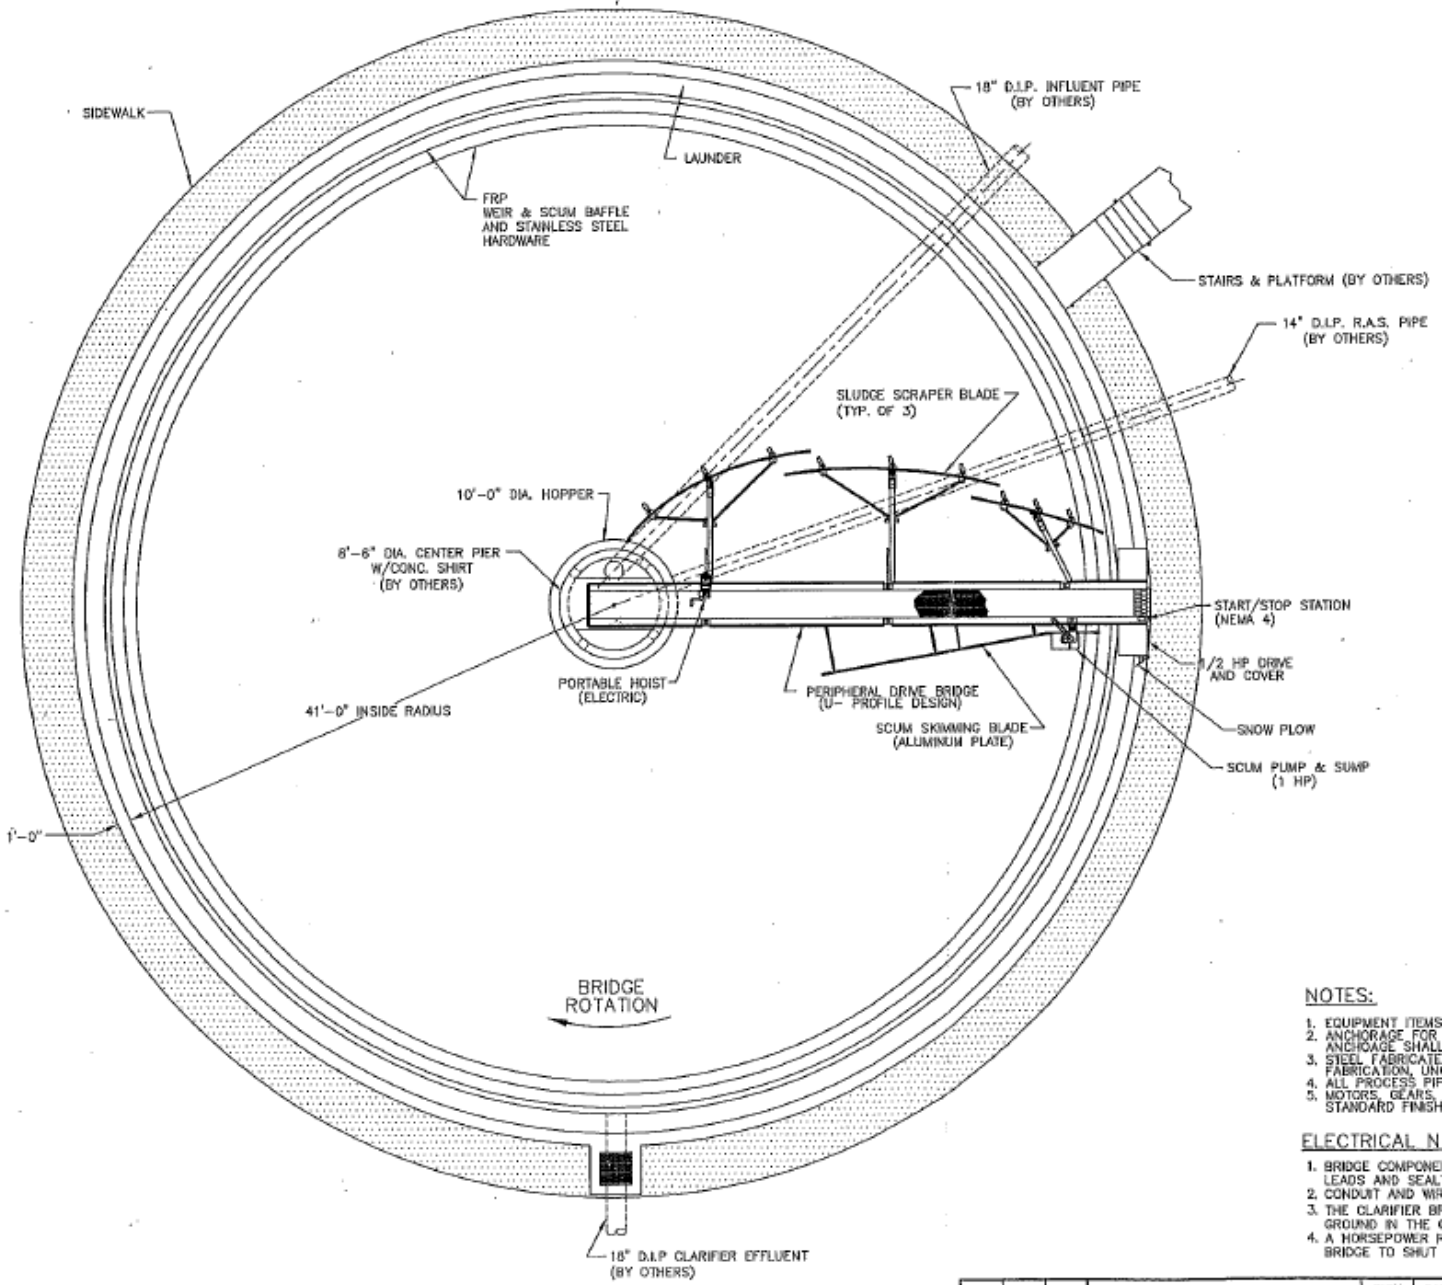
Figure 3 – Clarifier top view.

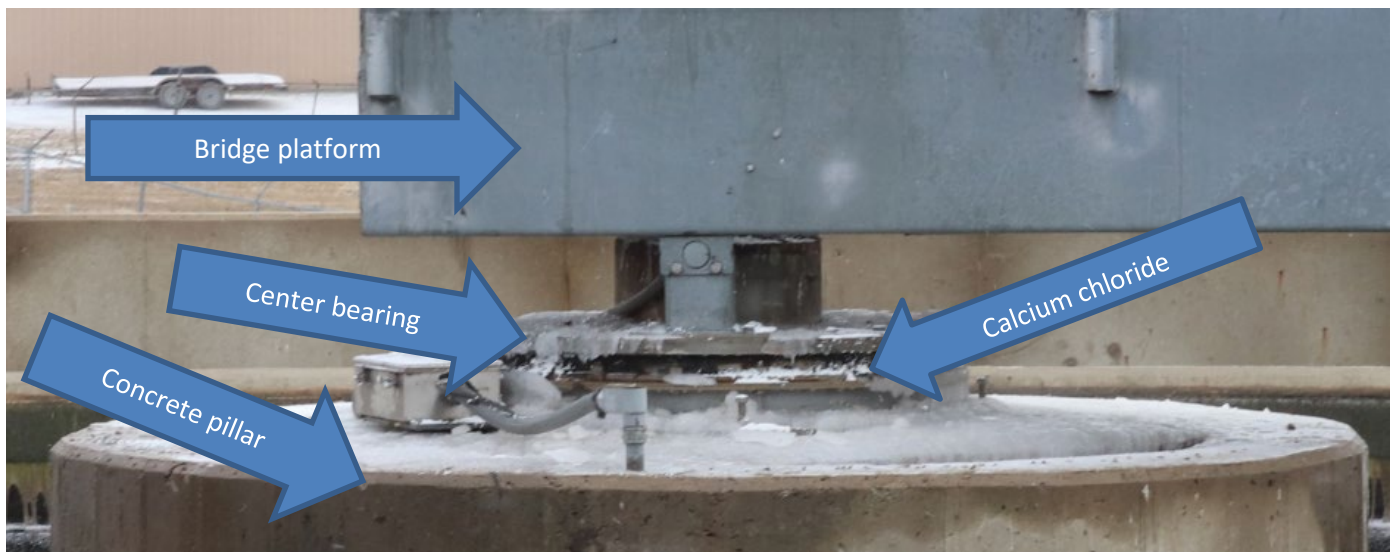
After ending the phone call at approximately 7:05 AM, it is presumed that the victim got on the clarifier bridge and attempted to troubleshoot the malfunction. It is likely that the bridge was bound up due to extremely cold weather and precipitation that froze the center bearing. Since the two peripheral drive motors are only rated at  $\frac{1}{2}$  hp each, they could not overcome a frozen center bearing and the bridge ceased to rotate. Photographs from the day of the incident show calcium chloride (ice melt) was present on the concrete pillar that houses the center bearing and the center bearing itself (see figure 4). It is highly likely that the victim applied the calcium chloride. The center bearing is located under the bridge walking platform and is not easily accessible from the platform. It is unknown, but possible that the victim was attempting to apply calcium chloride to the center bearing while leaning over the top rail or mid rail of the bridge guardrail and fell into the clarifier. The actual cause of the victim falling into the clarifier may never be known.

Figure 4 – Calcium chloride on the center bearing (photo credit: Illinois State Police).

1. The peripheral drive for the rotating bridge style clarifier malfunctioned due to a frozen center bearing as a result of extreme cold weather and precipitation. The clarifier manufacturer's winter maintenance procedures do not provide guidance on frozen center bearings. The municipality had experienced frozen center bearings in the past. Maintenance employees stated that they had previously used a wand propane torch to thaw a frozen center bearing.

- Attempt to increase resilience/reliability of plant equipment that may be subject to extreme environmental conditions. Reduce the potential for unscheduled maintenance.
- Ensure proper start work controls are in place when non-routine events occur.
- Apply additional controls for lone worker operations. Such controls may include but are not limited to lone worker phone apps, video surveillance, and prohibitions on certain work when alone.
- Train wastewater employees on the hazards of cold water immersion.
- Consider the use of personal floatation devices when workers are operating near water, especially when operating alone, and especially when operating in cold weather.
- Consider providing a method for self-rescue if a worker enters the water.

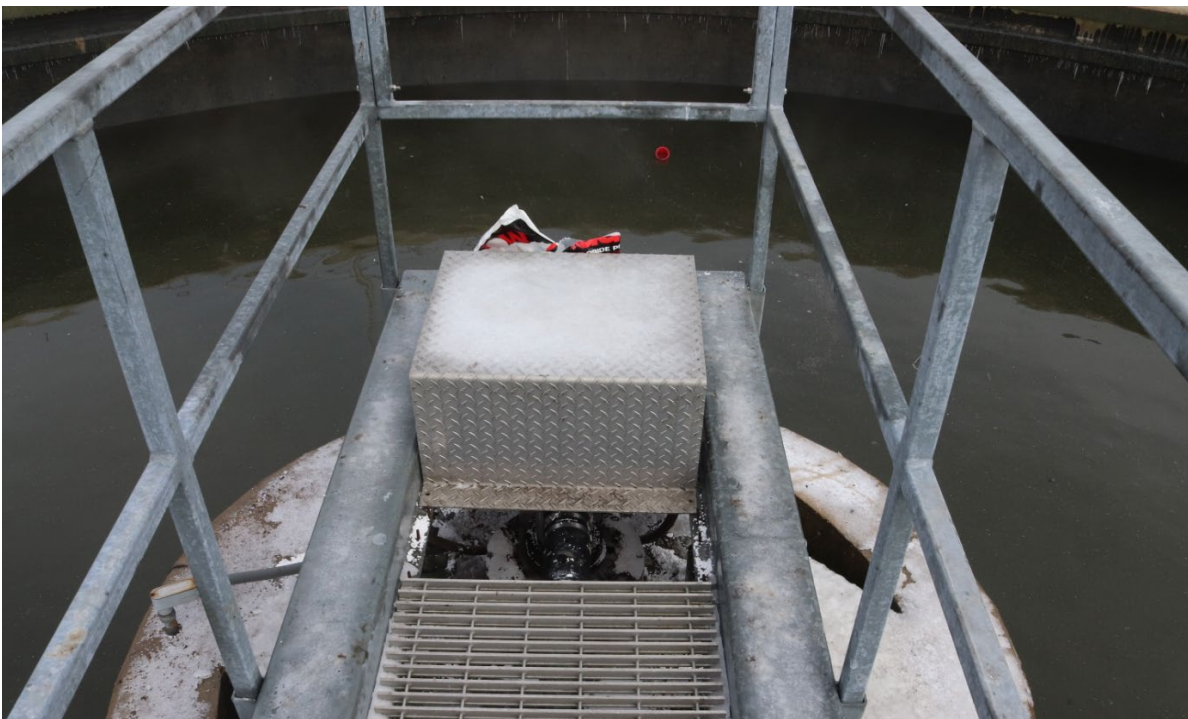
If the victim survived the initial entry into the water, it is possible that he would have attempted to grab onto or climb onto the concrete pillar at the center of the clarifier. Based on the victim's height, and the distance from the waterline to the top of the concrete pillar (approximately 2 feet), it is highly unlikely that the victim, even in normal temperatures, would have been able to grab the top of the pillar, and even less likely that he could have pulled himself out of the water.

*Figure 6 – View from bridge looking at center pillar and bearing. Red object in water is a coffee can presumably used to spread calcium chloride. Note: the clarifier had been drained below the operating level during search and rescue operations (Photo credit: Illinois State Police).*

7. If the victim survived the initial phase of cold water immersion, it would have been extremely difficult if not impossible to self-rescue using the center concrete pillar.
