INCIDENT REPORT

INSPECTION #: 1531592 **REPORT DATE:** July 12, 2021

The Myer Incident: Three Firefighters Hospitalized After Calling a Mayday and Bailing Out Second Floor of Apartment Building

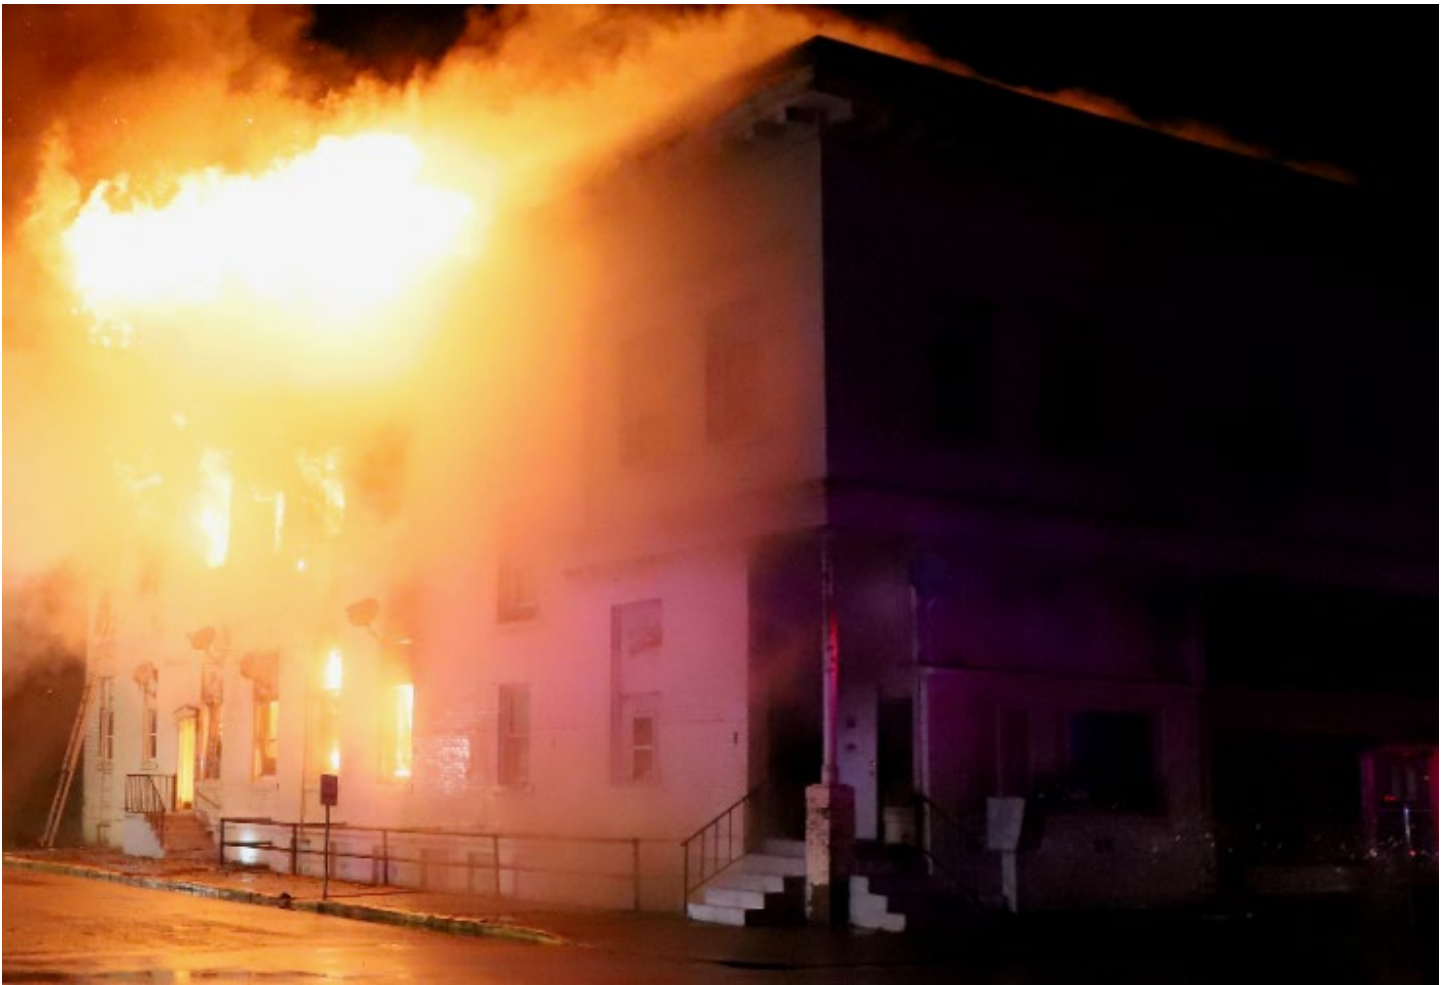
Figure 1 – Apartment building at 9:27 PM (photo credit: Brian DeLoche).

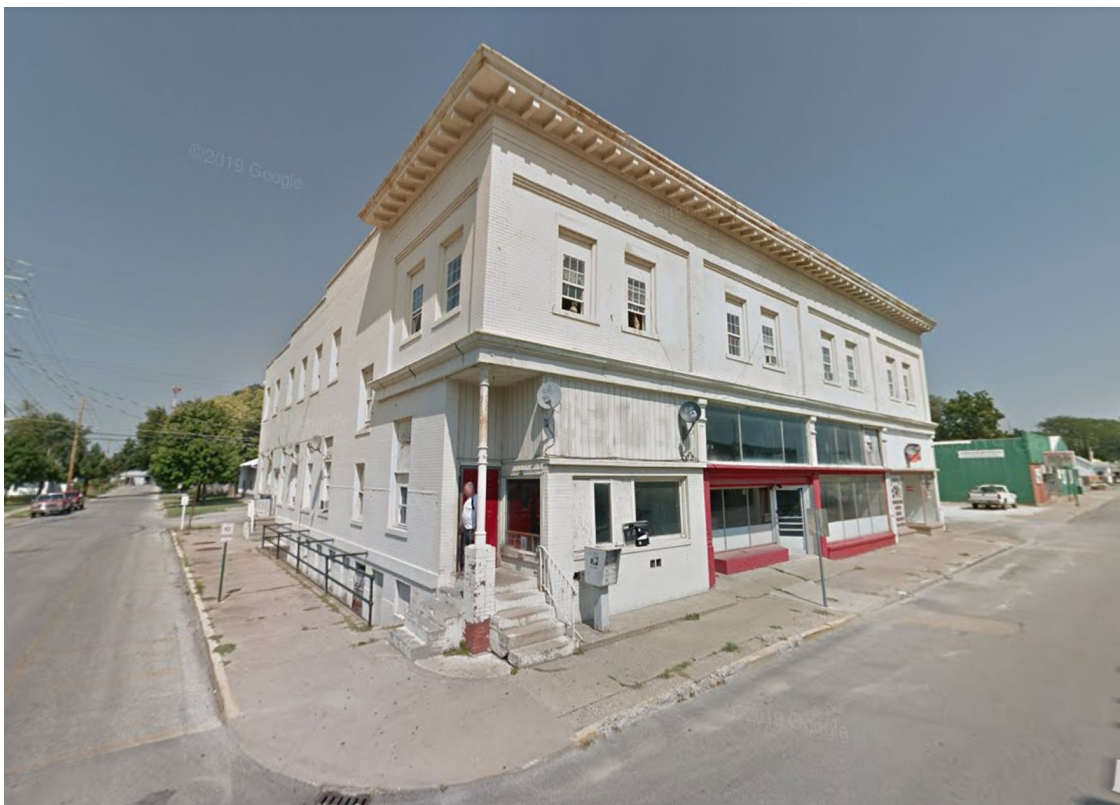
The involved structure was two-story, ordinary brick construction with a flat roof and full basement. It was originally built as a hotel in 1900. The building was not equipped with a fire alarm or sprinkler system and had limited, battery powered, standalone smoke detectors. Over 120 years, the building was modified to accommodate a variety of different occupancies and was last configured as an apartment building with two apartments on the first floor and eleven on the second floor.

Figure 2 – Building in September 2013 (photo credit: Google).

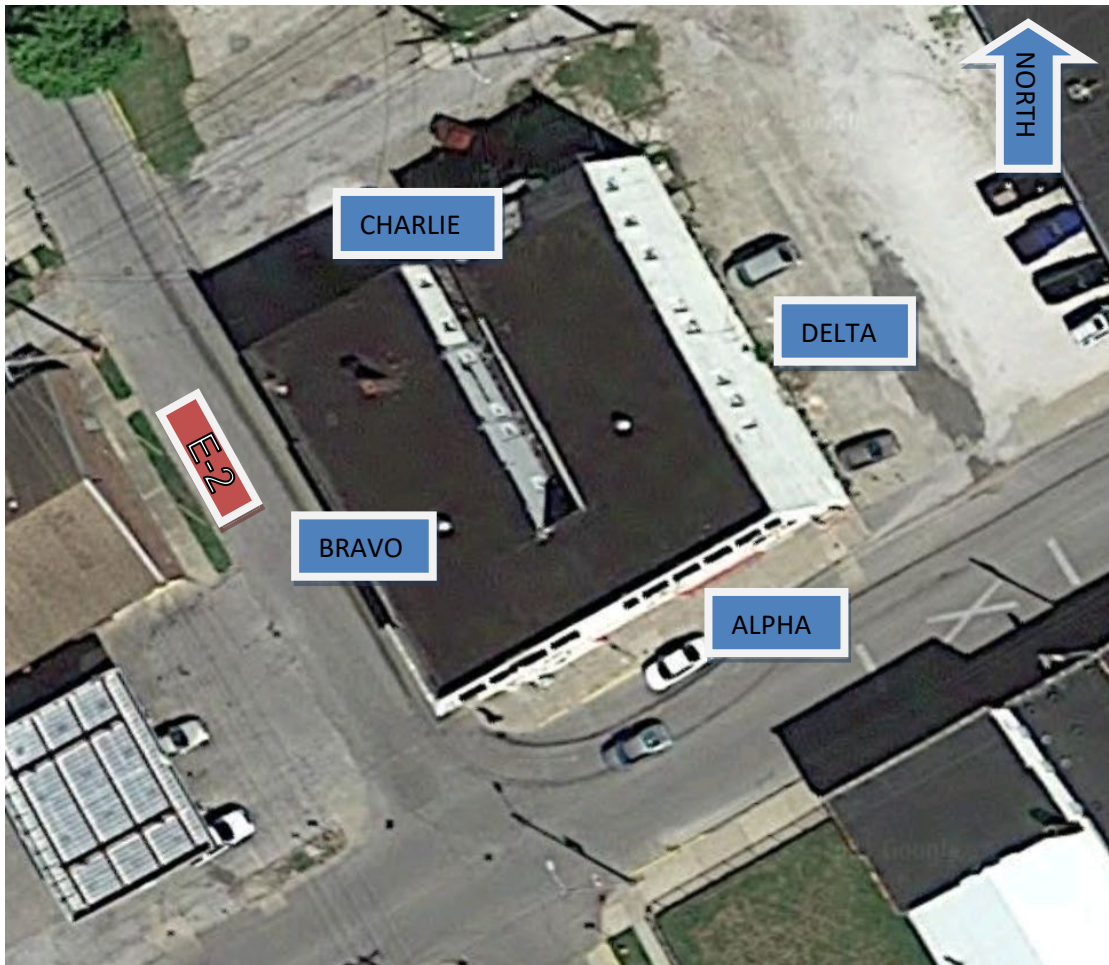
Figure 3 – Building aerial view (photo credit: Google).

The interior crew continues a right-hand search for several minutes until they arrive at a dead-end corridor on the second floor of the bravo/charlie side of the "U" shaped building (see figure 3). During this time several radio transmissions take place between the interior crew and assistant chief. A transmission is also made to clear the fire department channel until the mayday is over. The assistant chief instructs the interior crew to make their way to the alpha side of the building (Ladder 1 is setup for rescue on the alpha side). A further instruction from the assistant chief directs the fire chief to locate a window and activate his PASS

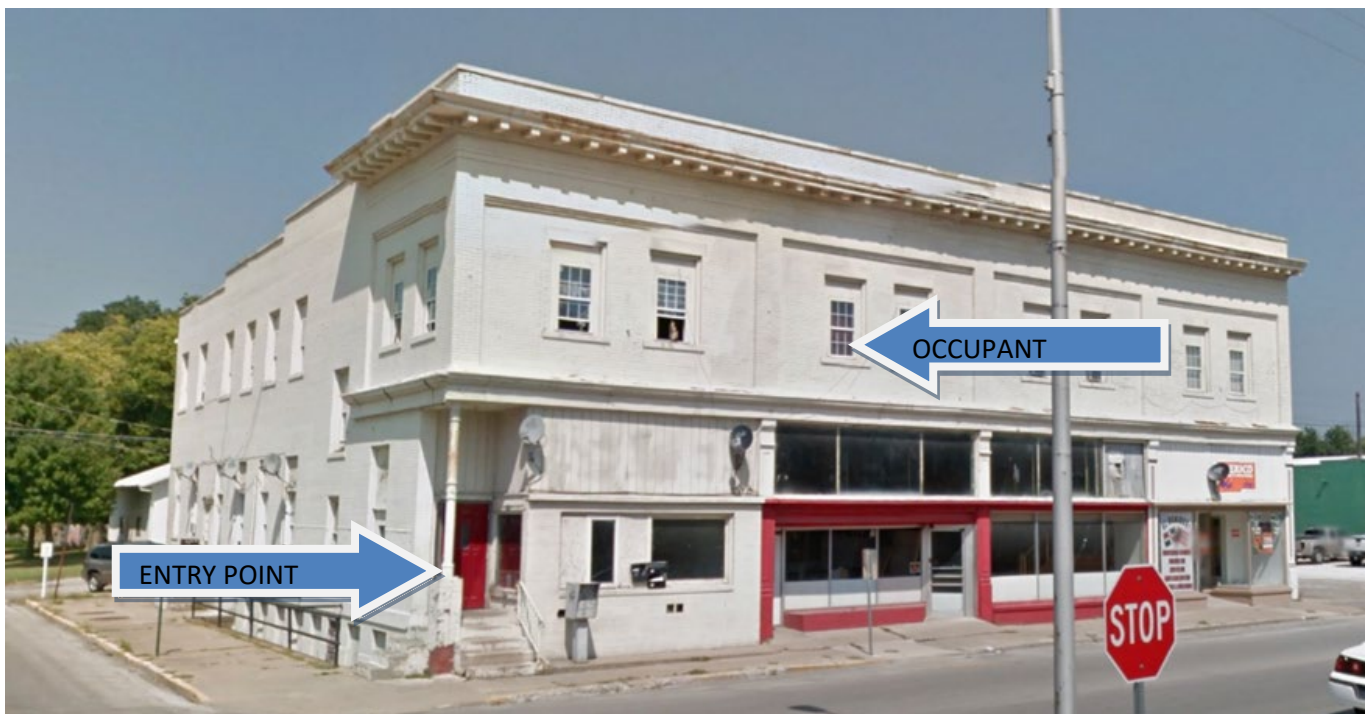
The fire chief then observes one female occupant in a window on the second floor of the building, alpha side (see figure 4). While preparing to make entry, a fourth firefighter arrives via personal vehicle (victim 2) and is instructed to don SCBA and join the chief and the third firefighter.

Figure 4 – Alpha/Bravo side of building (photo credit: Google).

At 8:51 PM the fire chief (victim 1) and two firefighters (victims 2 and 3) enter the structure through the 1st floor door on the alpha/bravo corner (see figure 4). Upon entry, the crew observes fire on the first floor, down the hallway at floor level. The crew enters the structure without a hoseline or tagline. No fire suppression is in operation by any on scene personnel at this point. Upon reaching the second floor, the crew observes the female occupant in the hallway under worsening visibility. One firefighter makes physical contact with the female occupant. A struggle ensues and the female occupant retreats from the hallway as visibility decreases to zero. After losing contact with the female occupant, the chief decides the crew needs to exit the building, however, the crew determines that they are disoriented. The crew proceeds with a right-hand search in an attempt to locate an exit. Approximately three minutes after entry, the chief makes a radio report stating that three firefighters are inside the building, they need help getting out, and they cannot find the exit. Immediately after this transmission, "Mayday mayday mayday" is transmitted over the radio. The assistant chief on Ladder 1 is setting up the aerial device and conducting a rescue of the female occupant (now back at the window noted in figure 4) while simultaneously managing the mayday call as well as overall incident command. The female occupant is rescued using Ladder 1's aerial device and is transported to a local hospital.

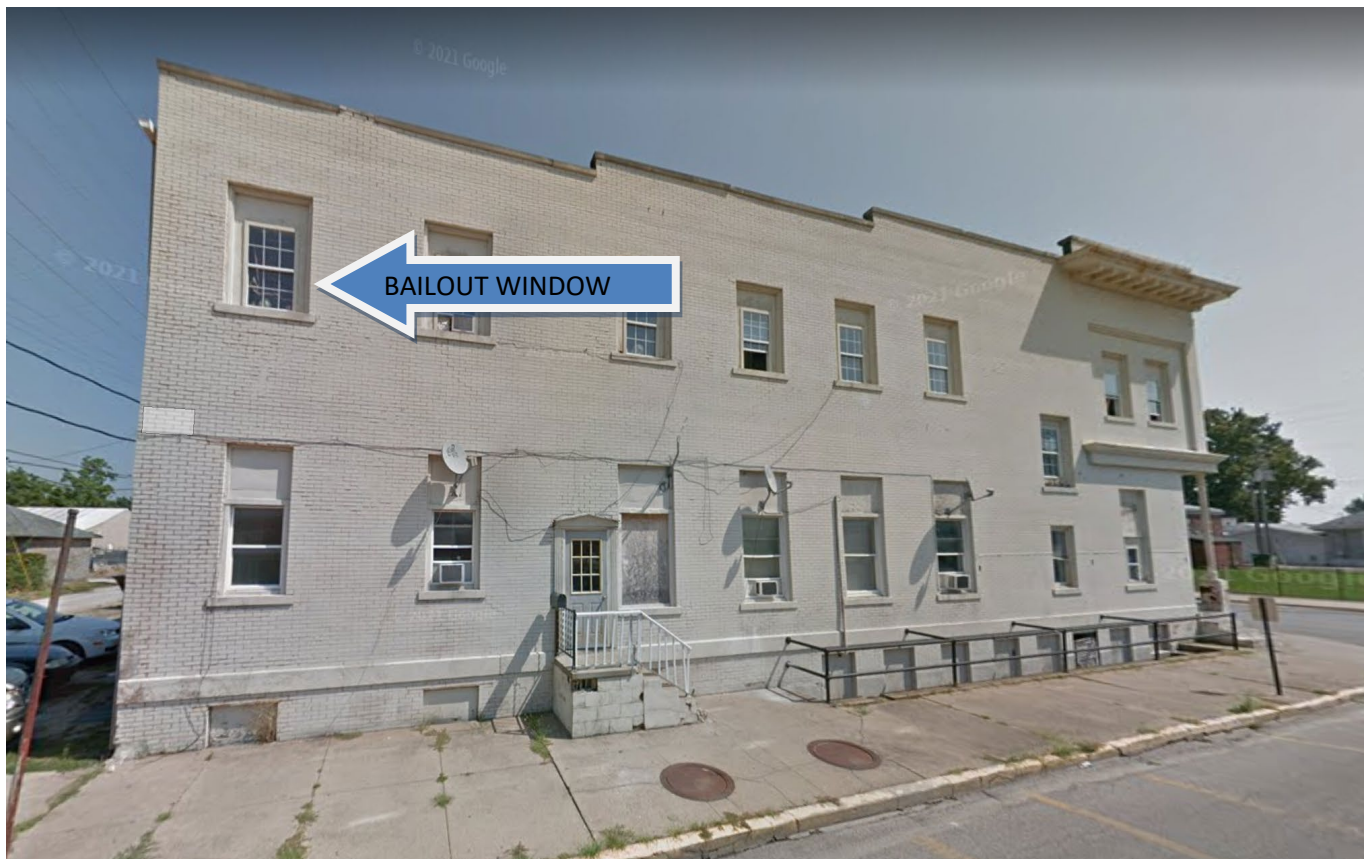
After arriving at the dead-end corridor, the fire chief continues a search and locates the door to the 2nd floor apartment on the bravo/charlie corner of the building. The fire chief then locates an exterior window (see figure 5) and breaks out the window using a haligan bar.

Figure 5 – Bravo side of building (Photo credit: Google).

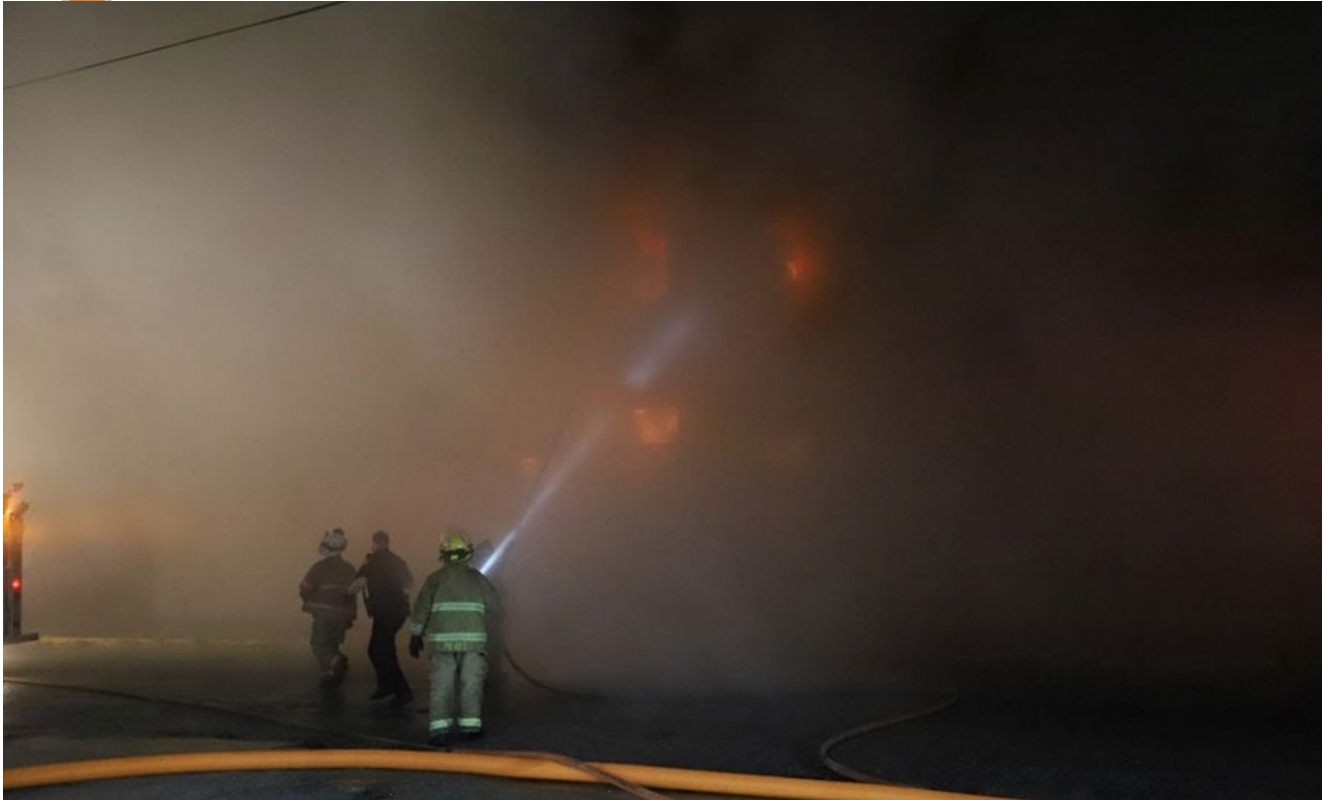
Figure 6 – Conditions on side bravo at approximate time of first bailout (Photo credit: Brian DeLoche).

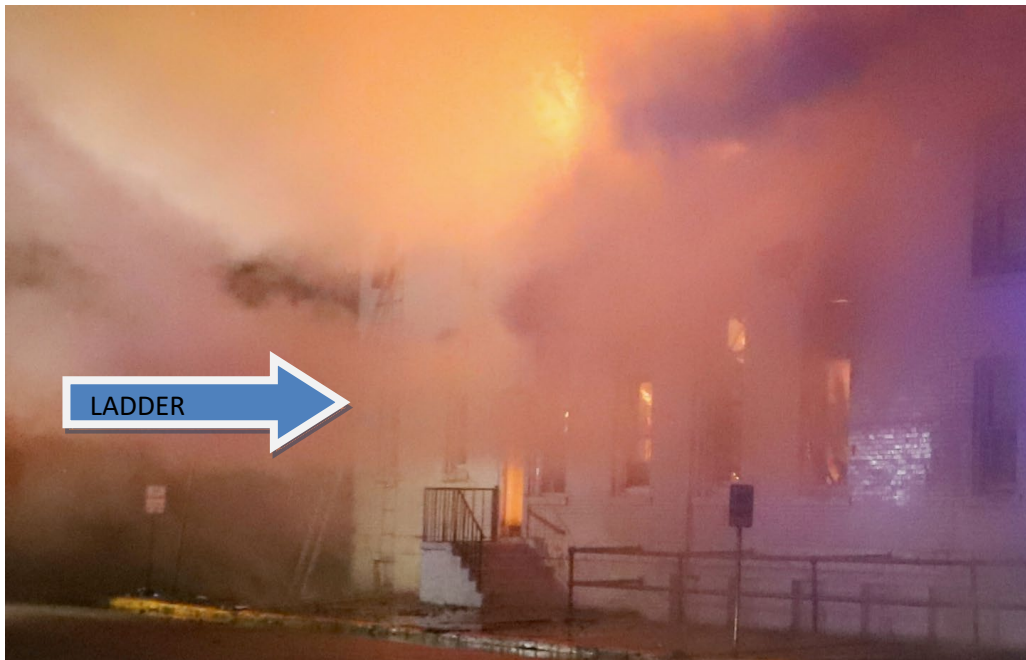
Figure 7 – Ground ladder at bailout location. Time is post-bailout (Photo credit: Brian DeLoche).

14. Exterior crews did not utilize a thermal imaging camera to attempt to visually locate the interior crew's bailout location.
15. When a ground ladder was placed at the bailout window, it was placed to the side of the window rather than under the window.

- Train and develop competency on different methods of ground ladder deployment based on circumstances (ex. ventilation vs. rescue).
- Provide training for all fire personnel on building construction, building size-up as related to fire conditions, and risk/reward when considering an offensive vs. defensive strategy.
