INCIDENT REPORT

INSPECTION #: 1567974 REPORT DATE: March 8, 2022 1568109

The Ridge Incident: Firefighter Dies in House Fire After First Floor Collapse and Loss of Accountability

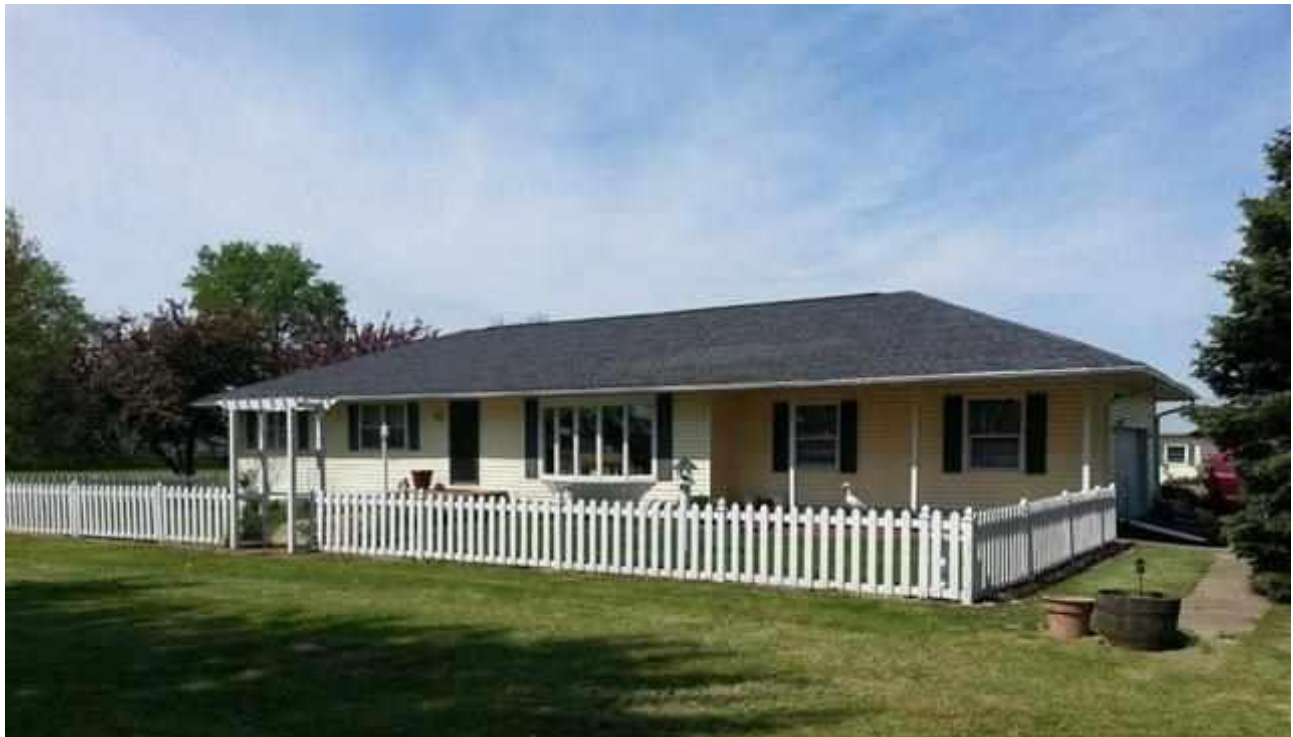
Figure 2 - Undated photo of "Alpha" side of residence (photo credit: Realtor.com)

Page 6 and 7: The employers observe that due to factors such as construction and time of day, that it was difficult to identify the presence of a basement during the size up. The basement windows on the “Alpha” side were covered by the homeowner. A mutual aid department also performed a size up upon arrival and noted no basement windows. Additionally, the stairs to the basement were in the back of the garage and the garage was the point of origin of the fire. *While these factors may have made size up more difficult, a basement window was present on the “Charlie” side (rear) of the home, and the occupants were at the scene to provide detailed information about the structure.*

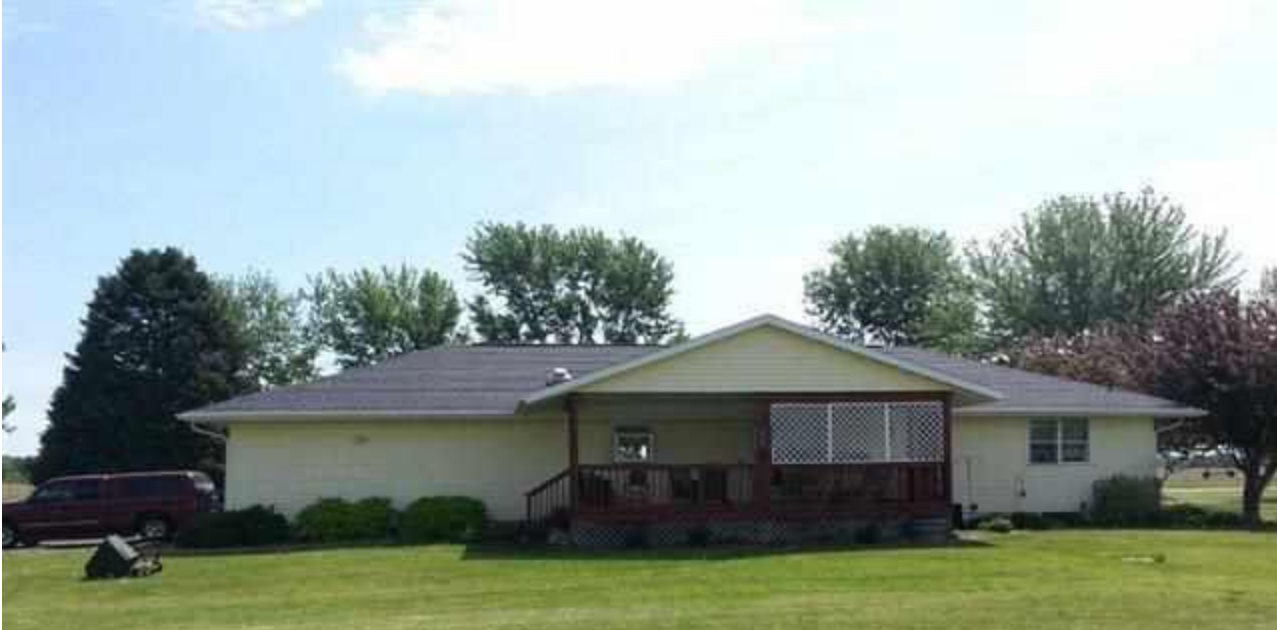
Figure 3 - Undated photo of "Charlie" side of residence (photo credit: Realtor.com)

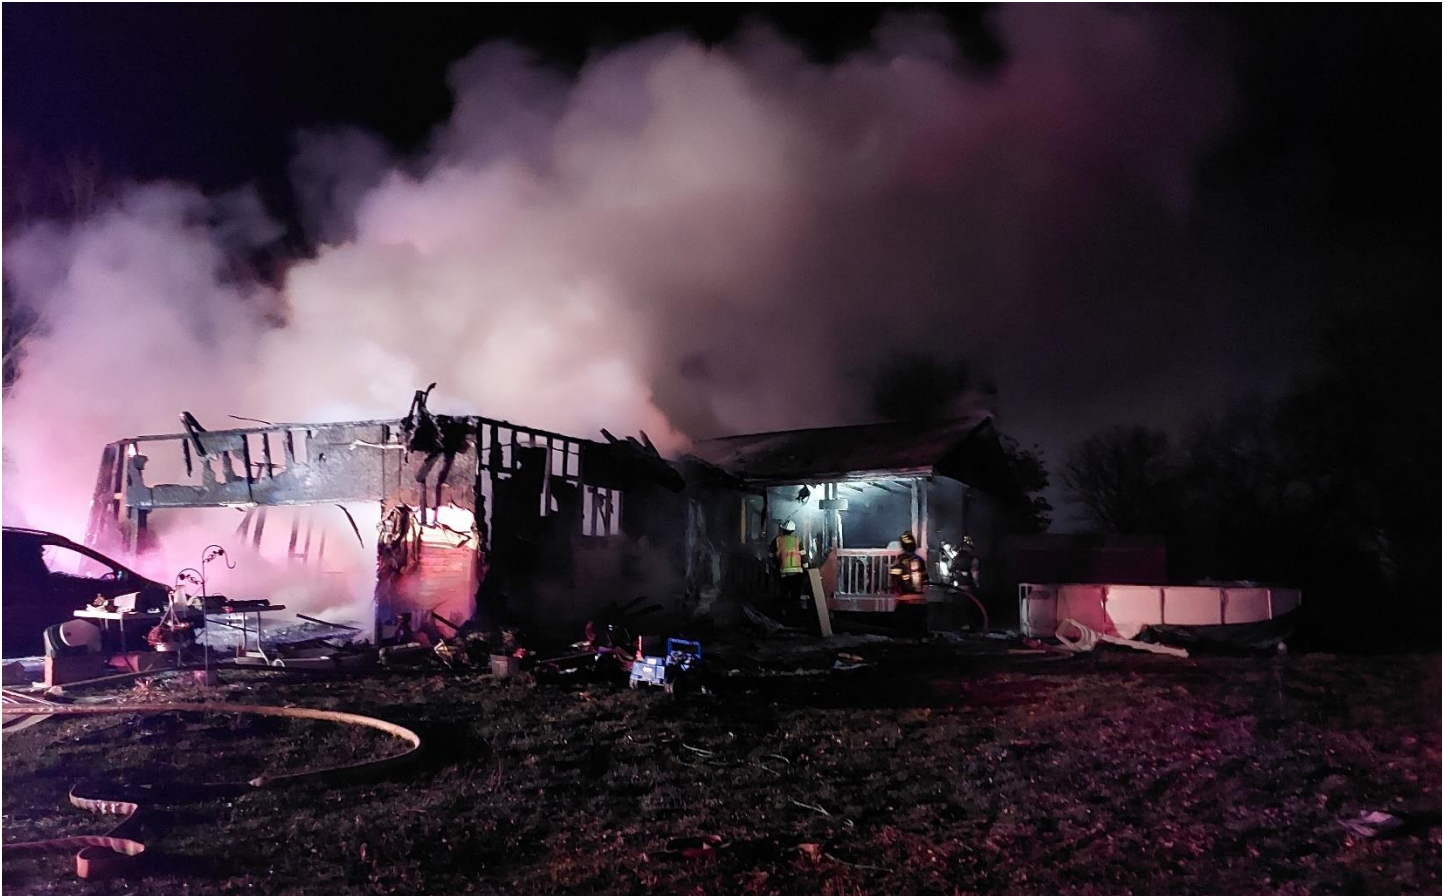
Figure 4 - "Charlie/Delta" side of residence at 11:56 PM (photo credit: Heather Smith, Eye on News)

After the PAR event, deteriorating conditions indicated the potential presence of a basement fire. At this point, at least forty minutes after arrival of the first unit, command had not confirmed the presence or absence of a basement. The incident commander then confirmed with the homeowners that there was a basement. A crew of two with FD #2 assigned to the exterior "Charlie" side were re-assigned to make entry into the basement. Once at the bottom of the basement stairs, the crew reported that they could not advance into the basement due to debris from the floor collapse.
