**Bulletin No: SA20170222**  
**Release Date: Feb 22, 2017**  
**Effective Date: Feb 22, 2017**  
**Supersedes: N/A**  
**Completion Date: Immediate**  
**Page: 1 of 3**

# SAFETY ALERT

Manufacturer: A.R.M. (USA), Inc.  
 Ride Name: Super Shot

Model(s): SS1001, SS200, SS300  
 & SS400

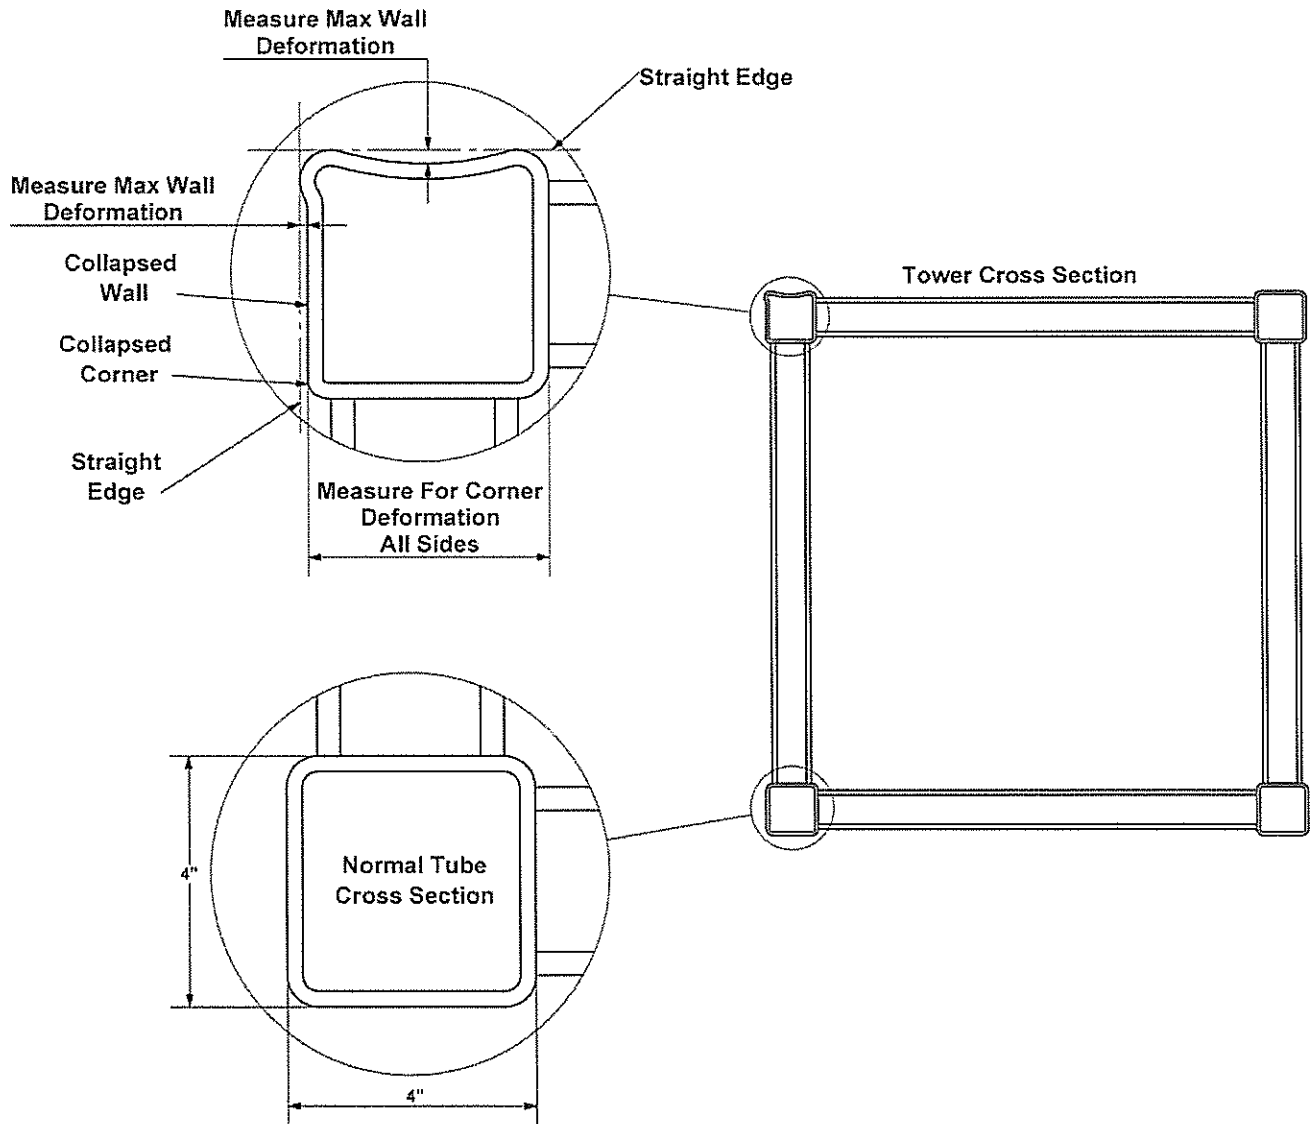
A.R.M. (USA), Inc. has been made aware of structural tube deformation on at least one mobile tower resulting from poor lift hook maintenance and improper engagement of the hooks when lifting the passenger carriage.

Precise alignment of the magnetic braking system is crucial for safe operation and requires accurate tracking of the guide wheels along the tower frame. Collapsed portions of the tower frame tubes will allow the passenger carriage to shift on the tower resulting in misalignment of the magnetic breaks in relation to the conductor rails affixed to the tower. Even slight misalignment will alter the performance of the magnetic brakes - and possible failure.

In the event that the lift trolley hooks are not properly engaged to the passenger carriage, the carriage will be lifted on one side only - thus causing disproportional forces on the guide wheels around the carriage and trolley frames. The excessive force on the wheels will gradually deform the walls and/or corners of the vertical tube members on the tower.

Immediate inspection of all tower structural tubes with emphasis on the four corner vertical tubes that the passenger carriage guide wheels contact. Any collapse of the tube walls or corners to be measured and reported to A.R.M. (USA), Inc. prior to continued operation.

Prior to continued operation, all tower corner tube members must be visually inspected for deformation, excessive wear, cracks or other damage. The depth of any collapsed portion of the tube members to be measured and reported to A.R.M. (USA), Inc. for review and possible repair advise.

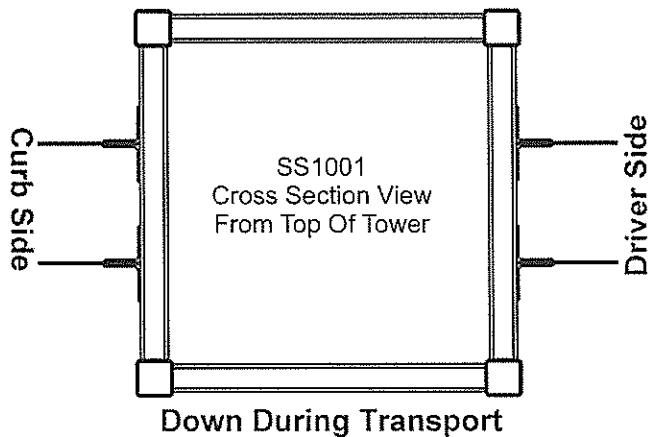
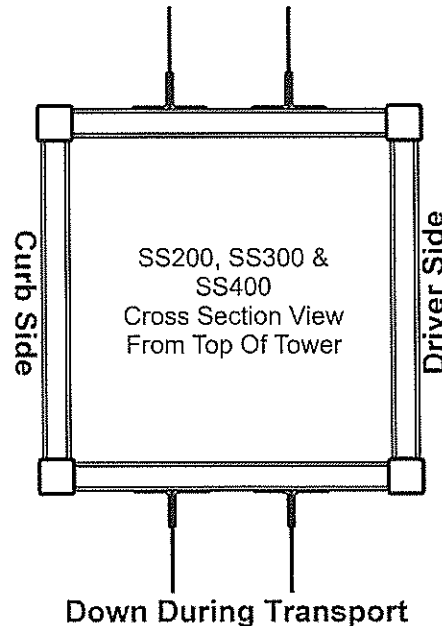
With Tower Wings Extended, Visually Inspect Entire Length Of The Tower & Measure Depth Of Any Tube Deformation. Indicate Position & Extent Of Most Severe Deformation And Return This Page To A.R.M. (USA), INC. For Repair Advise.

REPAIR TO TOWER STRUCTURE IS NOT RECOMMENDED  
 OR APPROVED UNLESS SPECIFIED, IN WRITING, BY  
 A.R.M. (USA), INC.
