INCIDENT REPORT

INSPECTION #: 1652863 **REPORT DATE: Mar. 4, 2025**

The Deming Incident: Water Department Employee Drowns During Repair of Valve in Water Main Vault

A 20-year-old male maintenance worker drowned due to engulfment in a flooded water main vault and entrapment of his right hand during repair of a leaking valve for a 12" water main.

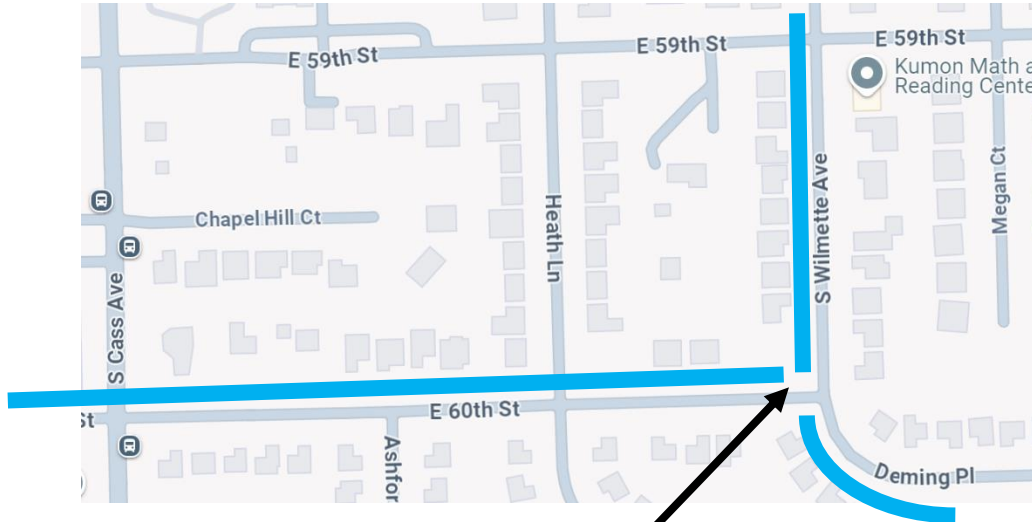
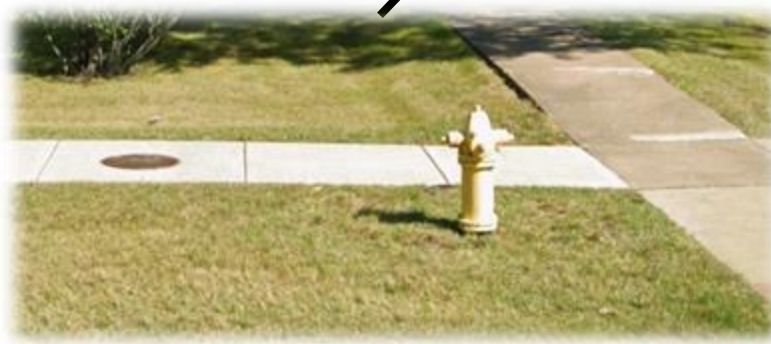
The village utilized a private contractor to exercise and assess water valves throughout the system. On Tuesday, February 21st, 2023, two days before the incident, the contractor advised the village that a 12” underground water main valve at East 60th Street and Deming Place (Figure 1) was leaking and in need of repair.

*Figure 1 – Street map of area with photo of worksite. Manhole cover (above left) provides access to valve vault.
(Photo credit: google earth)*

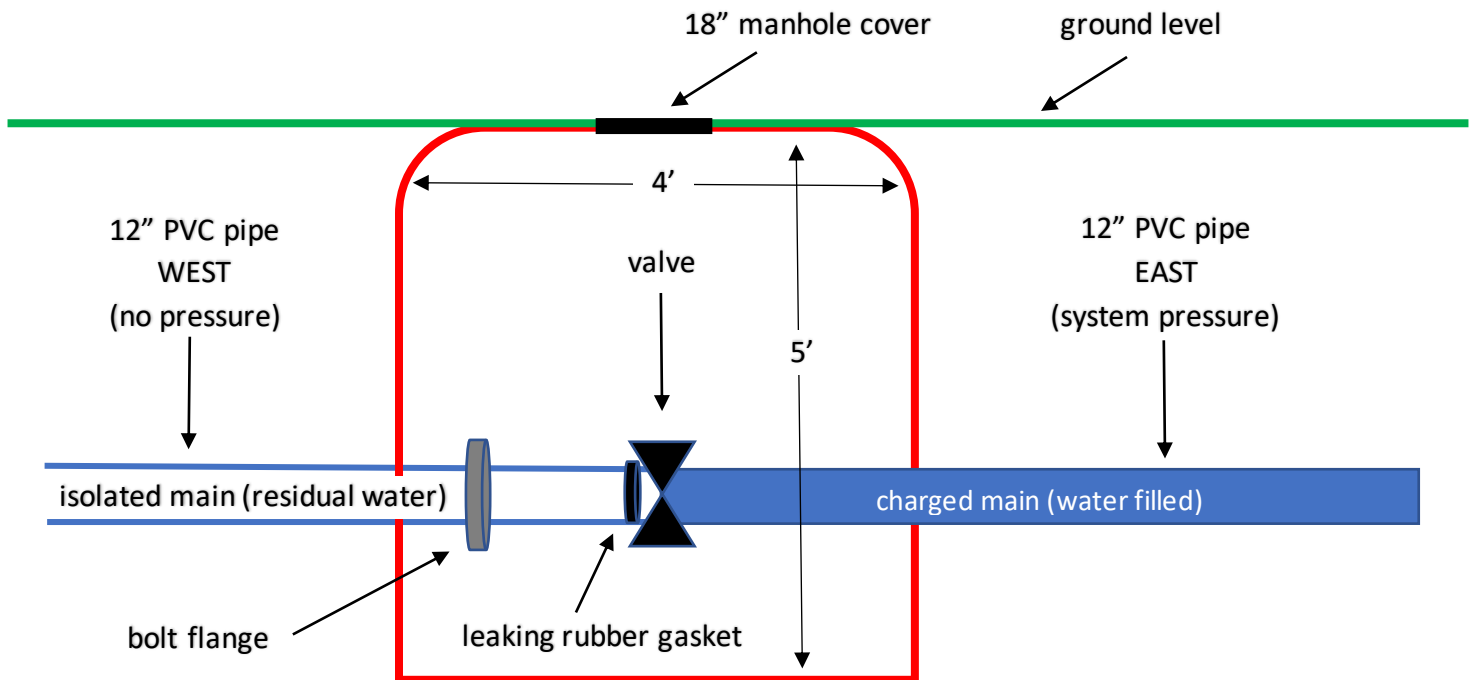
8:15 AM: The vault's manhole cover was removed. The vacuum truck was used to remove water, debris, and gravel in the vault to expose the leaking valve. Worker #1 entered the vault to assist with vacuuming and cleaning out an area around the bottom of the valve. The repair involved replacing a leaking gasket on the west side of the valve. Worker #1 then removed the valve flange on the west side of the valve and slid it back on the water main pipe. Initial attempts by worker #1 to remove the rubber gasket failed (Figure 2).

Figure 2 – Illustration of water main valve vault.

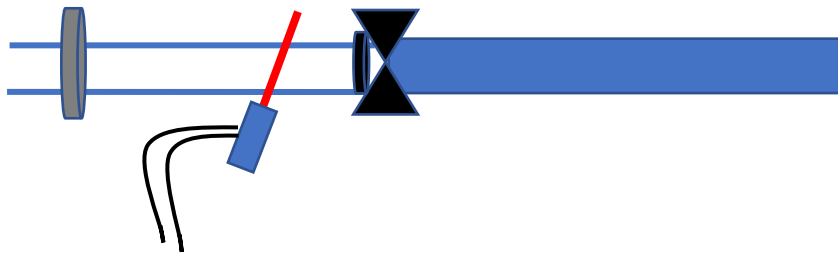
After the foreman returned, worker #1 went back into the vault to insert screws into the gasket. He likely used pliers to pull on the screws to attempt to free the gasket from the valve body. This was also unsuccessful. Worker #1 then began to use a hydraulically-powered chainsaw to cut the isolated pipe (Figure 3). Worker #2 continued to use the vacuum truck to remove groundwater in the vault as well as unpressurized residual water that was coming out of the cut in the isolated pipe. The chainsaw became stuck and worker #1 was unable to pull it out of the cut. Worker #2 switched from using the large vacuum truck to a smaller portable pump to continue removing water. Worker #1 then used a reciprocating saw to attempt to free the hydraulic saw. Worker #2 was sent back to the shop to wash out the vacuum truck and check in at the water plant. Worker #2 was not planning to return to the site unless he was called.

Figure 3 – Illustration of worker #1 using a hydraulically-powered chainsaw to cut the drained main.

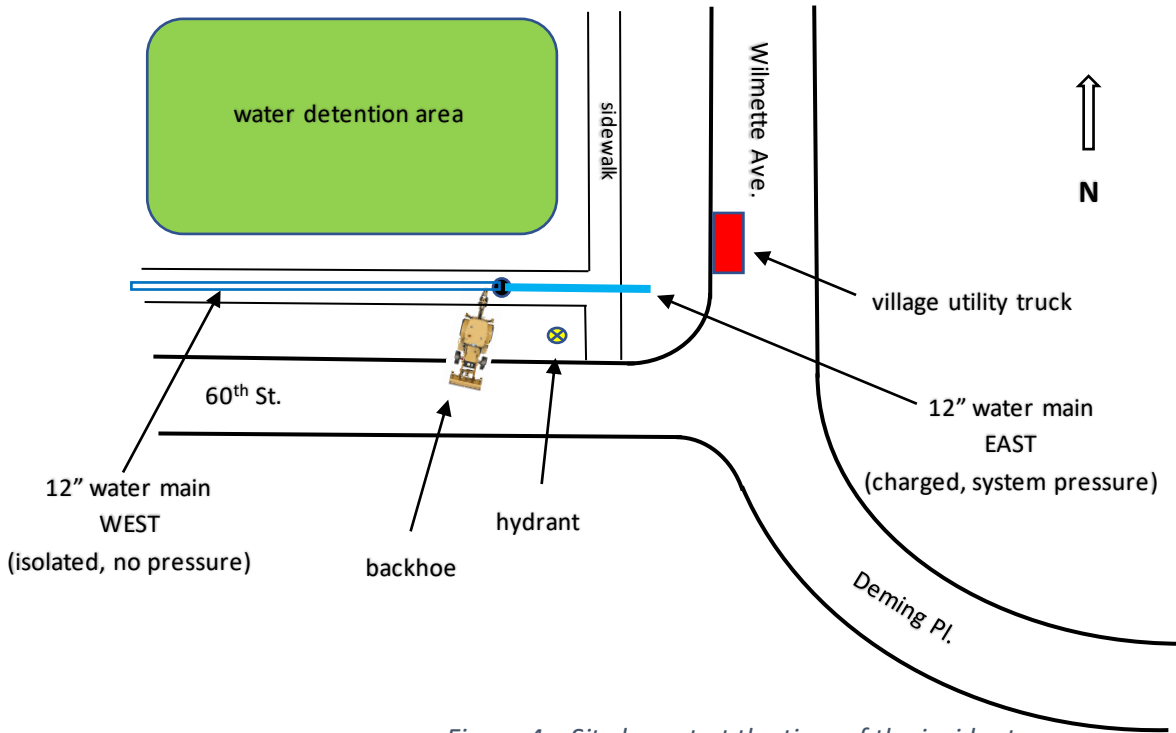
Figure 4 – Site layout at the time of the incident.

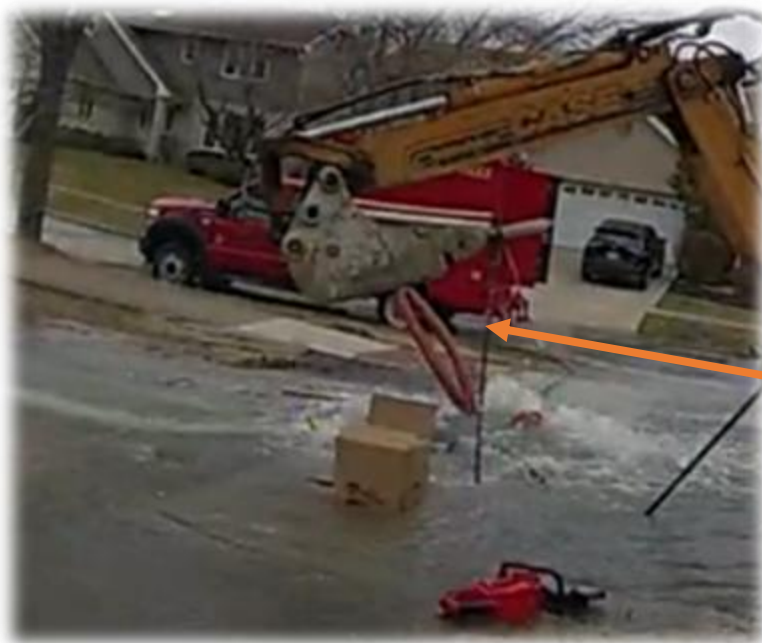
11:48 AM: Pressurized water from the charged (east) section of 12” water main pipe blew the valve off the pipe bringing a tremendous volume of water that quickly began to flood the small vault. Worker #1 told the foreman that he was stuck. The foreman grabbed worker #1 and attempted to pull him out of the vault but he was not able to. In seconds, water completely engulfed worker #1 and began to erupt from the manhole. The foreman waved down a village police officer who was driving by and told him, “Call 911, I got a guy down there stuck, and the water valve blew off, and he’s stuck, and I can’t get him out.” The foreman then ran one block to the north (E 59th St. and S Wilmette Ave.) attempting to shut off water valves. The foreman also attempted to call worker #2 to obtain longer valve keys to close the water valves but was unable to reach him.

Figure 5 – Still photo of a police officer body camera shows the volume of water that was pouring out of the vault. Note the chain attached to the backhoe going into the manhole.

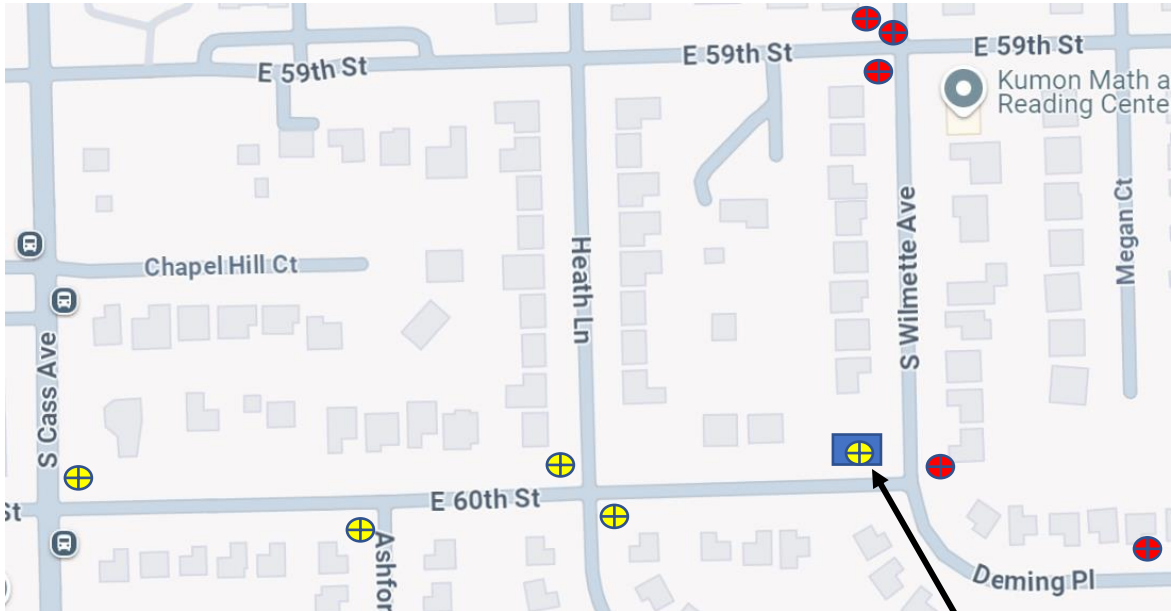
Valves that were closed before starting the repair. ⊕

Valves that were closed after the valve blew off. ⊕

Figure 6 – Street map of area with valve open/closed status before and after the valve blew off.

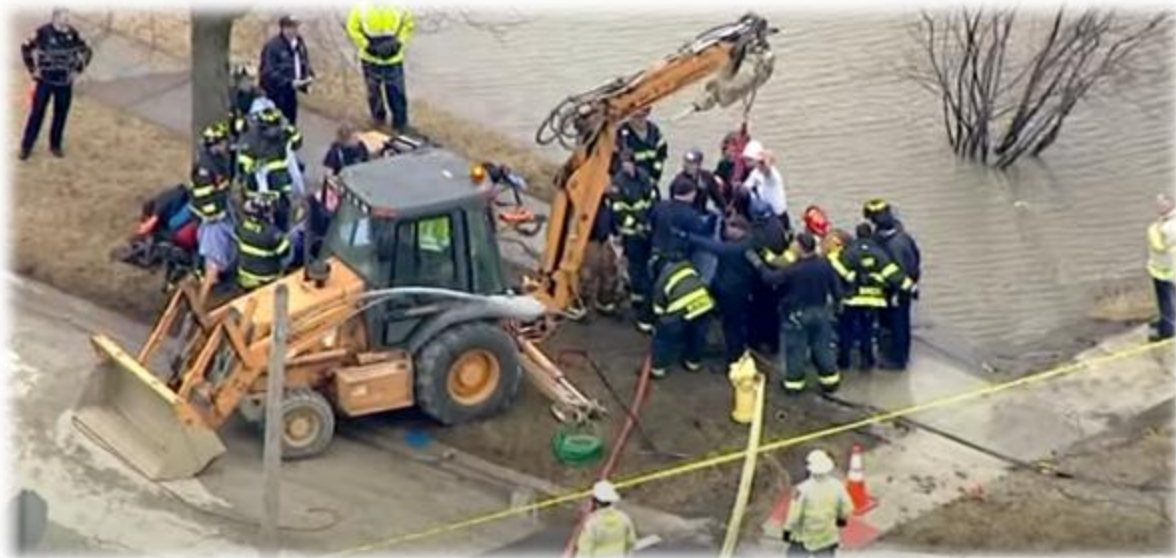
Figure 7 – Aerial view of incident scene as worker #1 is removed from the vault. (Photo credit: ABC 7 News Chicago)

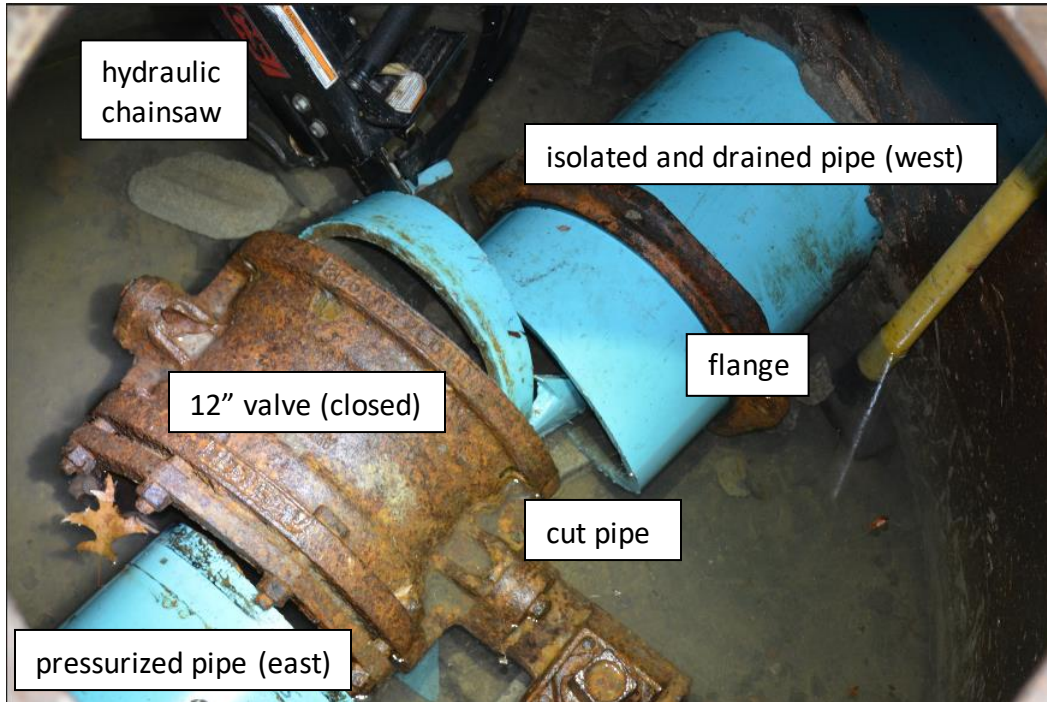
While IL OSHA cannot definitively identify the specific action that resulted in the valve blowing off, available evidence suggests the following series of events. Once the drained pipe (west) was cut, the opposing force pressing the valve against the pressurized water on the east side of the valve was compromised. After the cuts, the strength of the gasket and flange interface between the valve and the pressurized pipe (east) was all that was holding the valve in place. A significant amount of force from the pressurized water pushed against the closed valve plate. It is possible that additional cutting and/or use of a chain attached to the backhoe to remove tension on the pipe was enough for the pressurized water to blow the valve off the pipe. As this occurred worker #1’s right hand became trapped in the cut section of pipe, preventing his escape.

Figure 8 – Post-incident photo of work area in the vault.

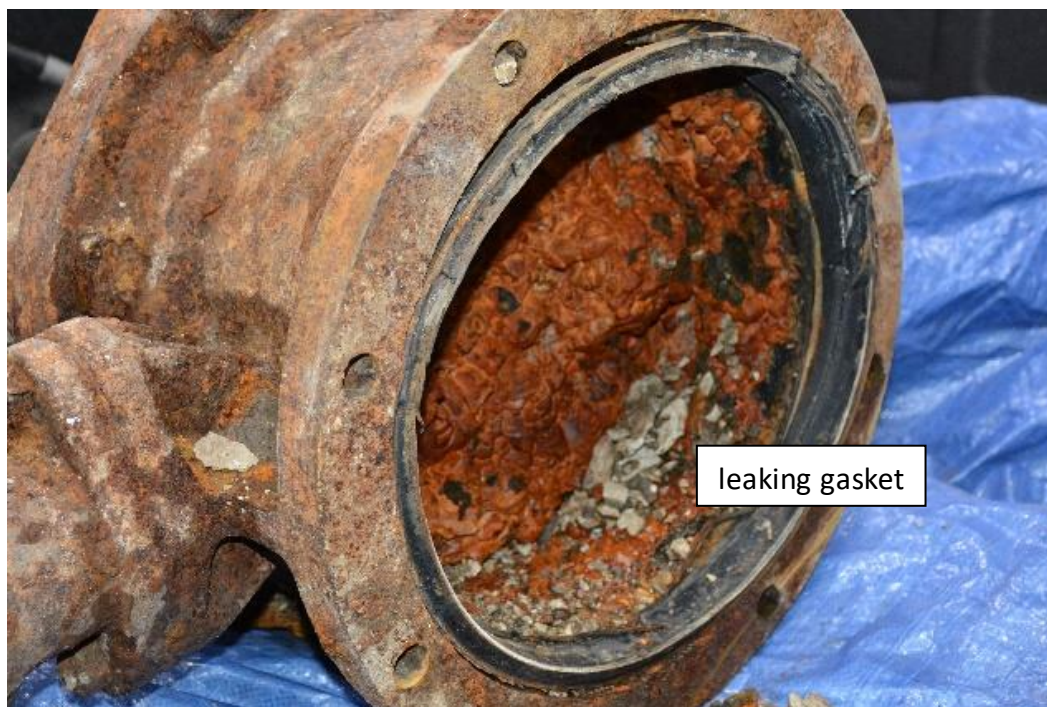
Figure 9 – 12" valve, and gasket that was leaking.

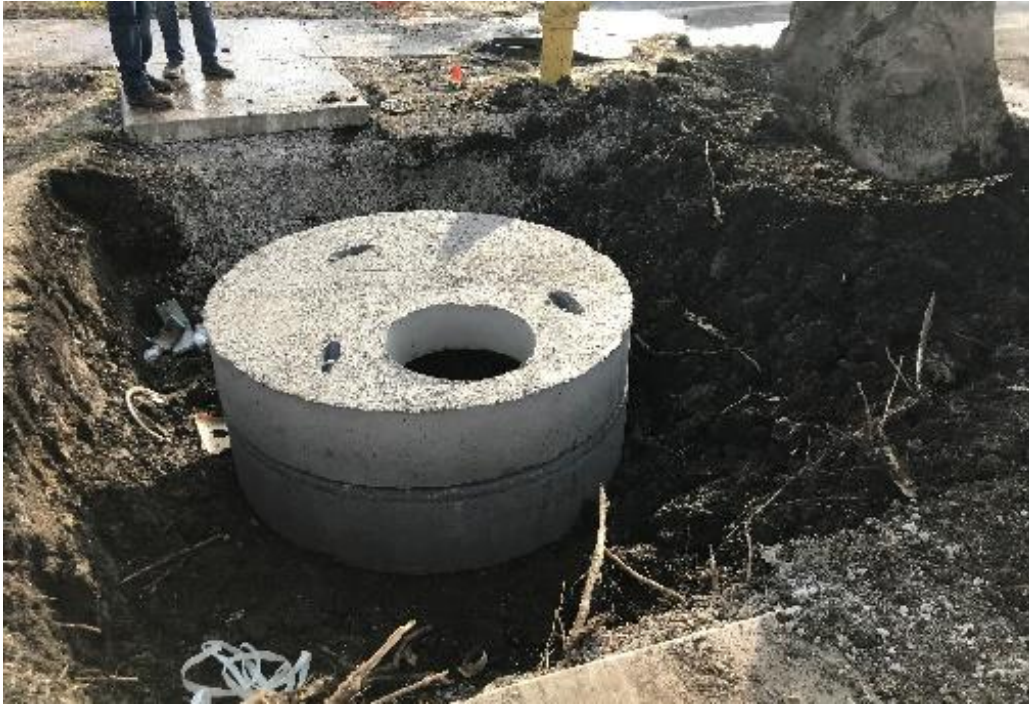
Figure 10 – Valve vault after excavation, post-incident.
