**LINE OF DUTY
DEATH REPORT
REPORT SLIDES**

F2019-09

Paid-On-Call Fire Fighter
Becomes Disorientated and Dies
Following Stairway Collapse in
Two-Story Vacant Structure Fire –
Illinois

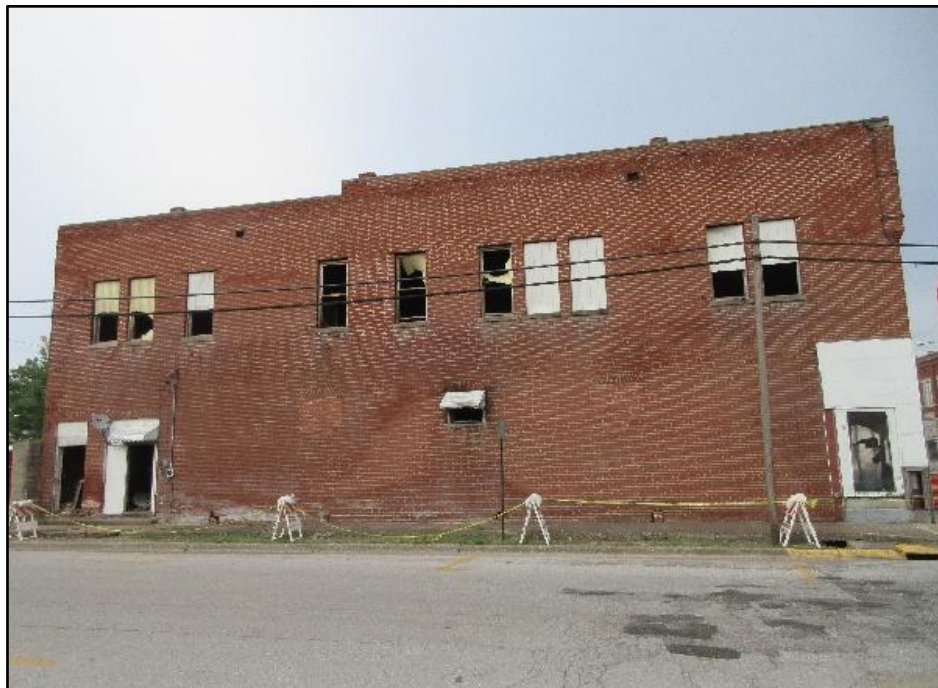
Side Bravo of the fire building.
(NIOSH photo)

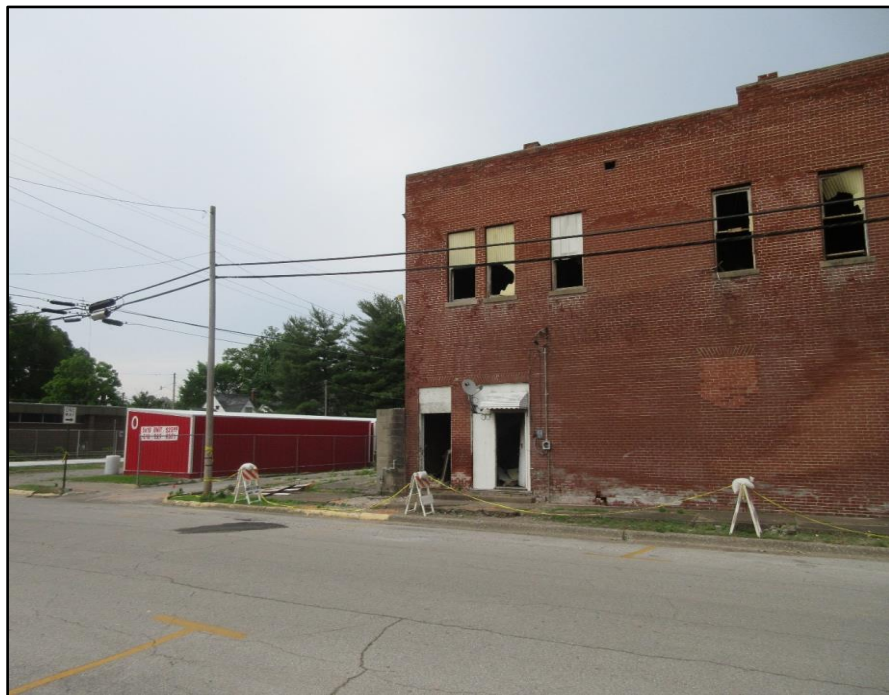
Side Bravo north and south doors, shown left to right. Engine 201 firefighters placed a ground ladder to the completely cleared window on the 2nd floor. *NIOSH Photo*

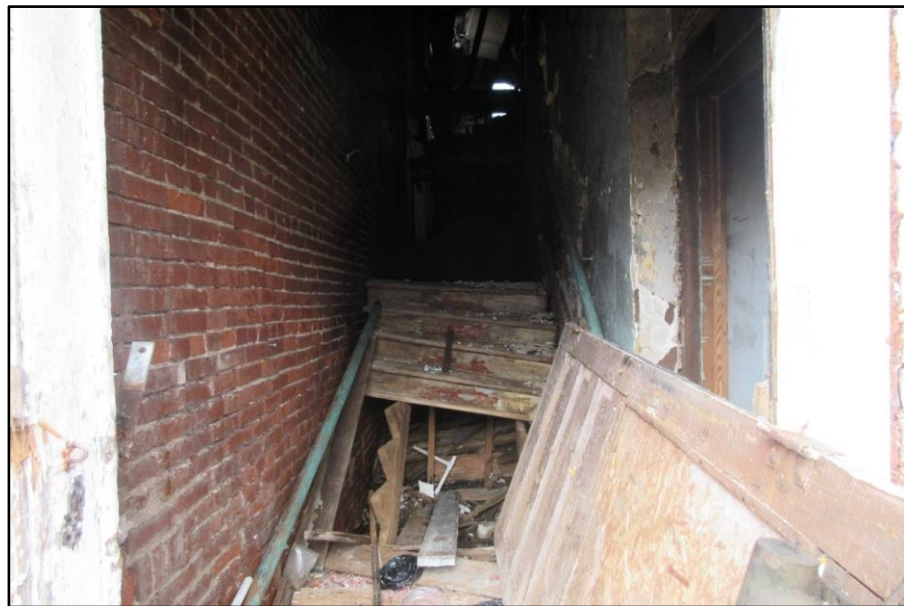
The stairwell against Side Charlie where the lieutenant and firefighter made entry to 2nd floor. The lieutenant was rescued by RIT underneath of the stairwell.

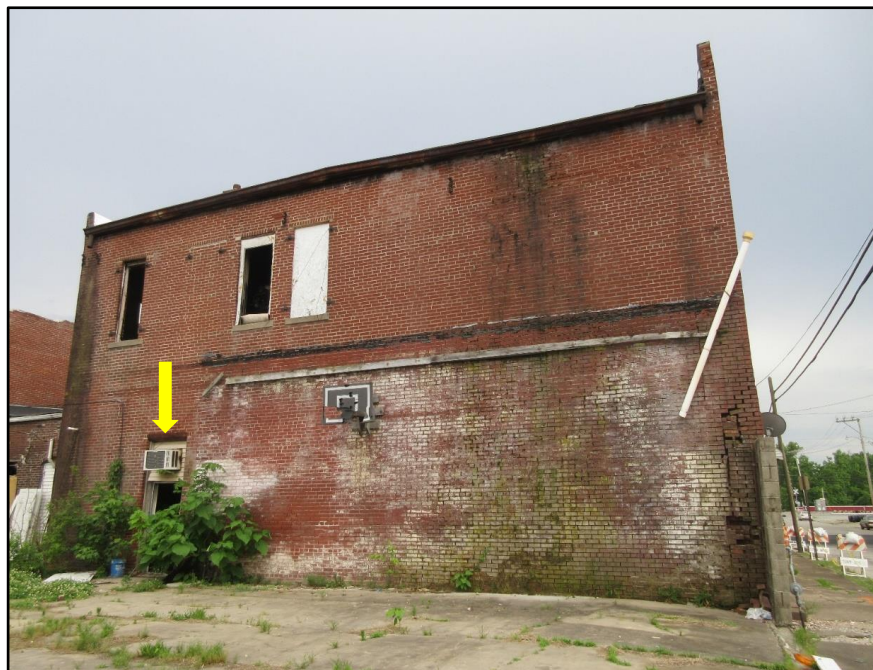
Side Charlie door with A/C unit over top of it. The stairwell landing to 2nd floor that collapsed is just above door and A/C unit inside the wall.
Photo by NIOSH

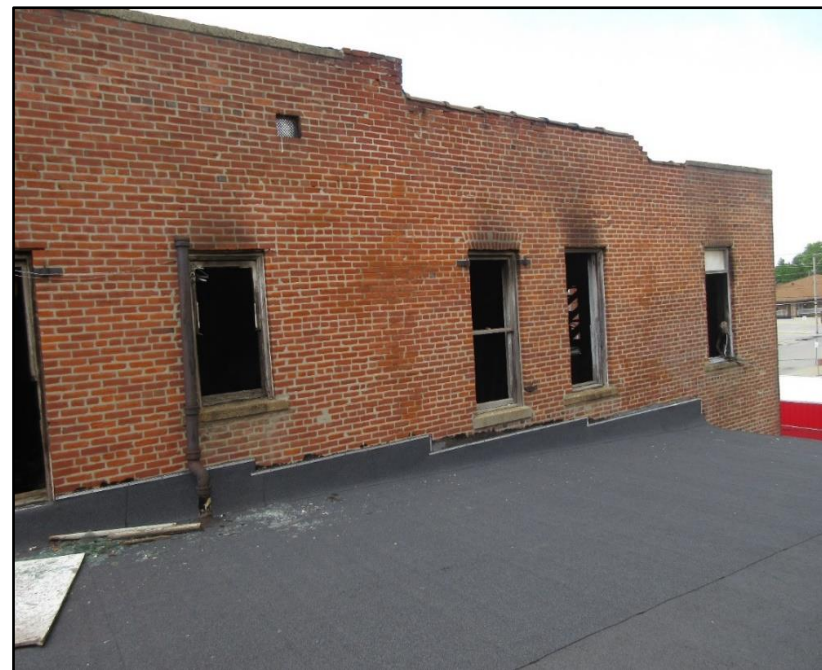
The Delta Exposure 1 first floor roof. The third window from left was used by RIT to recover firefighter.
Photo by NIOSH

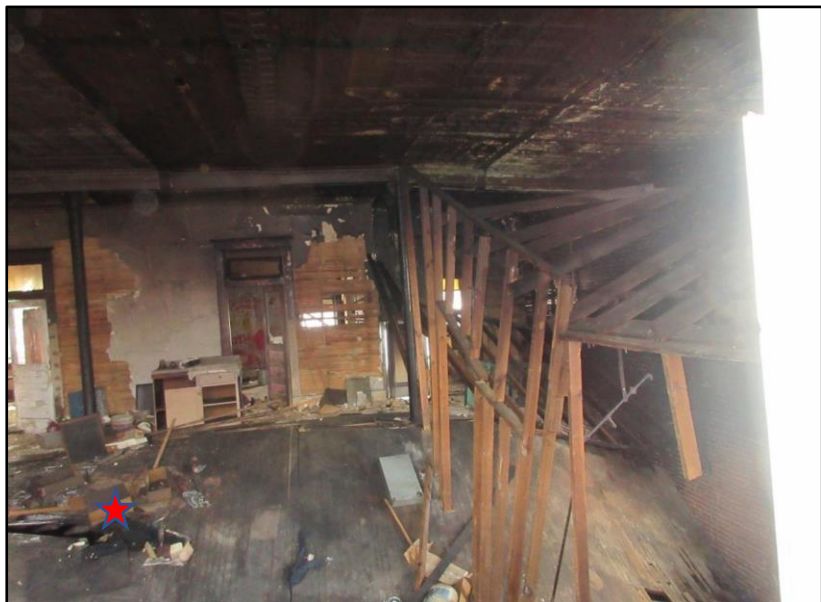
A view of the 2nd floor from Delta 1 Exposure roof. Note the hole in the Side Charlie/Side Delta corner. The red star indicates the approximate location of downed firefighter.

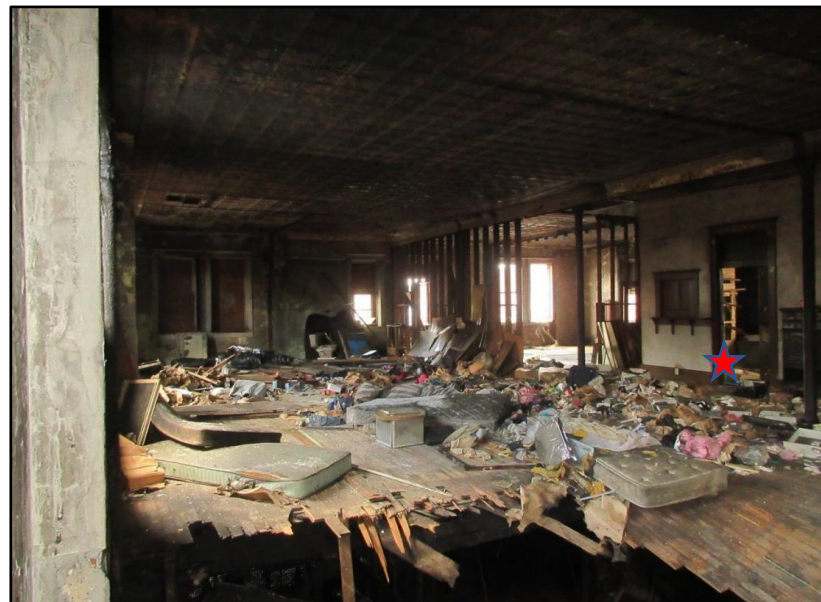
A view of the 2nd floor looking from Side Charlie/Delta corner to the Side Alpha/Side Bravo corner. The hole in the floor is approximately 10 feet x 25 feet on Side Charlie/Side Delta corner where the stairwell was located. The downed firefighter (indicated by red star) was located approximately 10 feet to the right of the mattress near the right corner of the hole. *Photo by NIOSH*
