INCIDENT REPORT

INSPECTION #: 1569882 REPORT DATE: 1/12/2024

The Marmora Incident: Firefighter Seriously Injured and Later Dies After Loss of Accountability at a Residential Fire

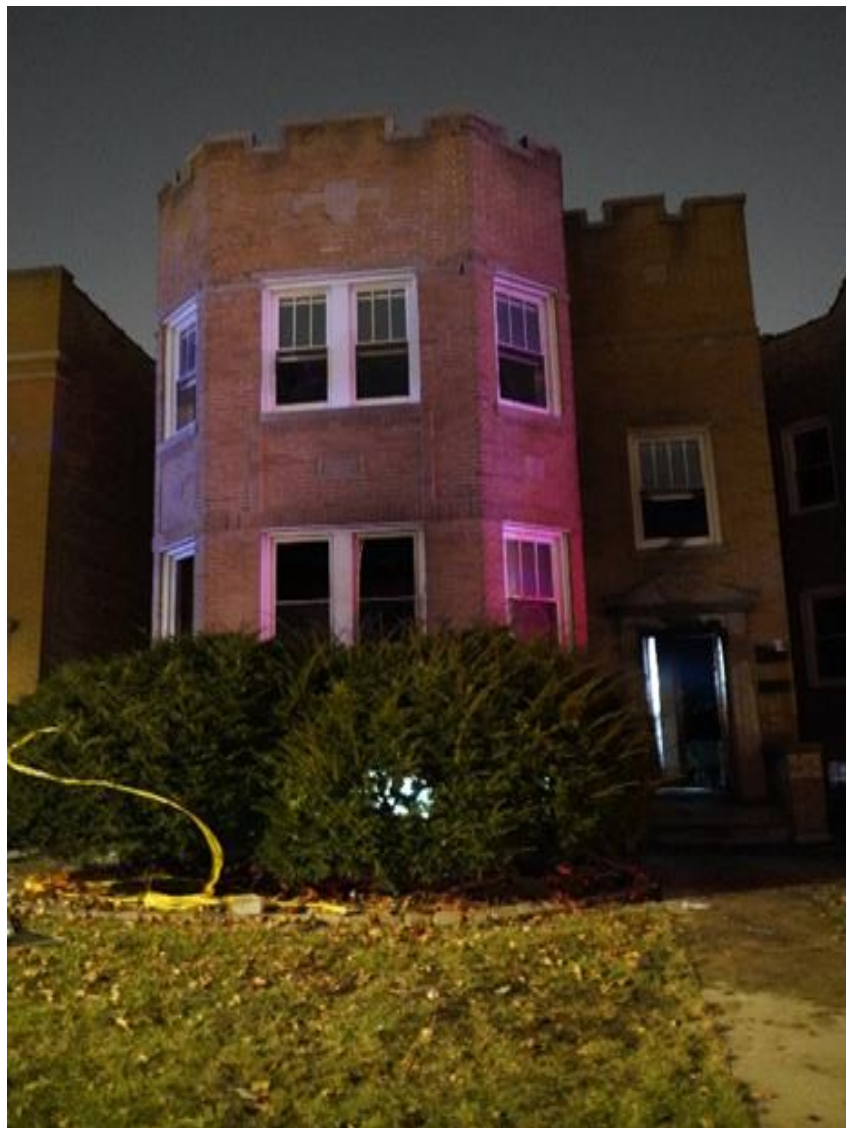
Figure 1 - "Alpha" side of residence after extinguishment (photo credit: affected department)

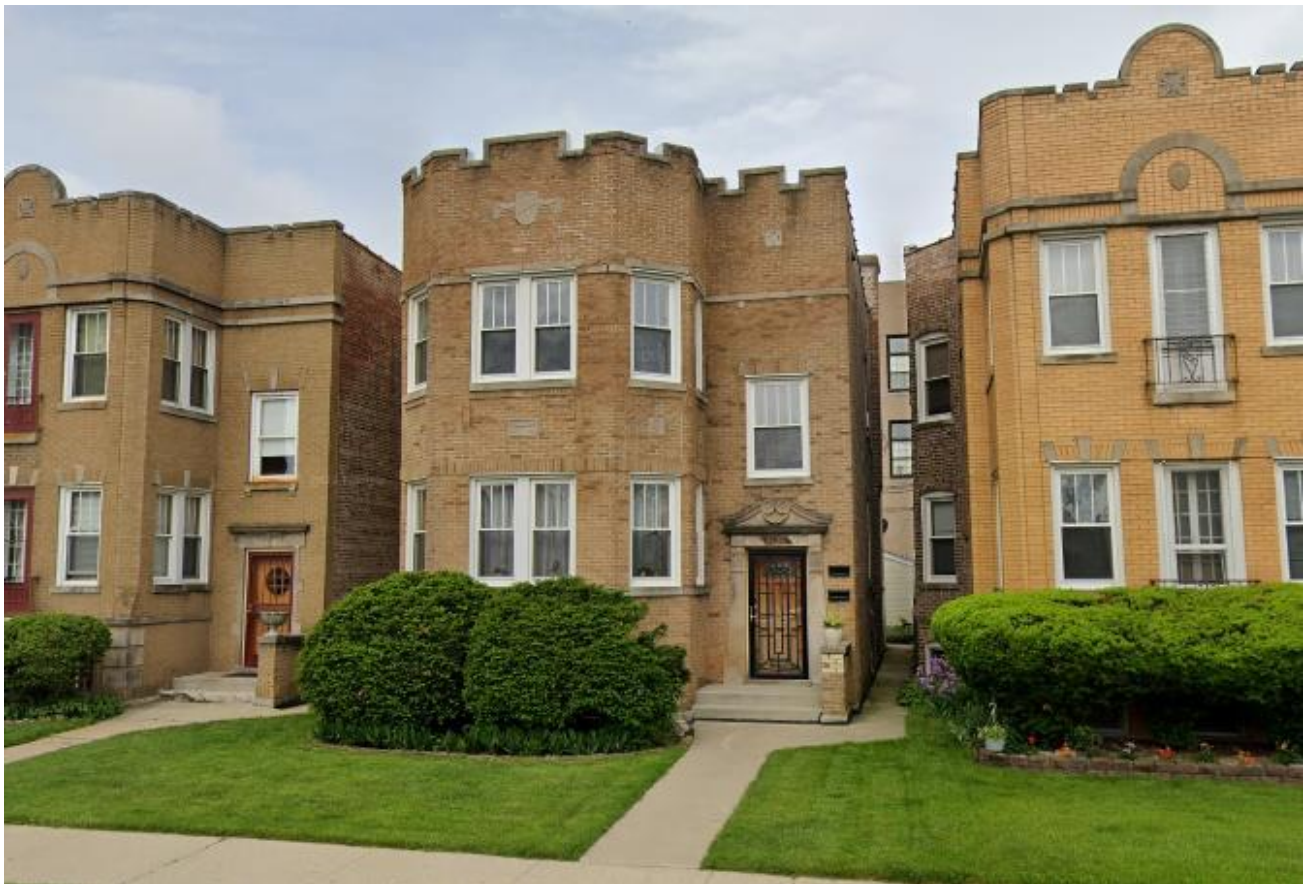
Figure 2 - May 2019 photo of "Alpha" side of residence (photo credit: Google)

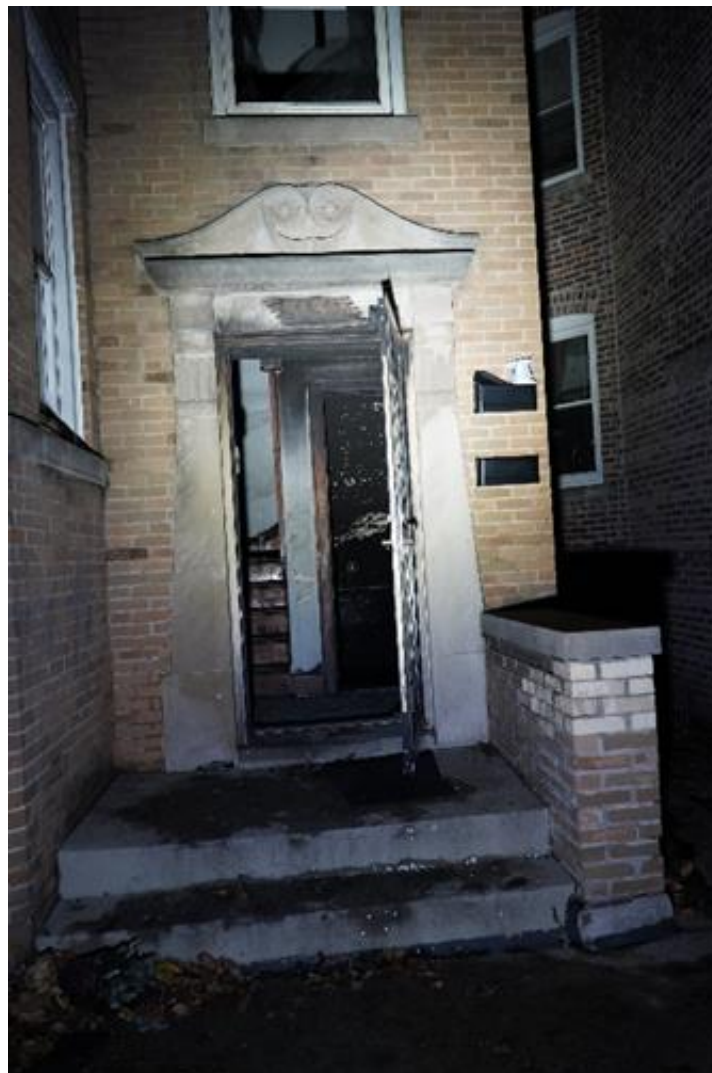
Figure 3- Entrance on “Alpha” side (photo credit: affected department)

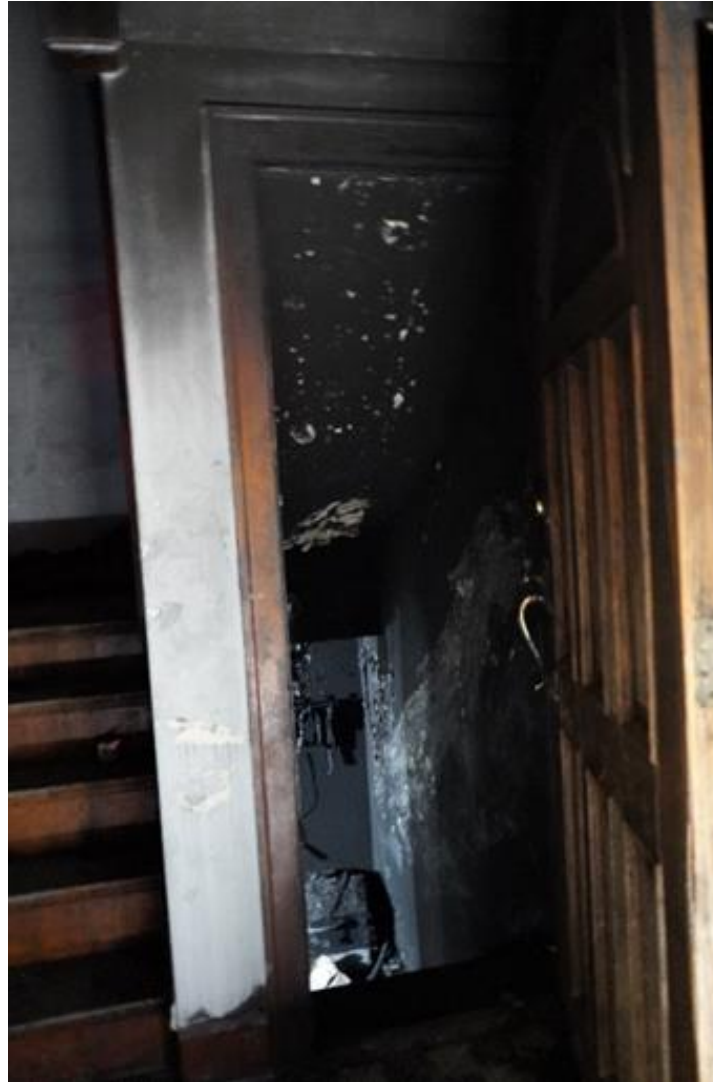
Figure 4- Foyer area inside entrance (photo credit: affected department)

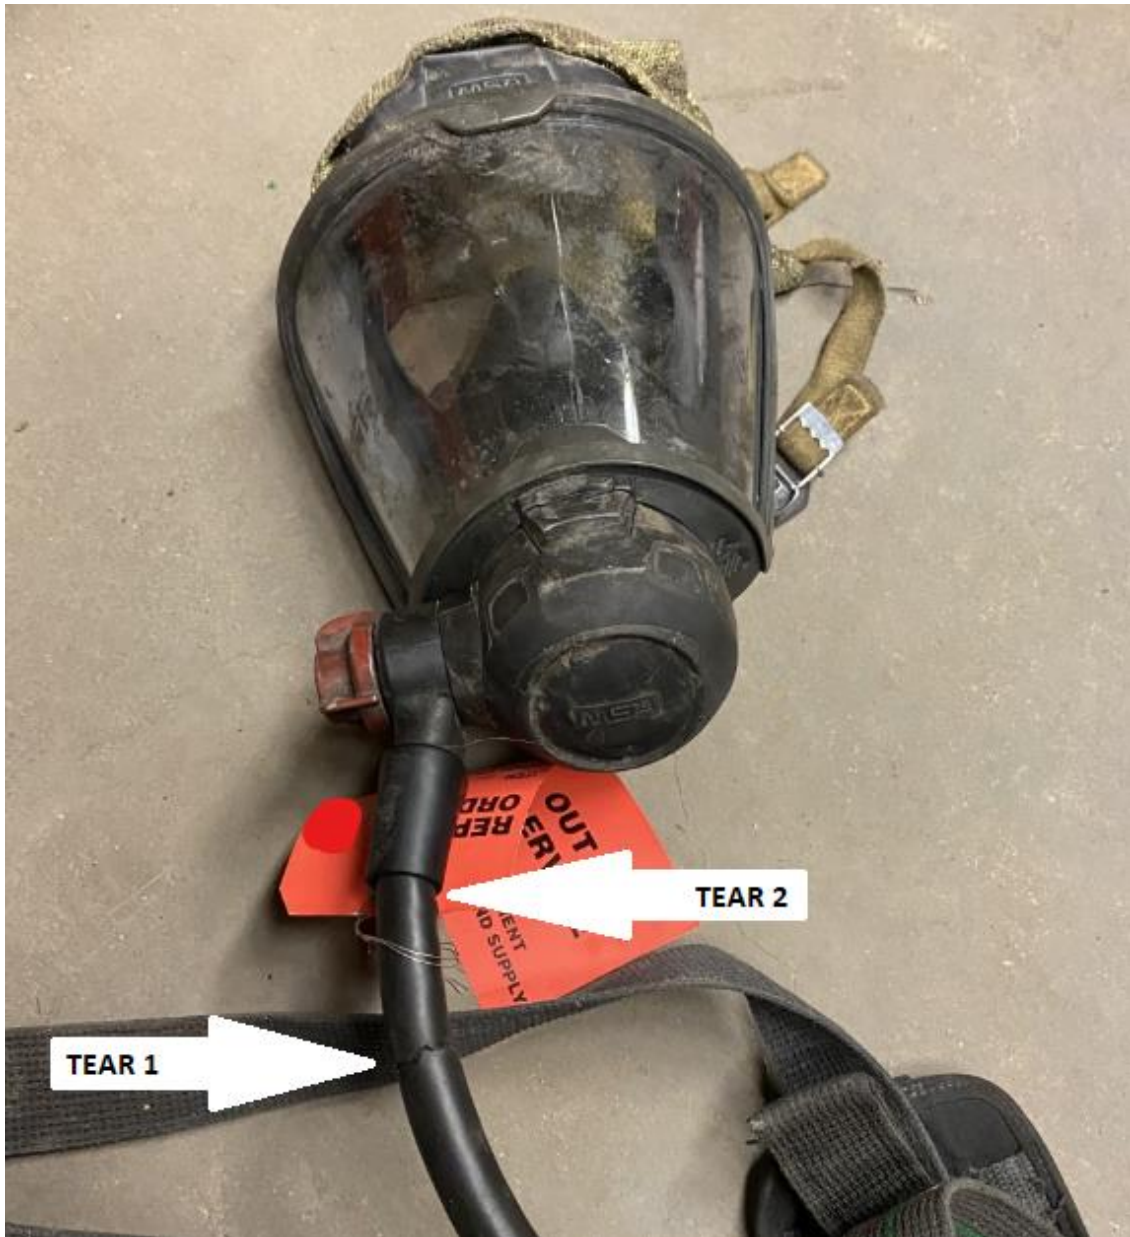
After the incident, the SCBA was confiscated by a command officer and provided to the department’s division of breathing apparatus services. The division performed a visual inspection, event log download, and flow test on the SCBA. The division report noted that the unit could not be flow tested in the present condition due to a damaged low-pressure hose. The low-pressure hose was replaced so the rest of the unit could be flow tested for proper function. The unit passed the flow test, however the facepiece failed the leak test as it was fouled with debris. The report notes that it is unknown how the damage occurred to the low-pressure hose, or when the fouling of the facepiece occurred.

Based on the information available, it appears that the SCBA performed normally until approximately 2:16 AM when the unit started to rapidly lose breathing air pressure. It is likely that this rapid loss is related to the damaged low-pressure hose. Photographs of the SCBA appear to show that the low-pressure hose is teared in

two places. One tear (“TEAR 1”) is relatively close to the connection point between the hose and the regulator. The other tear (“TEAR 2”) is at the connection point between the hose and the regulator.

Figure 5 - Post incident visual inspection of victim's SCBA (photo credit: affected department)

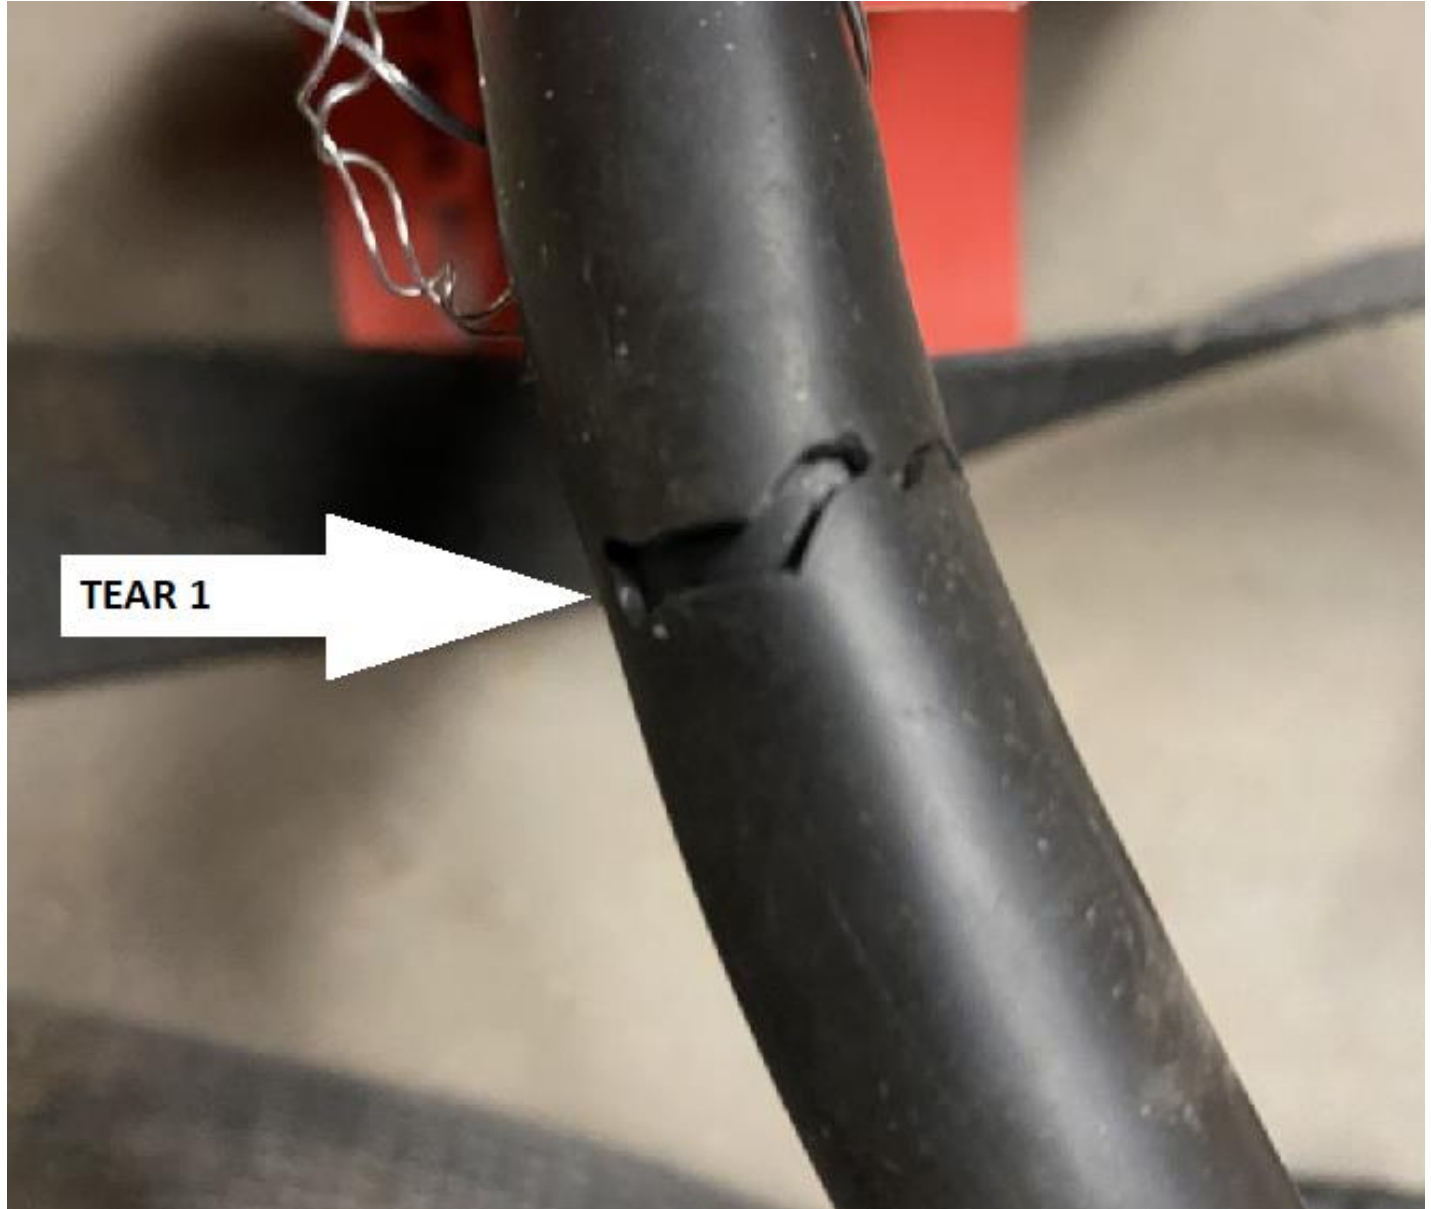
Figure 6 - Tear 1 close-up (photo credit: affected department)

IL OSHA could not determine what caused these tears that likely led to the rapid loss of breathing air. IL OSHA does presume that these tears did occur at approximately 2:16 AM since the SCBA performed normally during the morning inspection on December 15, 2021, and during the incident from approximately 2:13 AM until the rapid air loss event at approximately 2:16 AM.

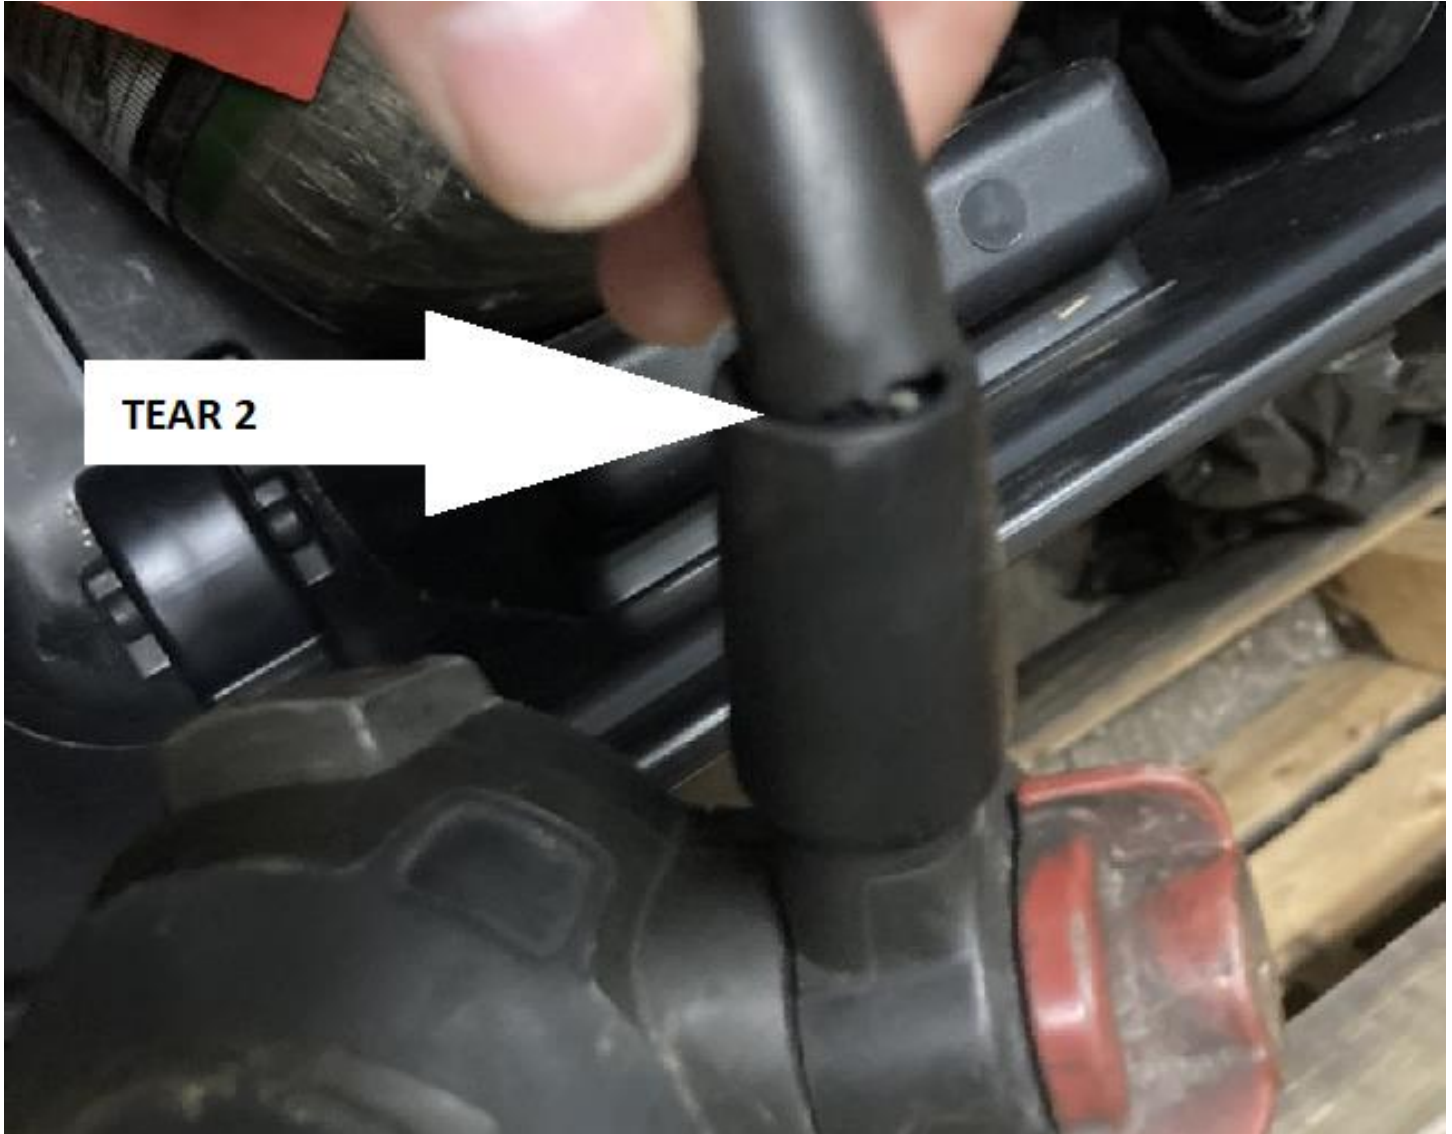
Figure 7 - Tear 2 close-up (photo credit: affected department)

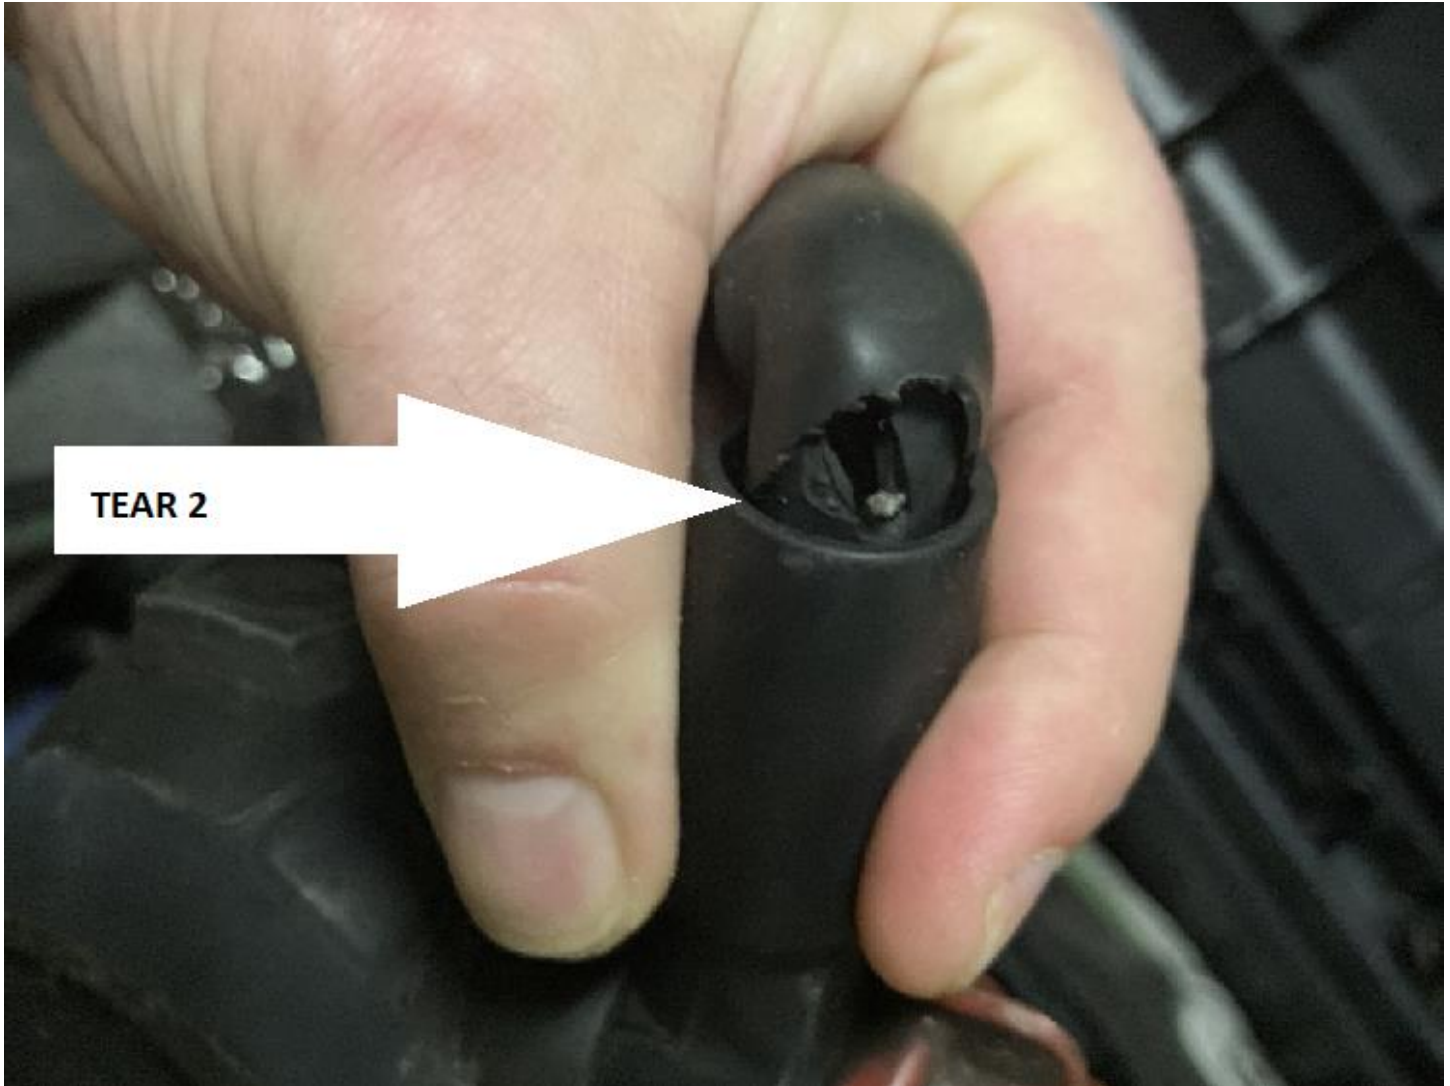
Figure 8 - Tear 2 close-up, hose pulled back (photo credit: affected department)
