INCIDENT REPORT

INSPECTION #: 1631129 REPORT DATE: 3/1/23

The Sacramento Incident: Laborer Dies After Being Struck and Crushed by Refuse Truck

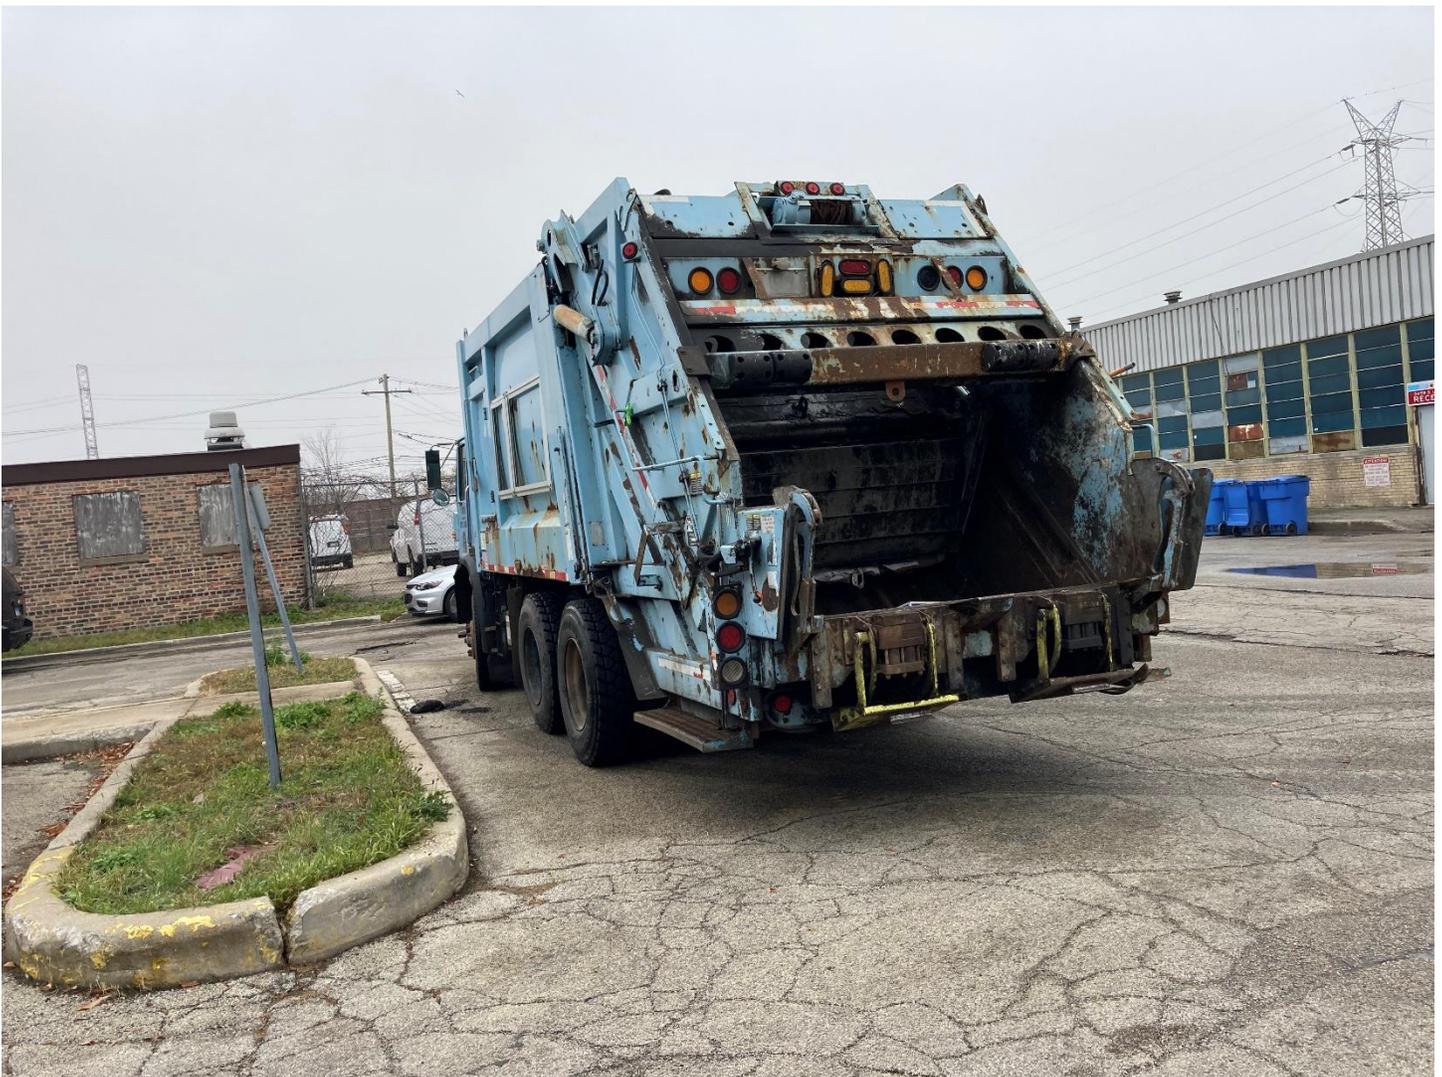
Figure 1 – The refuse truck involved in the incident.

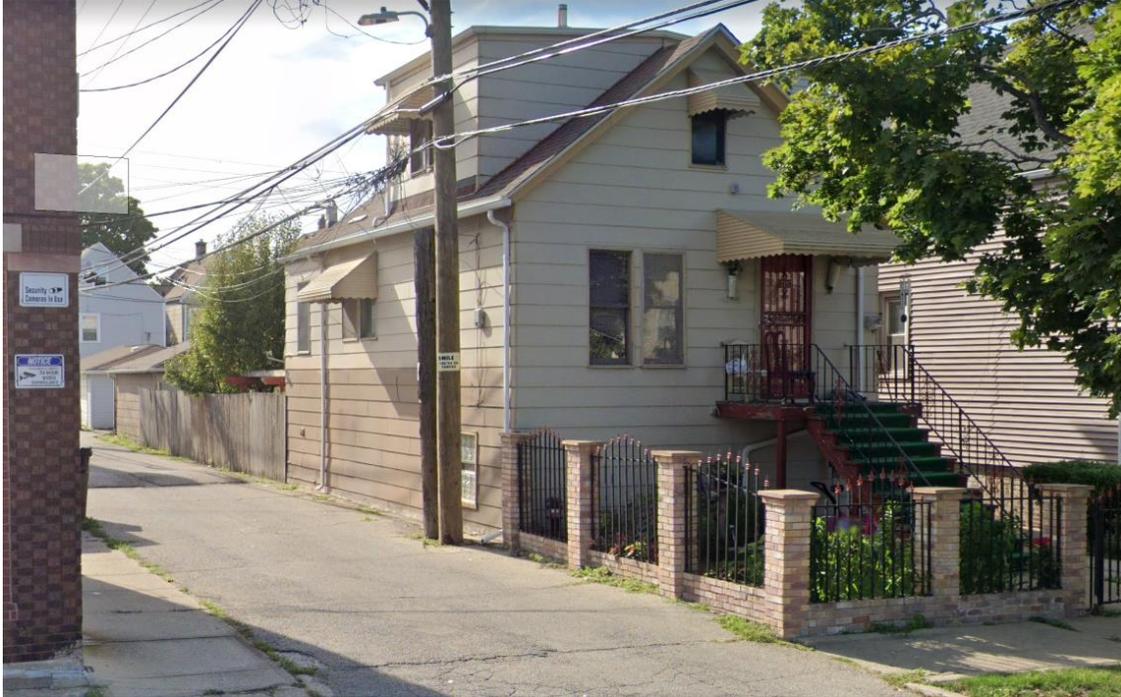
Figure 2 – Location pre-incident (photo credit: Google, Aug. 2019).

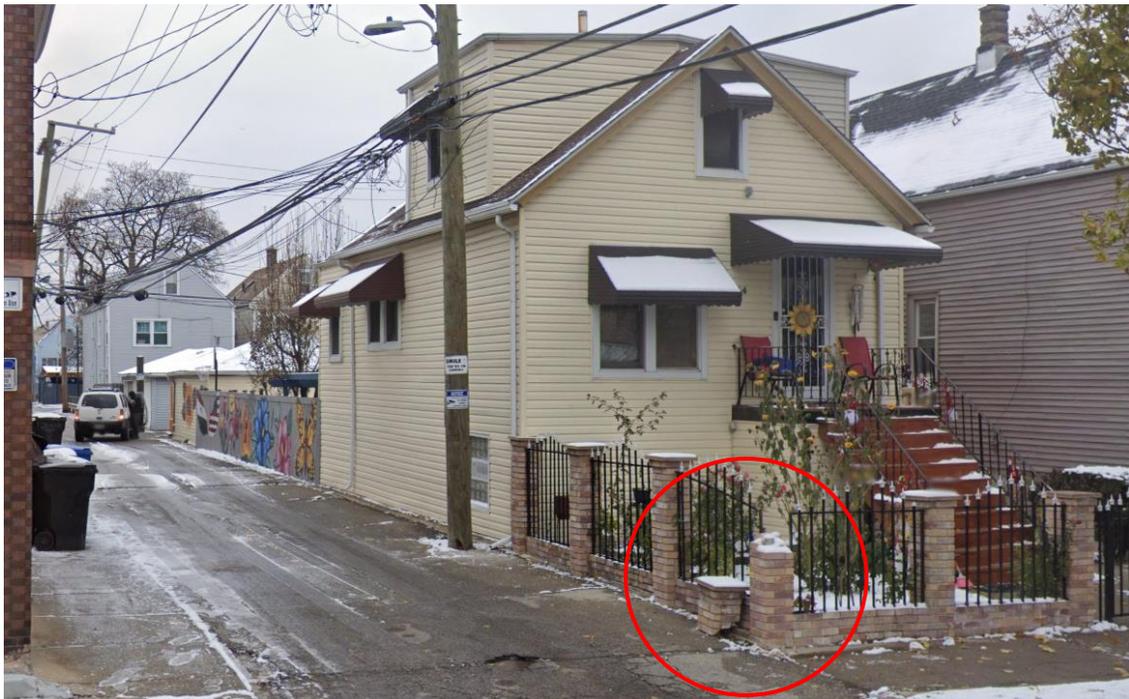
Figure 3 – Location post-incident with damaged brick column (photo credit: Google, Nov. 2022).

Direct Cause: According to the coroner's report, death was attributed to multiple blunt force injuries due to the victim being pinned between the truck and brick column.

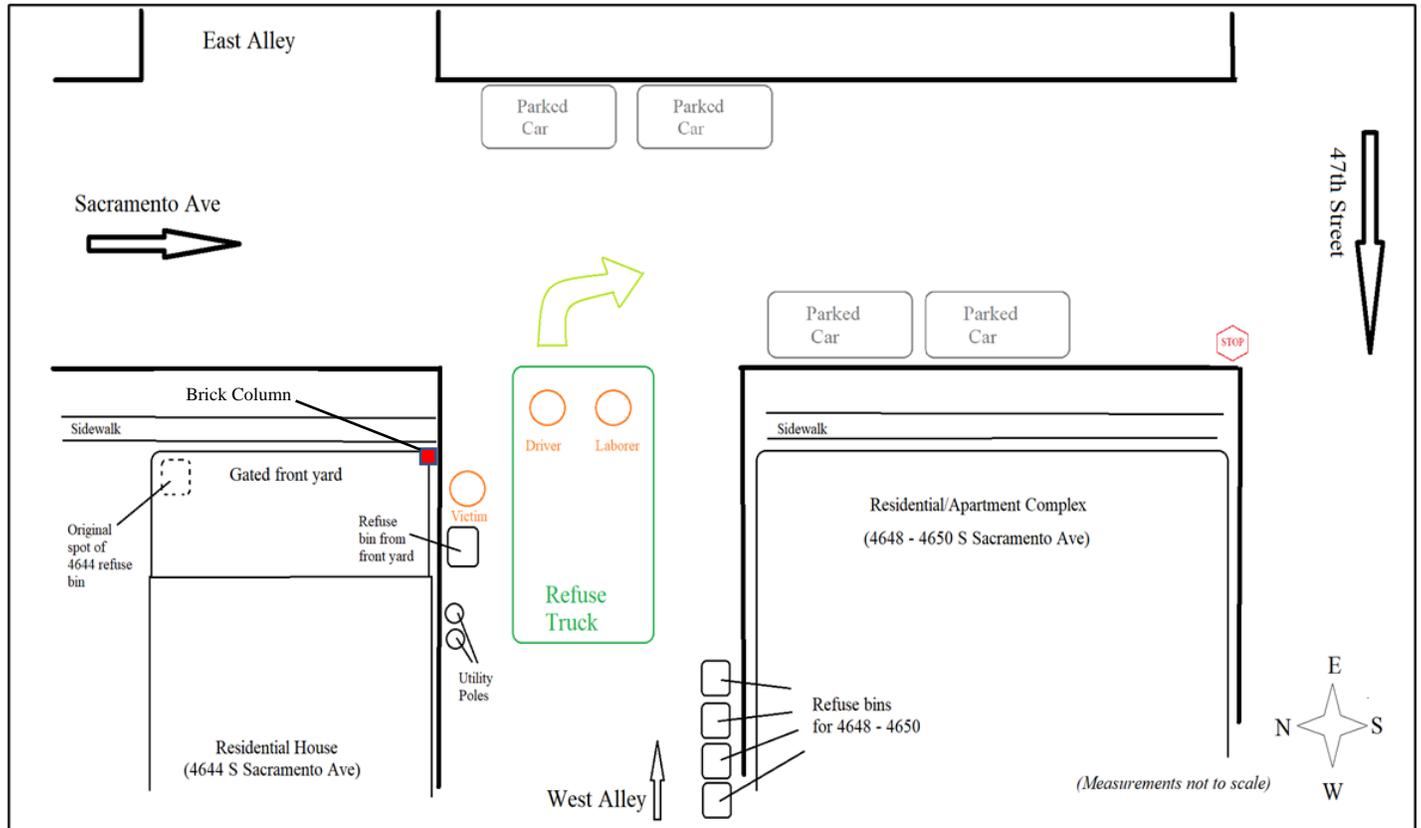
Figure 4 – Diagram indicating positions immediately prior to the incident.

3. The driver and victim did not establish and maintain visual contact during vehicle backing immediately prior to the incident.

Control measure: Ensure visual contact between the driver and laborer(s) during vehicle backing.

Control measure: Ensure vehicle perimeter safety cameras are installed on refuse trucks so drivers have enhanced visibility and situational awareness.
