# WORKPLACE SOLUTIONS

From the National Institute for Occupational Safety and Health

## Preventing Deaths and Injuries to Firefighters Working at Strip Mall Fires

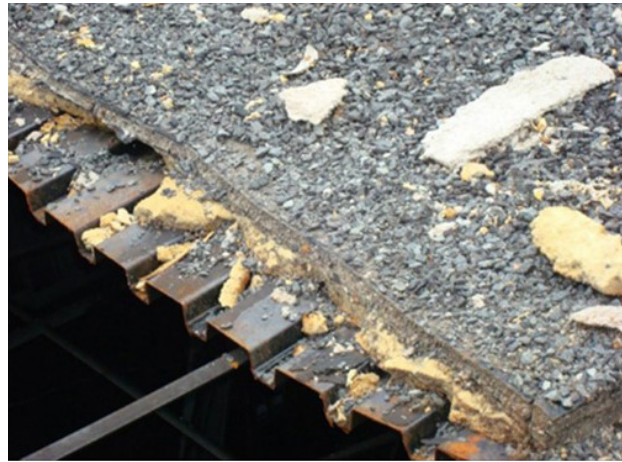
The ladder company had difficulty cutting through the flat metal roof due to the composition of the roof. They unsuccessfully tried to ventilate the roof using a chainsaw and had to switch to a circular saw with a metal cutting blade. (See **Photo 1**).

**Photo 1.** Construction of flat metal roof covered with asphalt foam insulation, and gravel. Chain saws were initially used to open the roof for vertical ventilation but would not cut through the metal deck. A circular saw with metal cutting blade had to be used.

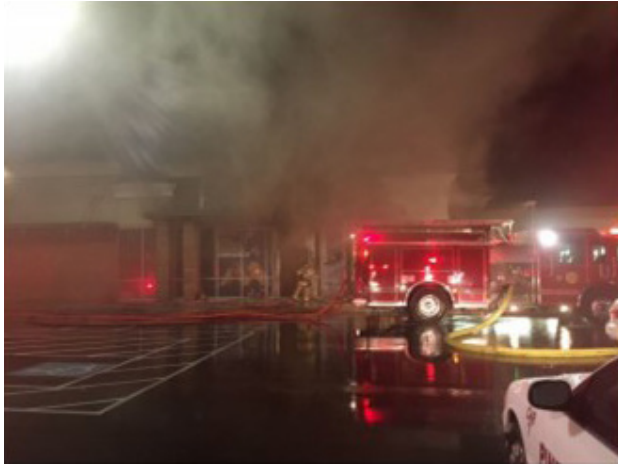
Conditions continued to deteriorate inside the structure with increasing smoke and heat, plus no visibility (See **Photo 2**). Due to the deteriorating conditions and trying to get FF2 out of the building, the Engine 3 lieutenant followed the hose-line until he came to a coupling. He looked back for FF2 and saw that he was standing. The lieutenant turned around and grabbed FF2. They fell over a display of golf bags and became separated from the hose-line.

**Photo 2.** The photo shows the interior conditions.
