**LINE OF DUTY  
DEATH REPORT  
REPORT SLIDES**

**F2019-03**

**Brick Gable End Collapses at a Residential Fire Killing a Fire Captain and Seriously Injuring Three Other Firefighters – Illinois**

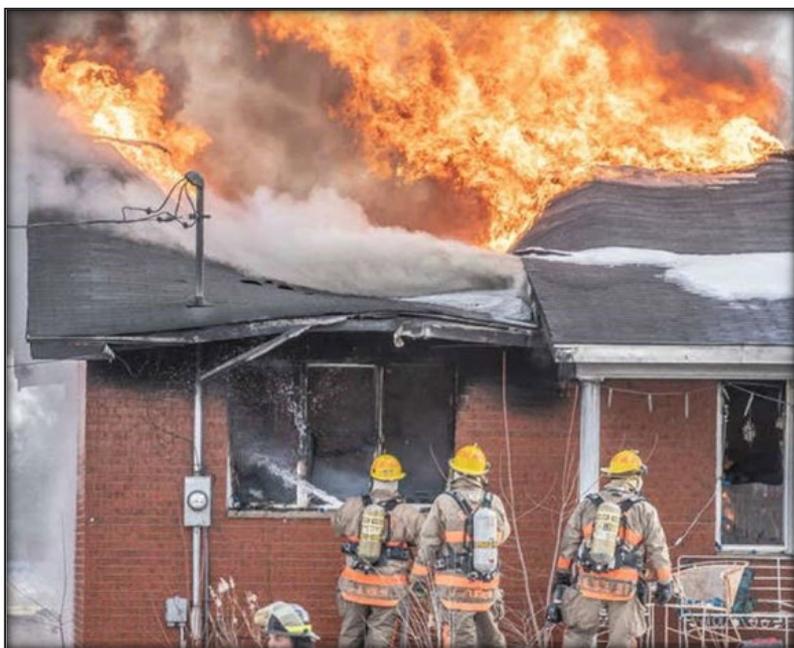
Firefighters flowing water through a window on Side Alpha. The roof had partially collapsed, but no collapse zone had been established.

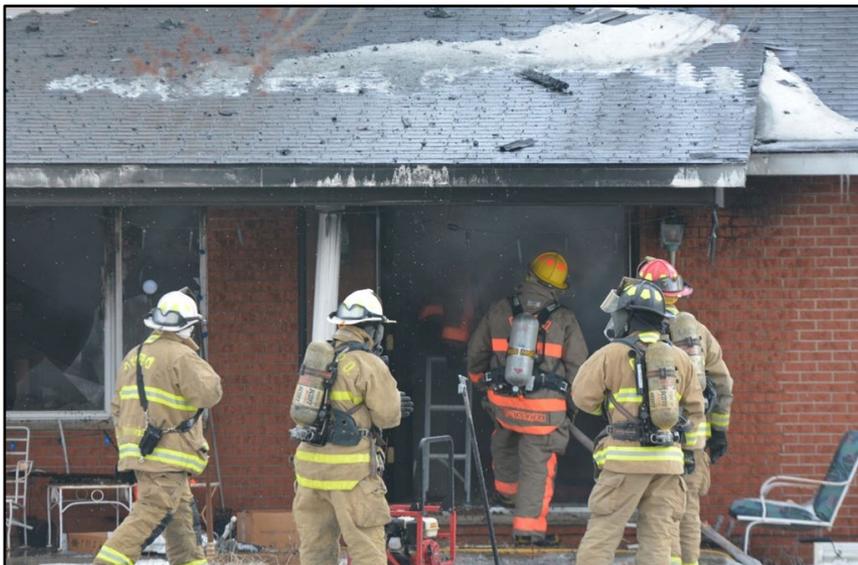
Crews are operating interior and using an attic ladder to gain access to the attic. Crews are attempting to stop the fire from spreading to Side Delta via the attic.

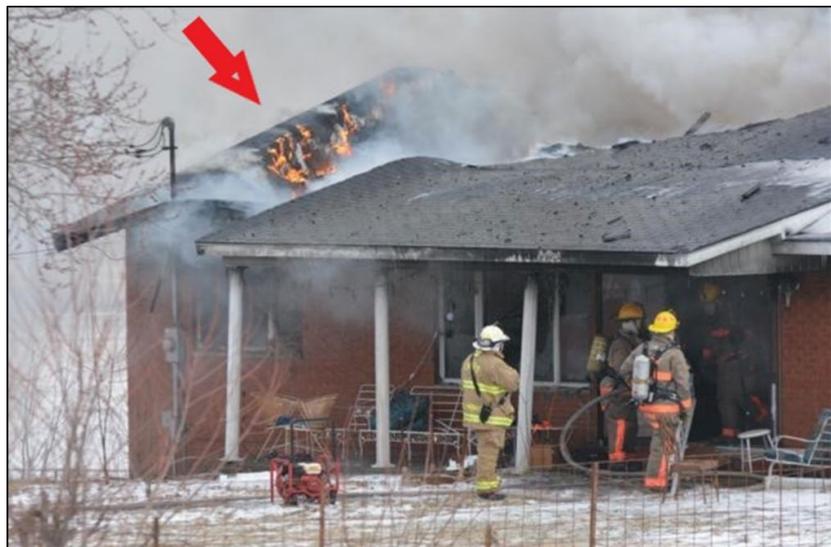
Firefighters conducting interior operations thru the front door even though approximately 45 to 50% of the roof had collapsed into the 1<sup>st</sup> floor. Red arrow indicates the end of the bricked gable rafter that eventually collapsed onto the driveway on Side Bravo. Photo taken from Side Alpha looking toward Side Bravo.

- At about 1655 hours, the assistant chiefs from FPD 16 and 22 became concerned about a possible roof collapse and the stability of the Side Bravo bricked gable rafter.
- These concerns were voiced to the Side Bravo/Charlie sector chief who felt the brick wall supporting the gable looked stable with no bulging, bowing, cracking, or spooling. Therefore, no collapse zone was established.
- NIOSH received conflicting information about whether these collapse concerns were voiced to Command.

- Fire departments should ensure Command establishes collapse/exclusion/no-entry zones at defensive fires **as needed** due to dangerous or hazardous conditions.
- Fire departments should ensure firefighters are trained in situational awareness, personal safety, and accountability.
- Fire departments should ensure the first arriving officer conducts a detailed scene size-up.
- During initial fire ground operations, fire departments should ensure Command conducts a risk assessment, develops a risk management plan, and incorporates these into an incident action plan (IAP). The IAP needs to be clearly communicated to responding personnel and, for more extensive incidents, a tactical worksheet may be required.

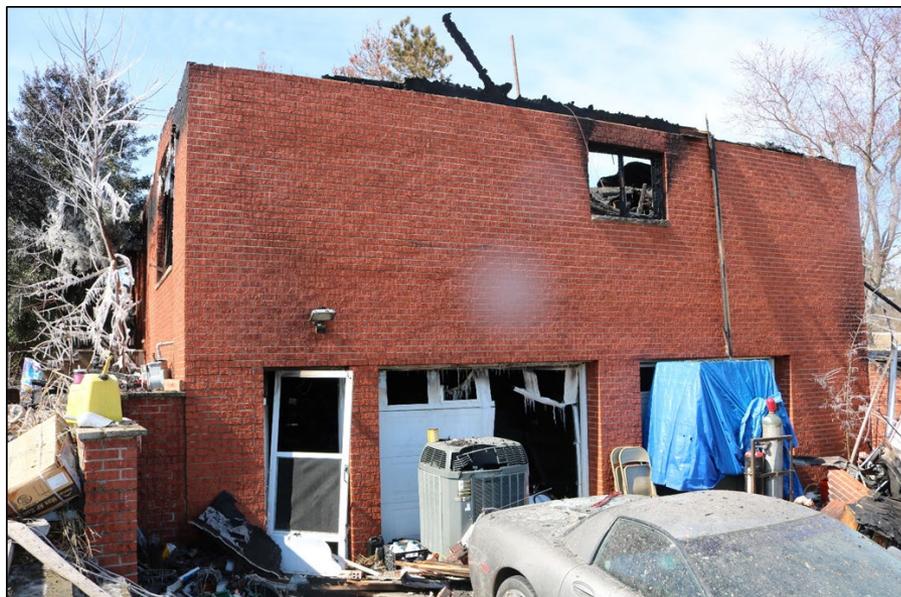
- At 1656 hours, Command radioed that the basement was about to be opened. It took a few minutes for the five firefighters operating and assisting with the K-12 saw to cut open the lower-level garage door (see photo on next slide).
- At 1703 hours, the roof's triangular brick gable rafter suddenly "tipped over" falling as a single sheet onto the driveway; a perimeter collapse (see photo on next slide).
- The gable fell approximately 21 feet before striking four firefighters from E1412 and E2212 working to open the garage door on Side Bravo. The fifth firefighter working on Side Bravo was not hit or injured.

Side Bravo showing below grade man door on the Side Bravo/Charlie corner, as well as the left and right garage doors. The photo was taken after the brick gable had collapsed. The right side of the garage door has been cut open.
