**KMG International BV**

Bulletin No:	FRB24-SB008
Release Date:	August 2 nd , 2017
Effective Date:	August 2 nd , 2017
Supersedes:	none
Completion Date:	See text
Page:	1 of 7

SAFETY ALERT

Ride Mfg:	KMG International BV	Affected Production Dates:	All
Ride Name:	Afterburner / Fireball Afterburner Park model	Affected Serial Numbers:	FRB24 serials 01 – 39 FRB24P serials 01 – 03
Model Number:	FRB24 and FRB24P		
Abstract of Issue:	Inspection of gondola support beam and joint

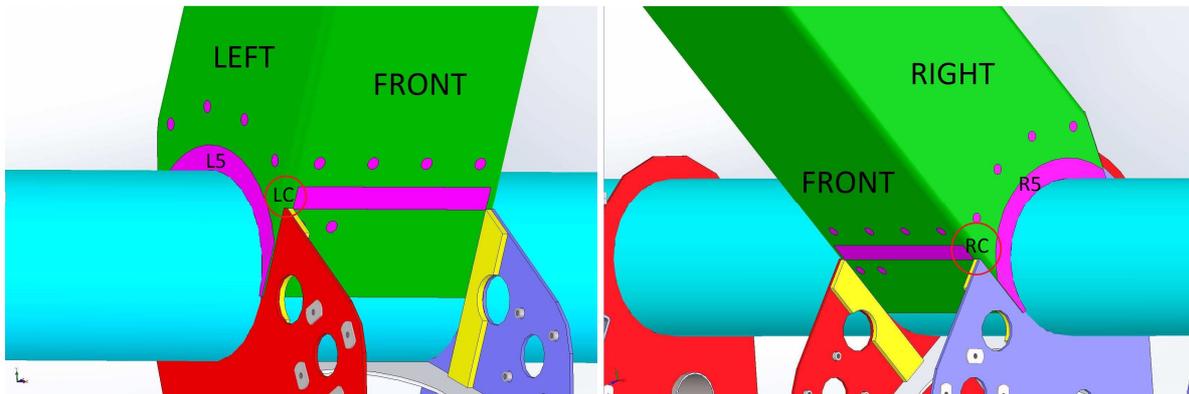
Areas:

- Gain access to all four sides of the gondola support beam and around the joint. The secondary lock solenoid can be left in place.
- Remove all parts and paint in below mentioned areas L5 and R5 on both sides of the beam joint and on both corners LC and RC of the support beam joint:

- Test for cracks using magnetic testing following ISO 17638.

Accepted: Magnetic test results are meeting class 1 criteria as per ISO 23278.

Rejected: Magnetic test results are not meeting class 1 criteria as per ISO 23278.

Do NOT return ride to service.

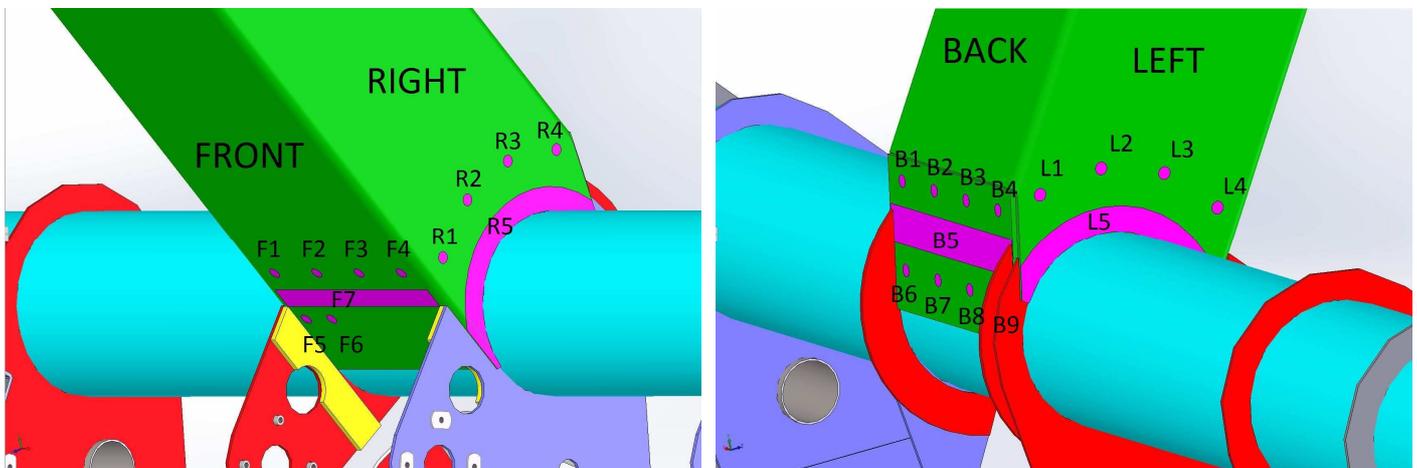
Areas:

1. Remove all parts and paint in below mentioned areas L, R, F, B following the specific locations in below drawings.
 2. Do a wall thickness measurement in all numbered areas L, R, F, B following the specific locations in below drawings.
- Applicable standard for inspection: EN14127. Equipment: Ultrasonic thickness measurement equipment with minimum an A-scan. Probe: GE / Krautkrämer DA312, Trusonic TS-400 or equivalent.

Areas L5, R5, B5, F7:

Test complete area and take smallest measurement over area.

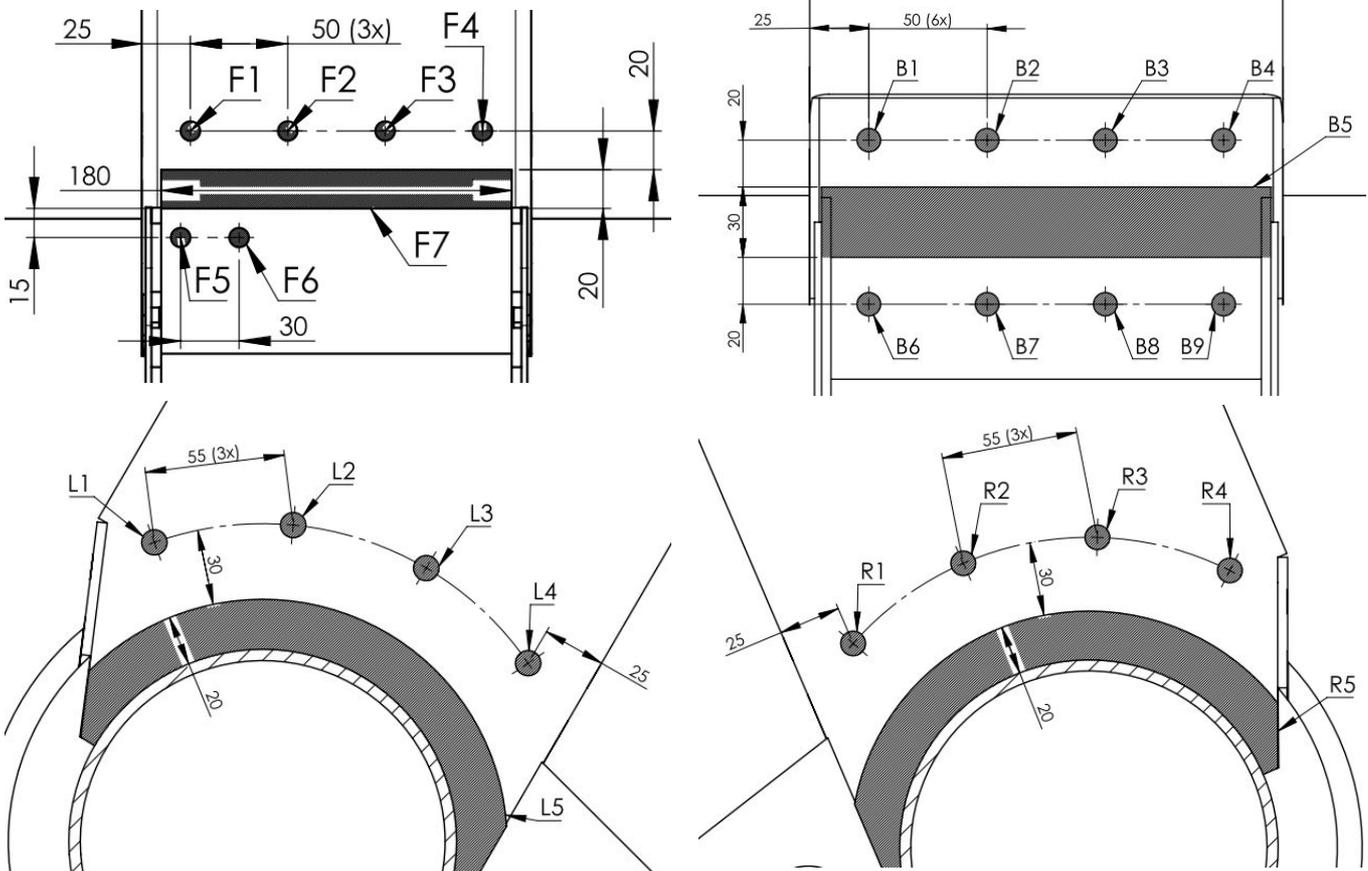
Location dimensions (measurements in metric unit mm):

Accepted: All measured area meet a wall thickness ≥ 3 mm.
 Rejected: One or more measured areas have a wall thickness less than 3mm.
Do NOT return ride to service.

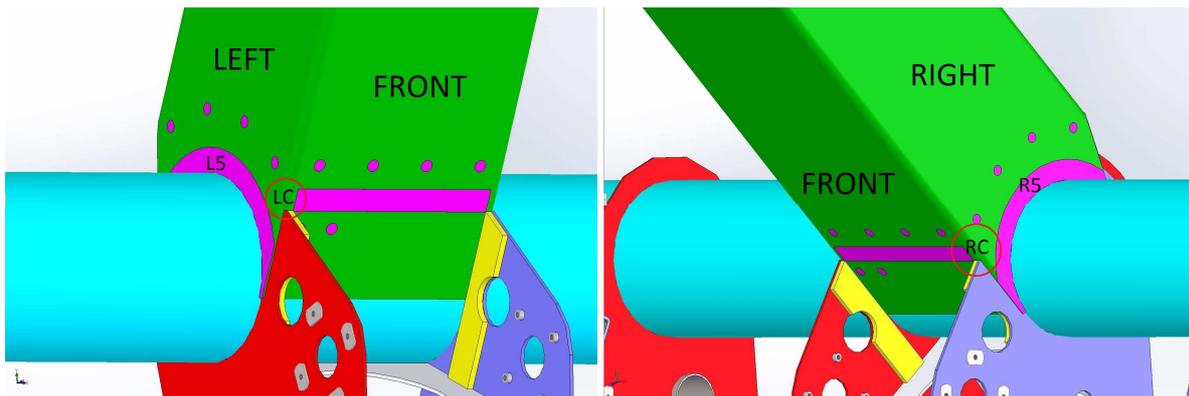
1. Gain access to areas described in below images.
2. Visually inspect areas L5 and R5 and corners LC and RC, looking for cracks. Applicable standard for inspection is ISO 17637 and acceptance criteria following ISO 5817 acceptance class B.

Accepted: Visual test results are meeting class B criteria as per ISO 5817.
 Rejected: Visual test results are not meeting class B criteria as per ISO 5817.
Do NOT return ride to service and consult KMG.
