# WORKPLACE SOLUTIONS

From the National Institute for Occupational Safety and Health

## Preventing Deaths and Injuries to Firefighters Working at Strip Mall Fires

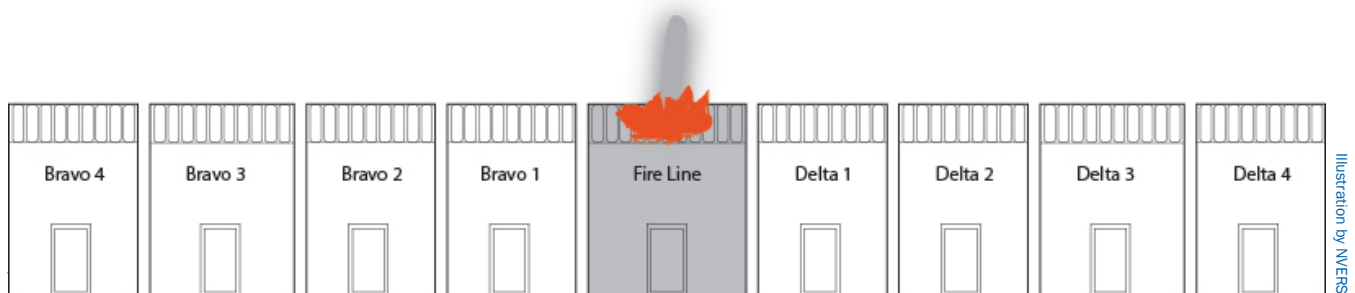
**Diagram 1.** Exposures can be indicated by the identifier for the side of the Extension (e.g., Bravo 1) followed by a number that starts adjacent to the unit on fire.
