**LINE OF DUTY  
DEATH REPORT  
REPORT SLIDES**

**F2019-03**

**Brick Gable End Collapses at a Residential Fire Killing a Fire Captain and Seriously Injuring Three Other Firefighters – Illinois**

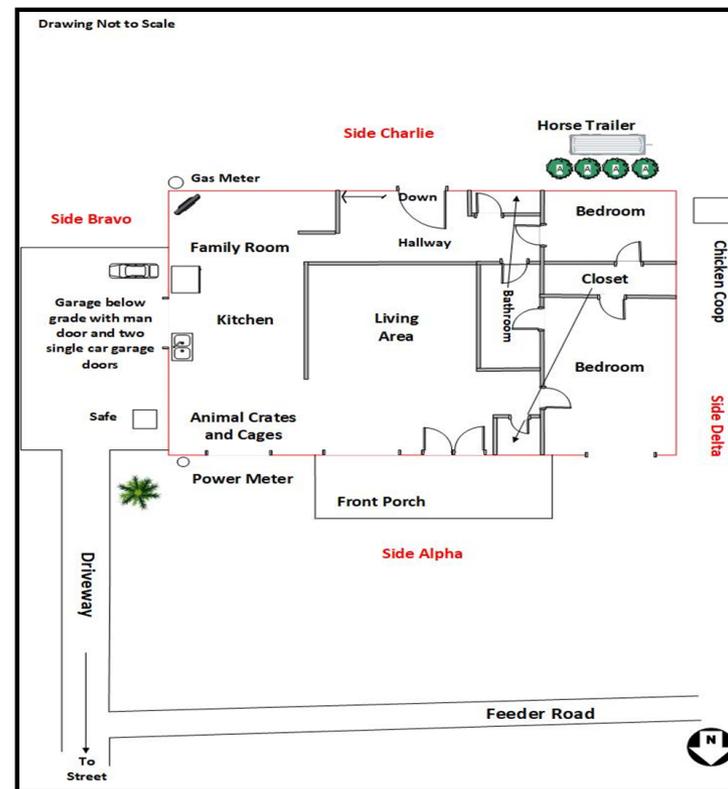
A diagram of the fire building's first floor and its position on the property. Dimensions are approximate. The home's square footage was 1,526 feet.

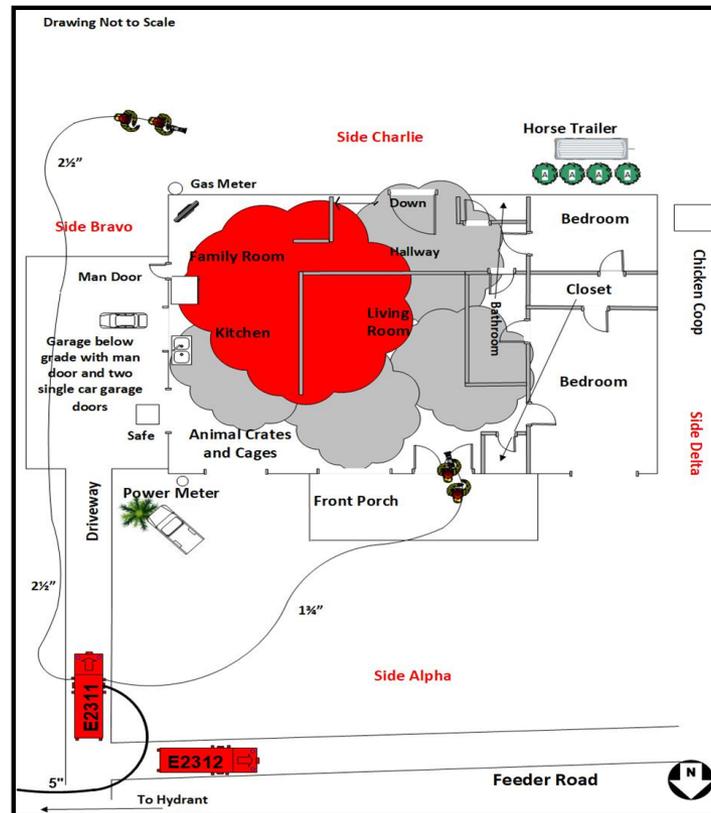
Sketch of the fire suppression equipment and personnel on the nozzles of the hoselines.
